Contract #: 04-0120F4Cty: SF/ALA Rte: 80 PM: 13.2/13.9File #: 69.28**WELDING INSPECTION REPORT****Resident Engineer:** Pursell, Gary**Address:** 333 Burma Road**City:** Oakland, CA 94607**Report No:** WIR-004003**Date Inspected:** 19-Aug-2008**Project Name:** SAS Superstructure**OSM Arrival Time:** 700**Prime Contractor:** American Bridge/Fluor Enterprises, a JV**OSM Departure Time:** 1730**Contractor:** Zhenhua Port Machinery Company, Ltd (ZPMC), Changxing Island **Location:** Shanghai, China**CWI Name:****CWI Present:**

Bridge No: 34-0006**Component:** OBG**Summary of Items Observed:**

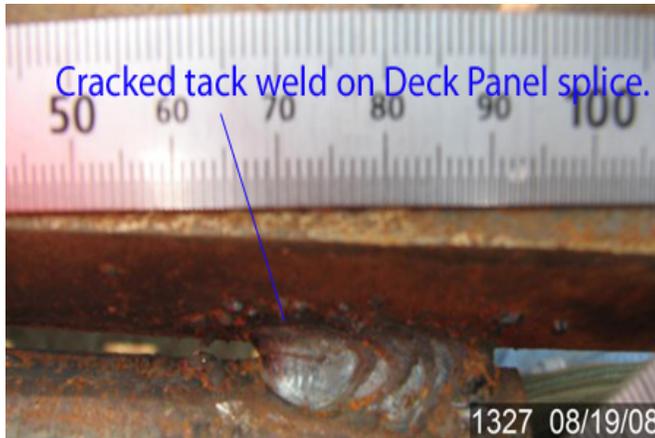
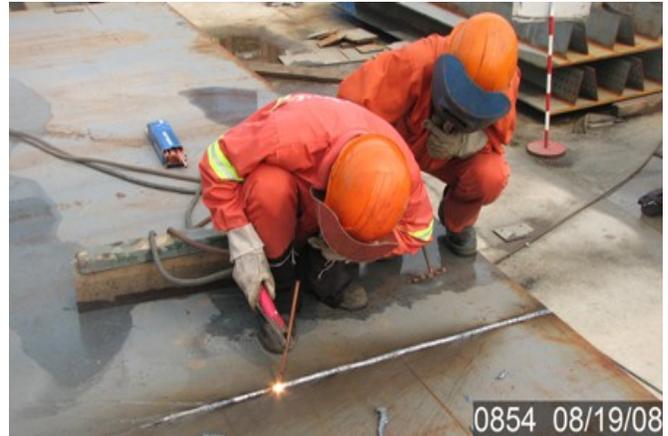
The Quality Assurance Inspector verified complete joint penetration weld joint joining deck panel 603-001 to deck panel 602-001. The Quality Assurance Inspector observed several cracked tack welds and weld splatter in the bevel joint. The Quality Assurance Inspector informed the on site ZPMC Quality Control Inspector about the cracked tacks in the bevel joint. The ZPMC Quality Control Inspector informed the Quality Assurance Inspector the tack welds will be repaired prior to welding. The Quality Assurance Inspector observed several tack welds were repaired by grinding.
