**DEPARTMENT OF TRANSPORTATION**

Contract #: 04-0120F4Cty: SF/ALA Rte: 80 PM: 13.2/13.9File #: 69.28**WELDING INSPECTION REPORT****Resident Engineer:** Pursell, Gary**Address:** 333 Burma Road**City:** Oakland, CA 94607**Report No:** WIR-003765**Date Inspected:** 01-Sep-2008**Project Name:** SAS Superstructure**OSM Arrival Time:** 700**Prime Contractor:** American Bridge/Fluor Enterprises, a JV**OSM Departure Time:** 1700**Contractor:** Zhenhua Port Machinery Company, Ltd (ZPMC), Changxing Island **Location:** Shanghai, China**CWI Name:** Sun Wei**CWI Present:** Yes No**Inspected CWI report:** Yes No N/A**Rod Oven in Use:** Yes No N/A**Electrode to specification:** Yes No N/A**Weld Procedures Followed:** Yes No N/A**Qualified Welders:** Yes No N/A**Verified Joint Fit-up:** Yes No N/A**Approved Drawings:** Yes No N/A**Approved WPS:** Yes No N/A**Delayed / Cancelled:** Yes No N/A**Bridge No:** 34-0006**Component:** OBG**Summary of Items Observed:**

**OBG Sub-Assembly Bay 1**

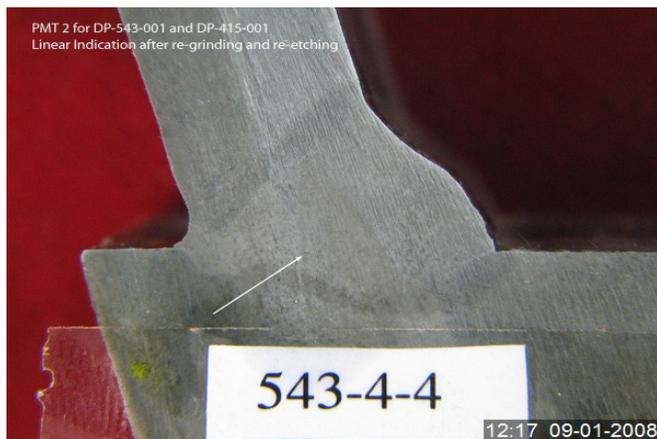
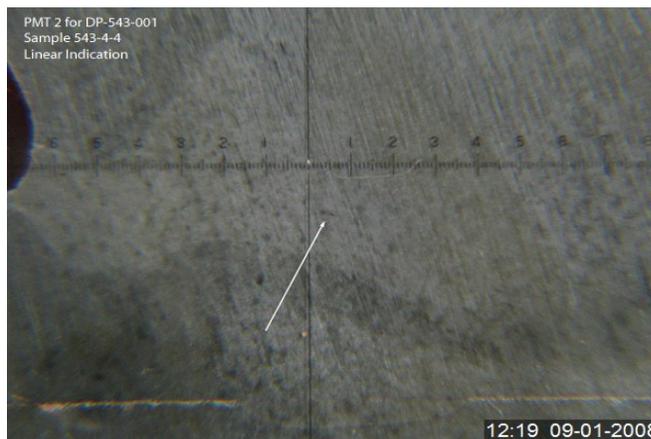
The Quality Assurance Inspector performed a visual inspection of production monitoring tests (PMT) macro etch samples, identified as DP-543-001/DP-415-001 after ZPMC and ABF had found the samples to be compliant with the contract documents. All samples appeared to contain penetration greater than 80 percent. The Quality Assurance Inspector observed one sample that contained a linear indication. ZPMC requested to grind and re-etch the sample. The sample was ground and re-etched and the linear indication remained. ABF then found the sample to be non compliant. The Quality Assurance agreed with ABF's results and signed the joint internal document. All the data from the review was recorded in a tracking log and forwarded to Quality Assurance Task Leaders and Structural Materials Representatives. The sample found to be non compliant was digitally photographed and placed on the internal server for future review. Below are two digital photographs of the sample with a linear indication. After completion of the Quality Assurance Inspectors shift the Quality Assurance Inspector was informed that ABF representative Steve Lawton had the sample ground and re-etched for a second time and found the sample to be in compliance. ZPMC then began welding the two above mentioned deck plates.
