**DEPARTMENT OF TRANSPORTATION**

Quality Assurance and Source Inspection

Contract #: 04-0120F4Cty: SF/ALA Rte: 80 PM: 13.2/13.9File #: 69.28**WELDING INSPECTION REPORT****Resident Engineer:** Pursell, Gary**Address:** 333 Burma Road**City:** Oakland, CA 94607**Report No:** WIR-004585**Date Inspected:** 08-Nov-2008**Project Name:** SAS Superstructure**OSM Arrival Time:** 700**Prime Contractor:** American Bridge/Fluor Enterprises, a JV**OSM Departure Time:** 1730**Contractor:** Zhenhua Port Machinery Company, Ltd (ZPMC), Changxing Island **Location:** Shanghai, China**CWI Name:** Hu Gui Hua**CWI Present:** Yes No**Inspected CWI report:** Yes No N/A**Rod Oven in Use:** Yes No N/A**Electrode to specification:** Yes No N/A**Weld Procedures Followed:** Yes No N/A**Qualified Welders:** Yes No N/A**Verified Joint Fit-up:** Yes No N/A**Approved Drawings:** Yes No N/A**Approved WPS:** Yes No N/A**Delayed / Cancelled:** Yes No N/A**Bridge No:** 34-0006**Component:** OBG**Summary of Items Observed:**

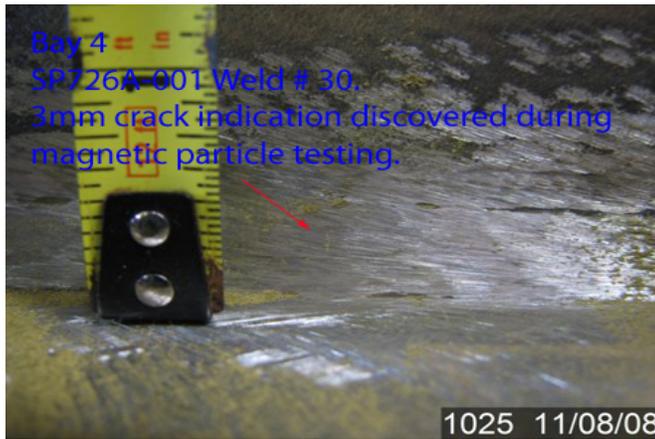
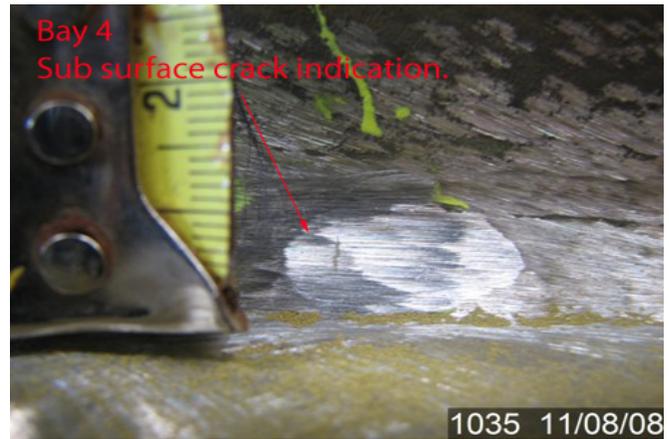
**SP726A**

The Quality Assurance Inspector discovered a crack indication overlooked by Quality Control while performing magnetic particle verification on weld # SP726A-001-030 located on the SP726A-001 side plate sub assembly. The Quality Assurance Inspector informed American Bridge/Fluor Quality Assurance Inspector Hu Gui Hua about the crack indication overlooked by ZPMC Quality Control Inspectors. Mr. Hua agreed with the Quality Assurance Inspector and informed ZPMC Quality Control Inspector Gui Yang Wei about the overlooked crack indication. The Quality Assurance Inspector observed ZPMC personnel have removed 1mm of filler metal by grinding in an effort to confirm if the indication discovered by the Quality Assurance Inspector is a surface indication. The Quality Assurance Inspector observed ZPMC Quality Control personnel perform magnetic particle testing on the ground area, revealing the crack indication is a sub surface indication. Mr. Hua informed the Quality Assurance

Inspector a critical weld repair will be issued prior to welding the repair. See Caltrans Incident Report TL-0015, dated Nov. 8, 2008 for additional information.
