DEPARTMENT OF TRANSPORTATION

Contract #: 04-0120F4Cty: SF/ALA Rte: 80 PM: 13.2/13.9File #: 69.28**WELDING INSPECTION REPORT****Resident Engineer:** Pursell, Gary**Address:** 333 Burma Road**City:** Oakland, CA 94607**Report No:** WIR-005653**Date Inspected:** 06-Feb-2009**Project Name:** SAS Superstructure**OSM Arrival Time:** 700**Prime Contractor:** American Bridge/Fluor Enterprises, a JV**OSM Departure Time:** 1900**Contractor:** Zhenhua Port Machinery Company, Ltd (ZPMC), Changxing Island **Location:** Shanghai, China**CWI Name:** Li Yan Hua**CWI Present:** Yes No**Inspected CWI report:** Yes No N/A**Rod Oven in Use:** Yes No N/A**Electrode to specification:** Yes No N/A**Weld Procedures Followed:** Yes No N/A**Qualified Welders:** Yes No N/A**Verified Joint Fit-up:** Yes No N/A**Approved Drawings:** Yes No N/A**Approved WPS:** Yes No N/A**Delayed / Cancelled:** Yes No N/A**Bridge No:** 34-0006**Component:** OBG Segment**Summary of Items Observed:**

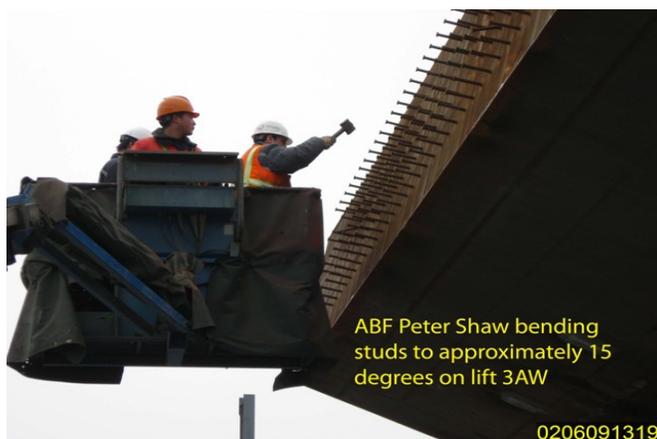
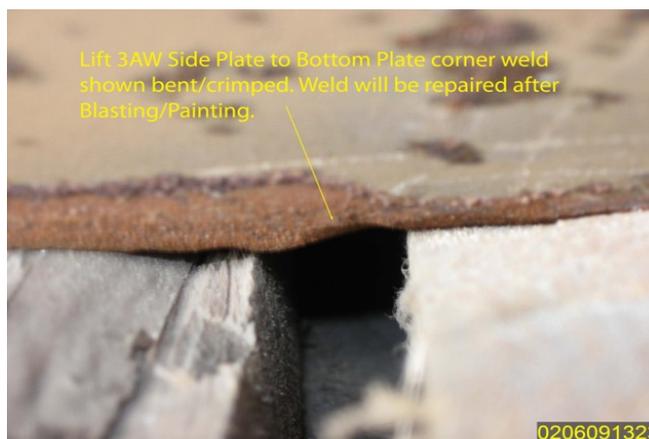
Outside Paint Shop lift 3AW: At 1030 ZPMC QC informed QA Inspector that lift 3AW is ready for QA inspection verification. QA Inspector reinspected the areas marked earlier this day and found indications to be corrected. Inside of lift 3AW visual inspection of base material and welds appears to be in compliance with AWS D1.5 (02) and the contract documents. At 1330 QA Inspector performed visual inspection verification on outside of lift 3AW welds and base material. ABF QC Inspector Mr. Peter Shaw was on site performing visual inspection and informed QA Inspector of two areas of concern. One area was on the bottom of lift side plate to bottom plate where the stanchions the lift is sitting on had created a crimp in the corner. ZPMC QC was informed of the condition and replied that the crimped area would be corrected after the lift had been painted. The second area of concern is that the 212 studs welded to the outside surface of the corner beam assembly do not exhibit a full 360 degree flash required by AWS D1.5 para. 7.8.1. See conversations below for further information.

AWS D1.5 para. 7.8.1 states that "If visual inspection reveals any stud that does not show a full 360 degree flash shall be bent to an angle of approximately 15 degrees from its original axis. The bending direction shall be bent in the opposite direction of the missing portion of the flash". QA Inspector observed ABF QC Mr. Peter Shaw bending approximately 20 studs to the requirements listed above and found to be sound. Mr. Peter Shaw informed that the issue is being addressed (Request for Information) with the Project Engineer back in the United States. QA Inspector informed Mr. Peter Shaw that until the stud issue is resolved QA inspection verification for studs is not acceptable at this time.
