DEPARTMENT OF TRANSPORTATION

Quality Assurance and Source Inspection

Contract #: 04-0120F4Cty: SF/ALA Rte: 80 PM: 13.2/13.9File #: 69.28**WELDING INSPECTION REPORT****Resident Engineer:** Pursell, Gary**Address:** 333 Burma Road**City:** Oakland, CA 94607**Report No:** WIR-006104**Date Inspected:** 21-Mar-2009**Project Name:** SAS Superstructure**OSM Arrival Time:** 645**Prime Contractor:** American Bridge/Fluor Enterprises, a JV**OSM Departure Time:** 1845**Contractor:** Zhenhua Port Machinery Company, Ltd (ZPMC), Changxing Island **Location:** Shanghai, China**CWI Name:** See Below**CWI Present:** Yes No**Inspected CWI report:** Yes No N/A**Rod Oven in Use:** Yes No N/A**Electrode to specification:** Yes No N/A**Weld Procedures Followed:** Yes No N/A**Qualified Welders:** Yes No N/A**Verified Joint Fit-up:** Yes No N/A**Approved Drawings:** Yes No N/A**Approved WPS:** Yes No N/A**Delayed / Cancelled:** Yes No N/A**Bridge No:** 34-0006**Component:** Tower Fabrication**Summary of Items Observed:**

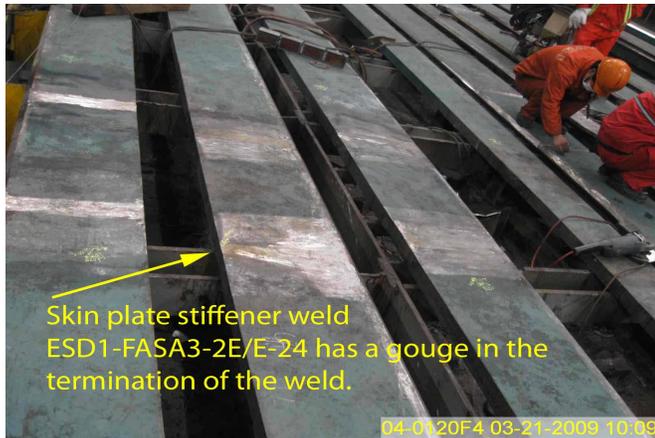
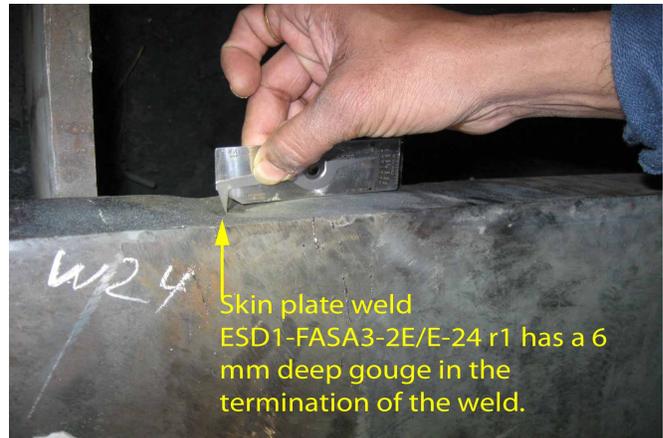
This QA Inspector performed random ultrasonic inspections of approximately 10 percent length of Lift 3 East tower skin plate A complete joint penetration stiffener butt welds ESD1-FASA3-2E/E-7, ESD1-FASA3-2E/E-12, ESD1-FASA3-2E/E-28, ESD1-FASA3-2E/E-38, ESD1-FASA3-2E/E-39, ESD1-FASA3-2E/E-43, ESD1-FASA3-2E/E-54, ESD1-FASA3-2E/E-55 and ESD1-FASA3-2E/E-59. These welds had previously been ultrasonically inspected and accepted by ZPMC inspection personnel. The QA Inspector observed the welds that were ultrasonically inspected by this QA Inspector appear to comply with AWS D1.5 UT requirements. For additional information on this inspection see the TL6027 Ultrasonic Test Report. The QA Inspector observed welds ESD1-FASA3-2E/E-23 and ESD1-FASA3-2E/E-24 have been marked as being ultrasonically rejected by ZPMC QC personnel and weld ESD1-FASA3-2E/E-24 has a 6 mm deep grinding gouge in one of the ends of the complete joint penetration weld. The QA Inspector informed ZPMC CWI Ms. Yu Dongping of the gouge and Ms. Yu Dongping informed the QA Inspector that night shift workers had performed welding repairs of weld ESD1-FASA3-2E/E-24 last night and this grinding gouge had been made after she had completed the initial visual inspections of this weld. Mr. Yu Dongping said ZPMC will weld repair the gouged area. See the photographs below for additional information.
