DEPARTMENT OF TRANSPORTATION

Quality Assurance and Source Inspection

Contract #: 04-0120F4Cty: SF/ALA Rte: 80 PM: 13.2/13.9File #: 69.28**WELDING INSPECTION REPORT****Resident Engineer:** Pursell, Gary**Address:** 333 Burma Road**City:** Oakland, CA 94607**Report No:** WIR-007224**Date Inspected:** 19-Apr-2009**Project Name:** SAS Superstructure**OSM Arrival Time:** 700**Prime Contractor:** American Bridge/Fluor Enterprises, a JV**OSM Departure Time:** 1900**Contractor:** Zhenhua Port Machinery Company, Ltd (ZPMC), Changxing Island **Location:** Shanghai, China**CWI Name:** Sun Wei / Sun Bo**CWI Present:** Yes No**Inspected CWI report:** Yes No N/A**Rod Oven in Use:** Yes No N/A**Electrode to specification:** Yes No N/A**Weld Procedures Followed:** Yes No N/A**Qualified Welders:** Yes No N/A**Verified Joint Fit-up:** Yes No N/A**Approved Drawings:** Yes No N/A**Approved WPS:** Yes No N/A**Delayed / Cancelled:** Yes No N/A**Bridge No:** 34-0006**Component:** TOWER**Summary of Items Observed:**

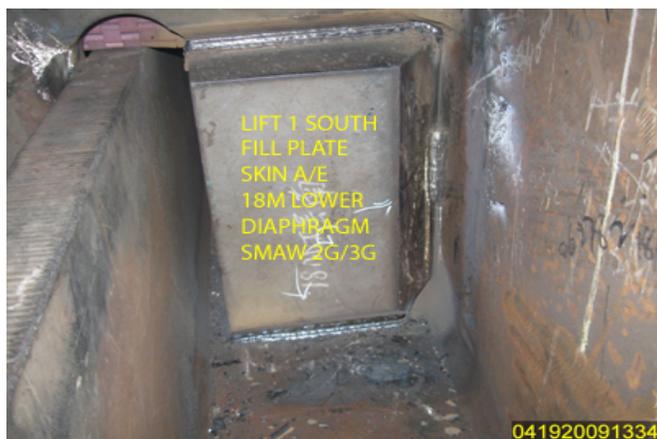
The QA Inspector randomly observed ZPMC welder Zhang Ji Hua ID 066482, utilizing the Flux Cored Arc Welding (FCAW) Process with ZPMC WPS WPS-B-T-4332-TC-P4-F in the 2G (Horizontal Groove) Position and WPS-B-T-4333-TC-P4-F in the 3G (Vertical Groove) Position to weld the fill piece to 18M Lower Diaphragm and to Skin Plates A and E. The QA Inspector randomly observed ZPMC QC monitoring weld parameters. Weld parameters appeared to comply with contract requirements. The attached photograph provides additional detail.

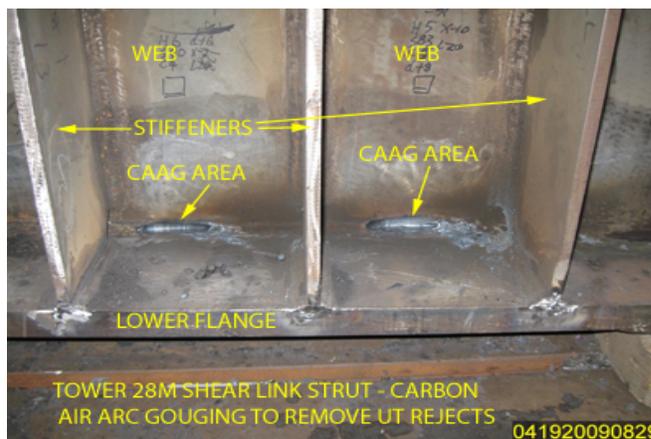
The QA Inspector randomly observed 3 ZPMC welders utilizing the Carbon Air Arc Gouging Process to gouge the welds attaching the lower flange to the web of 28M West Shear Link Strut, to remove rejects detected during previous Ultrasonic Testing Inspection. The attached photograph of WJ WD1-467-28M-1-3B, provides additional detail.
