DEPARTMENT OF TRANSPORTATION

Quality Assurance and Source Inspection

Contract #: 04-0120F4Cty: SF/ALA Rte: 80 PM: 13.2/13.9File #: 69.28**WELDING INSPECTION REPORT****Resident Engineer:** Pursell, Gary**Address:** 333 Burma Road**City:** Oakland, CA 94607**Report No:** WIR-006624**Date Inspected:** 05-May-2009**Project Name:** SAS Superstructure**OSM Arrival Time:** 1845**Prime Contractor:** American Bridge/Fluor Enterprises, a JV**OSM Departure Time:** 645**Contractor:** Zhenhua Port Machinery Company, Ltd (ZPMC), Changxing Island **Location:** Shanghai, China**CWI Name:** Tu Jian**CWI Present:** Yes No**Inspected CWI report:** Yes No N/A**Rod Oven in Use:** Yes No N/A**Electrode to specification:** Yes No N/A**Weld Procedures Followed:** Yes No N/A**Qualified Welders:** Yes No N/A**Verified Joint Fit-up:** Yes No N/A**Approved Drawings:** Yes No N/A**Approved WPS:** Yes No N/A**Delayed / Cancelled:** Yes No N/A**Bridge No:** 34-0006**Component:** Tower**Summary of Items Observed:**

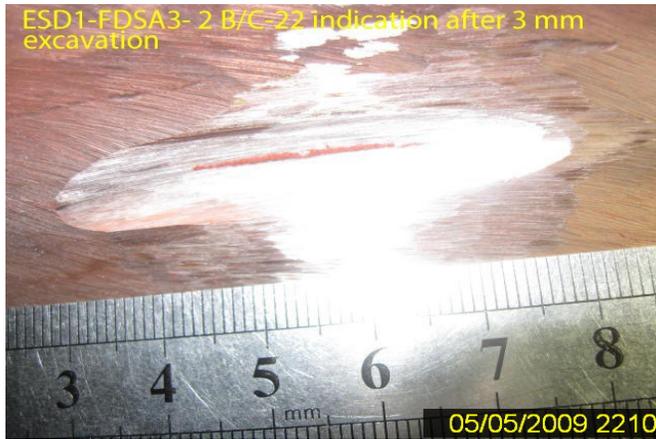
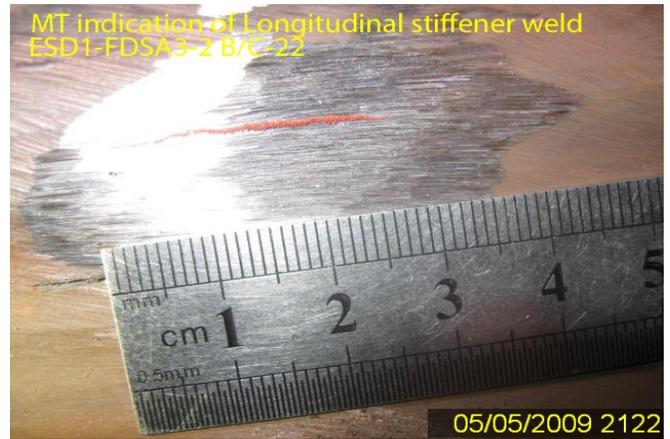
Bay 11-

During random verification Magnetic Particle Testing (MT) of Lift 3 East Tower Skin Plate D longitudinal stiffener welds, Caltrans Quality Assurance (QA) Inspector discovered a 30 mm long crack on weld ESD1-ESD1-FDSA3- 2 B/C-22. ZPMC personnel excavated the indication approximately 3 mm below the stiffener surface, crack was still present. These welds have been one hundred percent MT tested and inspected by ZPMC Quality Control MT Technicians. ZPMC QC stated a critical weld repair report would be submitted for Caltrans Engineering review and ZPMC will issue a Non Conformance Report for the noted discontinuity. Please see the attached photos below.
