Contract #: 04-0120F4Cty: SF/ALA Rte: 80 PM: 13.2/13.9File #: 69.28**WELDING INSPECTION REPORT****Resident Engineer:** Pursell, Gary**Address:** 333 Burma Road**City:** Oakland, CA 94607**Report No:** WIR-006788**Date Inspected:** 17-May-2009**Project Name:** SAS Superstructure**OSM Arrival Time:** 1845**Prime Contractor:** American Bridge/Fluor Enterprises, a JV**OSM Departure Time:** 645**Contractor:** Zhenhua Port Machinery Company, Ltd (ZPMC), Changxing Island **Location:** Shanghai, China

WELDING INSPECTION REPORT

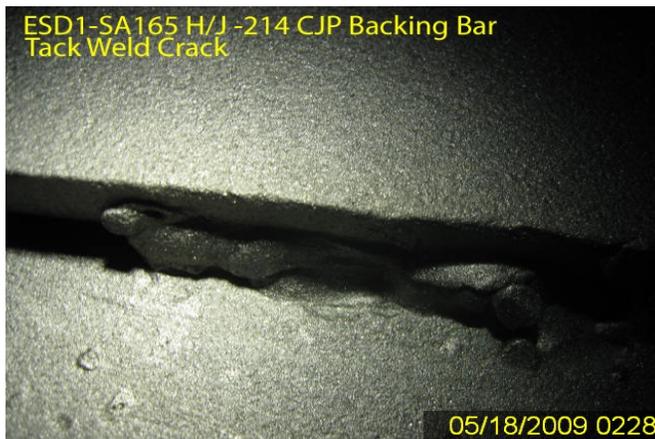
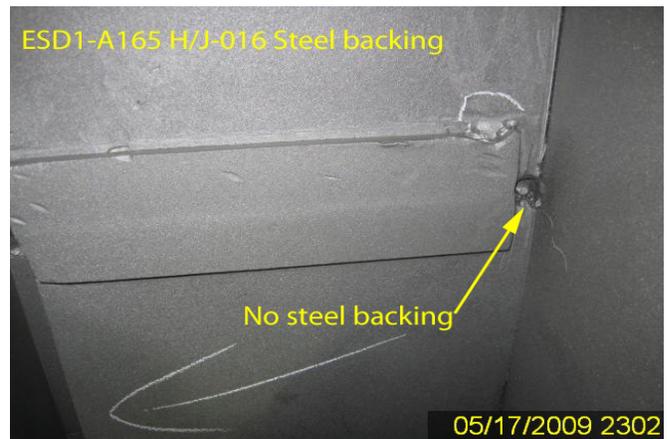
Caltrans Quality Assurance (QA) Inspectors Viars, Alaniz and Gaikwad performed random internal visual inspection of East Tower Lift 1 from 43 Top Diaphragm to 47.6 Meter bottom diaphragm after grit blasting. During Caltrans visual inspection, Caltrans QA inspectors observed that steel backing tack welds were cracked for 47.6 Meter Diaphragm to Diaphragm insert Plate CJP welds at Skin "A" to "E" and "E" to "D" corners. ZPMC personnel did not weld a continuous fillet the full length of the steel backing. ZPMC weld backing for Weld ESD1-A165 H/J-016 did not run the full length of the weld. It was also noted that gouges up to 4 mm were found at steel backing tack weld locations. An Incident report for steel backing was issued on this date. Please see the attached photographs of above mentioned anomalies.

Various discontinuities were found to include but not limited to, Slag, porosity, crater cracks, weld spatter, base metal gouges and arc strikes. This QA Inspector did not observe ZPMC personnel perform MT of Arc Strike areas after grinding.
