Contract #: 04-0120F4Cty: SF/ALA Rte: 80 PM: 13.2/13.9File #: 69.28**WELDING INSPECTION REPORT****Resident Engineer:** Pursell, Gary**Address:** 333 Burma Road**City:** Oakland, CA 94607**Report No:** WIR-006832**Date Inspected:** 21-May-2009**Project Name:** SAS Superstructure**OSM Arrival Time:** 700**Prime Contractor:** American Bridge/Fluor Enterprises, a JV**OSM Departure Time:** 1700**Contractor:** Zhenhua Port Machinery Company, Ltd (ZPMC), Changxing Island **Location:** Shanghai, China**CWI Name:** Chen Xi**CWI Present:** Yes No**Inspected CWI report:** Yes No N/A**Rod Oven in Use:** Yes No N/A**Electrode to specification:** Yes No N/A**Weld Procedures Followed:** Yes No N/A**Qualified Welders:** Yes No N/A**Verified Joint Fit-up:** Yes No N/A**Approved Drawings:** Yes No N/A**Approved WPS:** Yes No N/A**Delayed / Cancelled:** Yes No N/A**Bridge No:** 34-0006**Component:** OBG crossbeams**Summary of Items Observed:**

OBG cross beam CB7

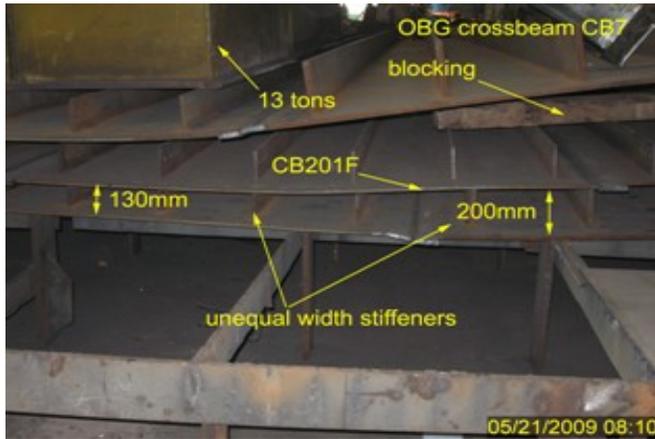
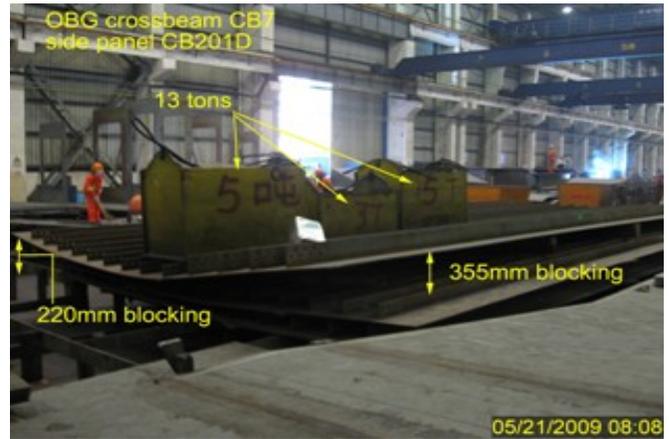
This Quality Assurance Inspector (QA) observed that the contractor has performed flame straightening on side panel identified as CB201D without an approved procedure. The procedure presented to this QA indicated that the distortion was 5mm on 18mm plate. This is non compliant to the Contract Special Provisions 8-3.01 which specifies "for material more than 16mm, the contractor shall not heat straighten members more than 3 in 1000 without prior approval of the Engineer. Furthermore, the contractors personnel did not follow the available procedure on the shop floor identified as Heat Straightening Report number HSR1(B)-6427. The procedure did not indicate the use of blocks under each edge of the panel as shown in the photos below.

This Quality Assurance (QA) inspector observed that the contractor has bent one of the side panels for crossbeam CB7. This panel is identified as CB201F. The panel in question was underneath side panel identified as CB201D that was being straightened by the use of heat and counter weights. The total weight of the counterweights was 13 tons. This force bent this side panel over top of unequal width stiffeners on another side panel below it. See attached photos. This is non compliant to Caltrans 1999 standard specifications section 6-1.3 which specifies "Articles or materials to be incorporated in the work shall be stored in such a manner as to ensure the preservation of their quality and fitness for the work, and to facilitate inspection".
