DEPARTMENT OF TRANSPORTATION

Office of Structural Materials

Contract #: 04-0120F4Cty: SF/ALA Rte: 80 PM: 13.2/13.9File #: 69.28**WELDING INSPECTION REPORT****Resident Engineer:** Pursell, Gary**Address:** 333 Burma Road**City:** Oakland, CA 94607**Report No:** WIR-006840**Date Inspected:** 17-May-2009**Project Name:** SAS Superstructure**OSM Arrival Time:** 700**Prime Contractor:** American Bridge/Fluor Enterprises, a JV**OSM Departure Time:** 1900**Contractor:** Zhenhua Port Machinery Company, Ltd (ZPMC), Changxing Island **Location:** Shanghai, China**CWI Name:** Li Yang**CWI Present:** Yes No**Inspected CWI report:** Yes No N/A**Rod Oven in Use:** Yes No N/A**Electrode to specification:** Yes No N/A**Weld Procedures Followed:** Yes No N/A**Qualified Welders:** Yes No N/A**Verified Joint Fit-up:** Yes No N/A**Approved Drawings:** Yes No N/A**Approved WPS:** Yes No N/A**Delayed / Cancelled:** Yes No N/A**Bridge No:** 34-0006**Component:** OBG crossbeams and superstructure trial asse**Summary of Items Observed:**

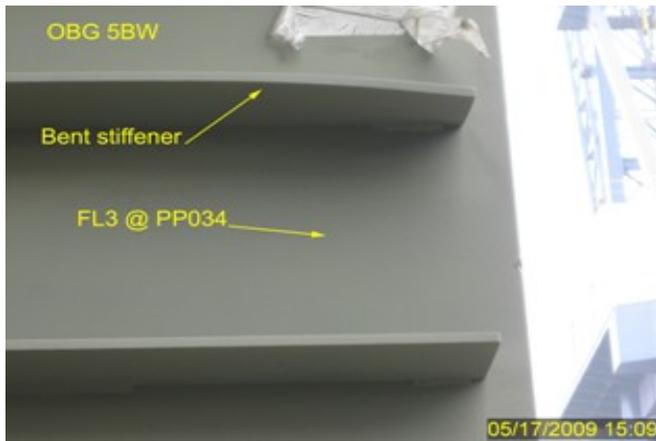
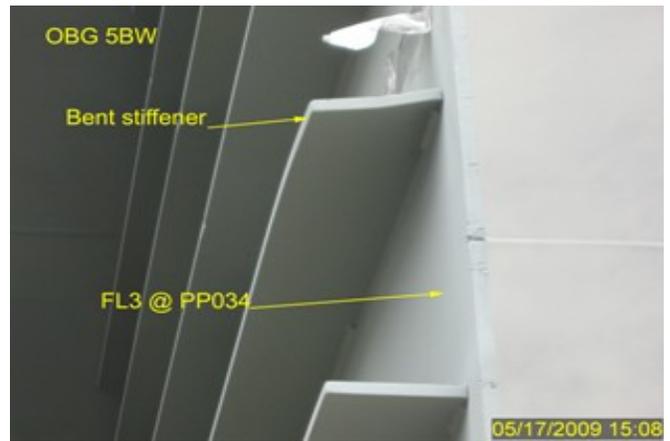
During random Visual Testing (VT) of the above mentioned OBG segment this QA observed the end of a horizontal Floorbeam web stiffener was bent downward. This stiffener is located on the inboard side of floorbeam sub assembly identified as FL3 at PP034. The stiffener in question is the fifth stiffener from the bottom flange of the FL3 floorbeam. See photos for details. This QA notified ZPMC QA inspector identified as Mr. Wang Lu of this issue. Mr. Wang informed this QA that ZPMC would prepare and submit to the Engineer a repair procedure to correct this deficiency.
