DEPARTMENT OF TRANSPORTATION

Contract #: 04-0120F4Cty: SF/ALA Rte: 80 PM: 13.2/13.9File #: 69.28**WELDING INSPECTION REPORT****Resident Engineer:** Pursell, Gary**Address:** 333 Burma Road**City:** Oakland, CA 94607**Report No:** WIR-007118**Date Inspected:** 10-May-2009**Project Name:** SAS Superstructure**OSM Arrival Time:** 1900**Prime Contractor:** American Bridge/Fluor Enterprises, a JV**OSM Departure Time:** 700**Contractor:** Zhenhua Port Machinery Company, Ltd (ZPMC), Changxing Island **Location:** Shanghai, China

WELDING INSPECTION REPORT

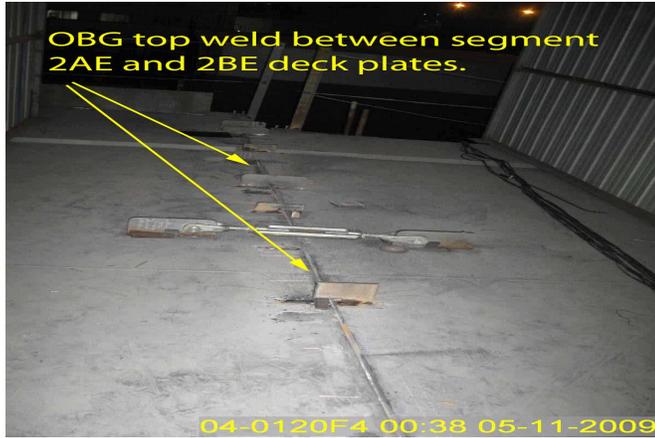
This QA Inspector and Caltrans QA Inspector Mr. Umesh Gaikwad performed weld joint root gap, plate offset and weld joint groove angles of the groove welds between OBG segment 2AE and 2BE between the top deck plates, side plates between the top deck and the interior cross beam, on both sides of the OBG. Dayshift QA Inspectors had previously completed measurements of the bottom panels. The measurements that were recorded were documented on the forms that dayshift QA personnel had provided for recording of these dimensions, and the completed forms were given to dayshift personnel for evaluation. See the photographs below for additional information.
