DEPARTMENT OF TRANSPORTATION

Contract #: 04-0120F4Cty: SF/ALA Rte: 80 PM: 13.2/13.9File #: 69.28**WELDING INSPECTION REPORT****Resident Engineer:** Pursell, Gary**Address:** 333 Burma Road**City:** Oakland, CA 94607**Report No:** WIR-007525**Date Inspected:** 14-Jun-2009**Project Name:** SAS Superstructure**OSM Arrival Time:** 700**Prime Contractor:** American Bridge/Fluor Enterprises, a JV**OSM Departure Time:** 1900**Contractor:** Zhenhua Port Machinery Company, Ltd (ZPMC), Changxing Island **Location:** Shanghai, China**CWI Name:** Xu Le Feng, Liu Yang**CWI Present:** Yes No**Inspected CWI report:** Yes No N/A**Rod Oven in Use:** Yes No N/A**Electrode to specification:** Yes No N/A**Weld Procedures Followed:** Yes No N/A**Qualified Welders:** Yes No N/A**Verified Joint Fit-up:** Yes No N/A**Approved Drawings:** Yes No N/A**Approved WPS:** Yes No N/A**Delayed / Cancelled:** Yes No N/A**Bridge No:** 34-0006**Component:** TOWER**Summary of Items Observed:**

WELDING INSPECTION REPORT

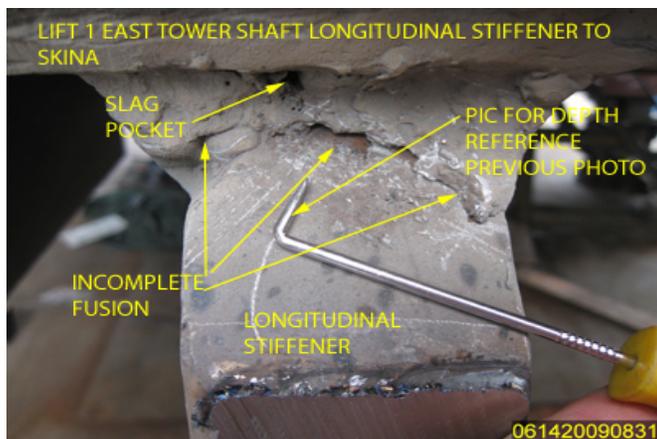
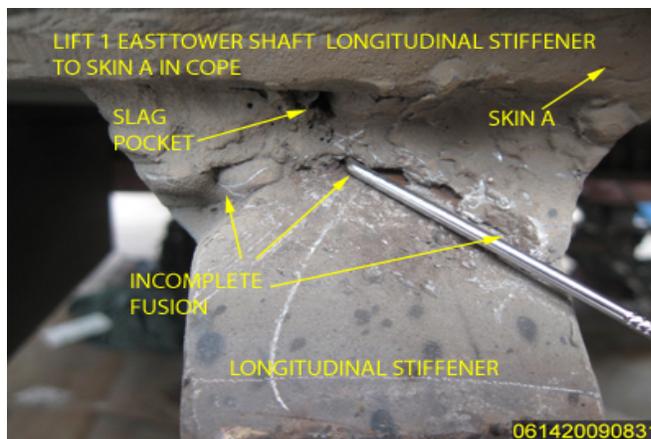
The QA Inspector randomly observed several areas on the longitudinal stiffeners and skin plates on Lift 1 East that contained incomplete fusion, slag inclusions and porosity. ZPMC Quality Personnel informed the QA Inspector that these areas would be repaired. The attached photographs provide additional detail.
