DEPARTMENT OF TRANSPORTATION

Contract #: 04-0120F4Cty: SF/ALA Rte: 80 PM: 13.2/13.9File #: 69.28**WELDING INSPECTION REPORT****Resident Engineer:** Pursell, Gary**Address:** 333 Burma Road**City:** Oakland, CA 94607**Report No:** WIR-007610**Date Inspected:** 23-Jun-2009**Project Name:** SAS Superstructure**OSM Arrival Time:** 1845**Prime Contractor:** American Bridge/Fluor Enterprises, a JV**OSM Departure Time:** 645**Contractor:** Zhenhua Port Machinery Company, Ltd (ZPMC), Changxing Island **Location:** Shanghai, China**CWI Name:** Chen Xi**CWI Present:** Yes No**Inspected CWI report:** Yes No N/A**Rod Oven in Use:** Yes No N/A**Electrode to specification:** Yes No N/A**Weld Procedures Followed:** Yes No N/A**Qualified Welders:** Yes No N/A**Verified Joint Fit-up:** Yes No N/A**Approved Drawings:** Yes No N/A**Approved WPS:** Yes No N/A**Delayed / Cancelled:** Yes No N/A**Bridge No:** 34-0006**Component:** OBG**Summary of Items Observed:**

This Caltrans QA inspector monitored activities related to internal stiffener replacement for Partial Joint Penetration (PJP) welds exceeding Welding Procedure Specification maximum root gap dimension on OBG segment 1AAW.

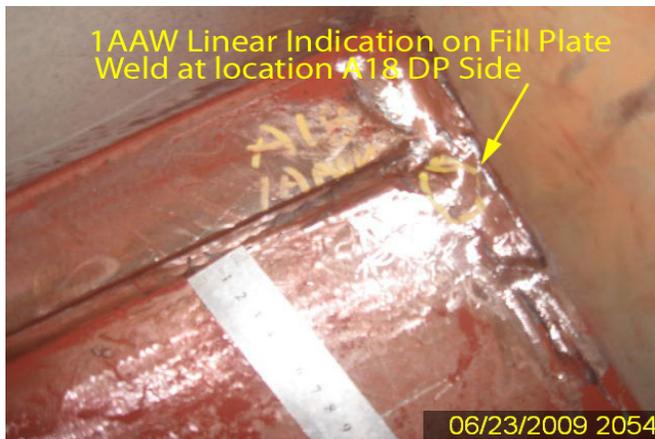
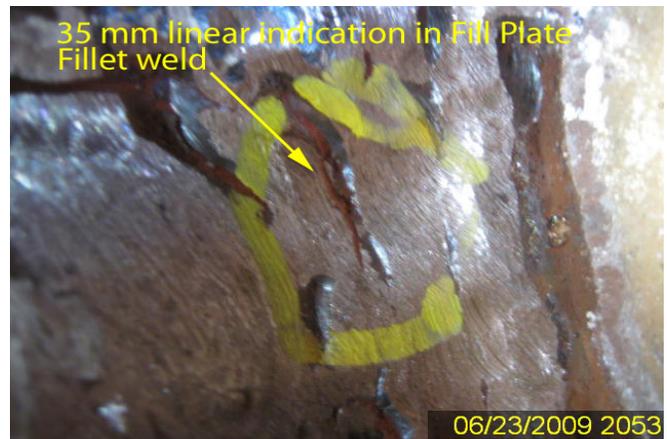
Caltrans QA performed MT verification of the following shim plates. A18 shim was rejected by Caltrans QA for a 35 mm linear indication. An incident report was issued for ZPMC QC accepting this area. This area was excavated and Magnetic Particle testing was performed. ZPMC repaired the area and MT was performed after the weld cooled to ambient temperature. See the attached digital photographs of the above mentioned indication prior to

repair.

A18- (Deck Plate Side) excavation and repair
