Contract #: 04-0120F4Cty: SF/ALA Rte: 80 PM: 13.2/13.9File #: 69.28**WELDING INSPECTION REPORT****Resident Engineer:** Pursell, Gary**Address:** 333 Burma Road**City:** Oakland, CA 94607**Report No:** WIR-008058**Date Inspected:** 04-Aug-2009**Project Name:** SAS Superstructure**OSM Arrival Time:** 1900**Prime Contractor:** American Bridge/Fluor Enterprises, a JV**OSM Departure Time:** 700**Contractor:** Zhenhua Port Machinery Company, Ltd (ZPMC), Changxing Island **Location:** Shanghai, China

Bridge No: 34-0006**Component:** OBG segments**Summary of Items Observed:**

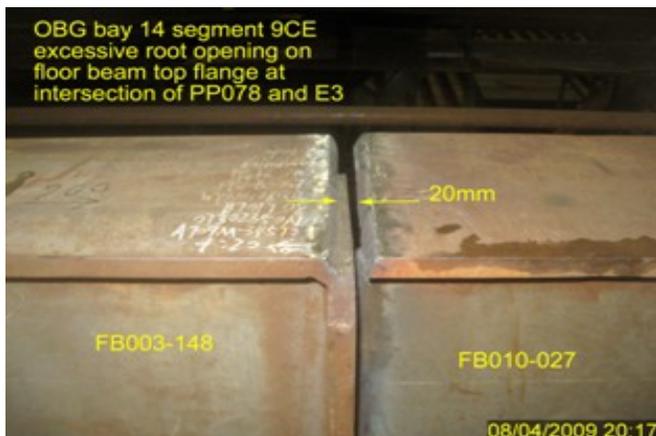
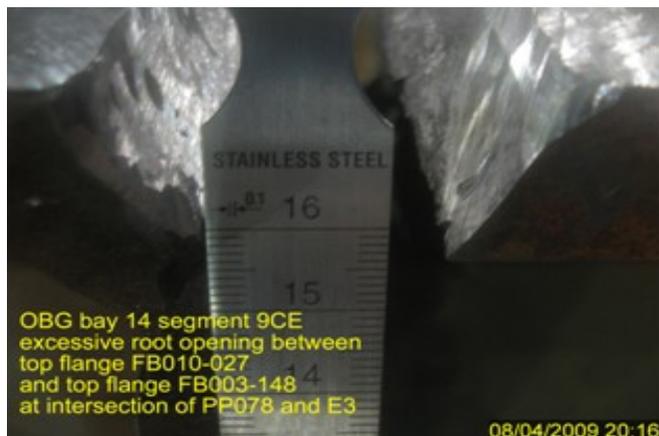
During random in process fit up inspection this QA observed a CJP weld excessive root opening of approximately 20mm. This joint is located on the top flange of floor beams identified as FB010-027 and FB003-148 at the intersection of PP078 and E3 on OBG segment identified as 9CE. This QA informed American

Bridge Fluor (ABF) inspector identified as Mr. Bao Qian and ZPMC QC inspector identified as Mr. Guo Xing Hai of this discrepancy. Both inspectors indicated that ZPMC would “butter” (build up with weld) the weld joint prior to commencing with the welding of this joint. Mr. Bao and Mr. Guos’ proposal to “butter” the weld joint appears to be an acceptable method of repair according to AWS D1.5 2002. See attached photos.
