DEPARTMENT OF TRANSPORTATION

Contract #: 04-0120F4Cty: SF/ALA Rte: 80 PM: 13.2/13.9File #: 69.28**WELDING INSPECTION REPORT****Resident Engineer:** Pursell, Gary**Address:** 333 Burma Road**City:** Oakland, CA 94607**Report No:** WIR-008407**Date Inspected:** 12-Aug-2009**Project Name:** SAS Superstructure**OSM Arrival Time:** 1900**Prime Contractor:** American Bridge/Fluor Enterprises, a JV**OSM Departure Time:** 700**Contractor:** Zhenhua Port Machinery Company, Ltd (ZPMC), Changxing Island **Location:** Shanghai, China**CWI Name:** Lu Li Qing**CWI Present:** Yes No**Inspected CWI report:** Yes No N/A**Rod Oven in Use:** Yes No N/A**Electrode to specification:** Yes No N/A**Weld Procedures Followed:** Yes No N/A**Qualified Welders:** Yes No N/A**Verified Joint Fit-up:** Yes No N/A**Approved Drawings:** Yes No N/A**Approved WPS:** Yes No N/A**Delayed / Cancelled:** Yes No N/A**Bridge No:** 34-0006**Component:** OBG segments**Summary of Items Observed:**

WELDING INSPECTION REPORT

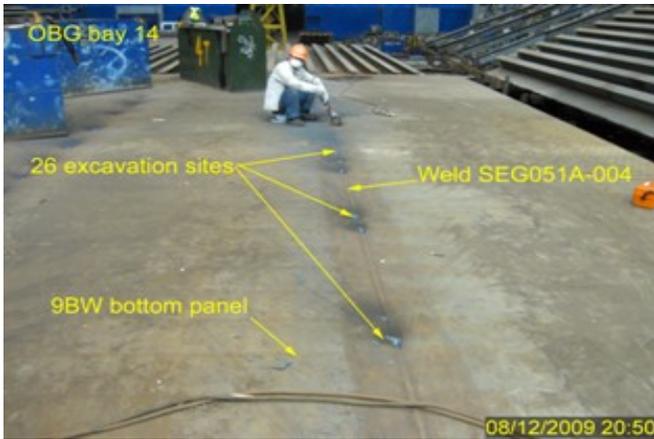
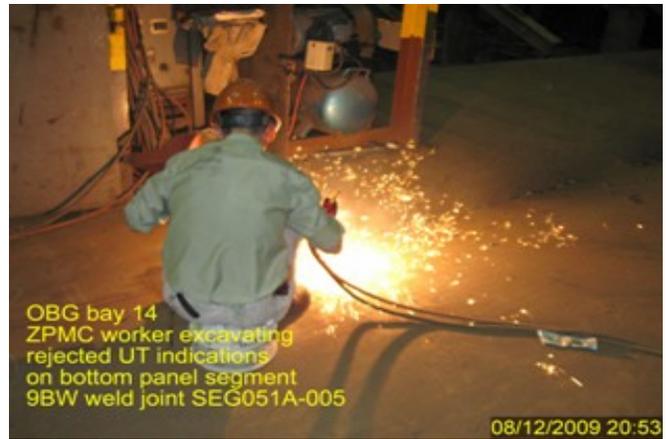
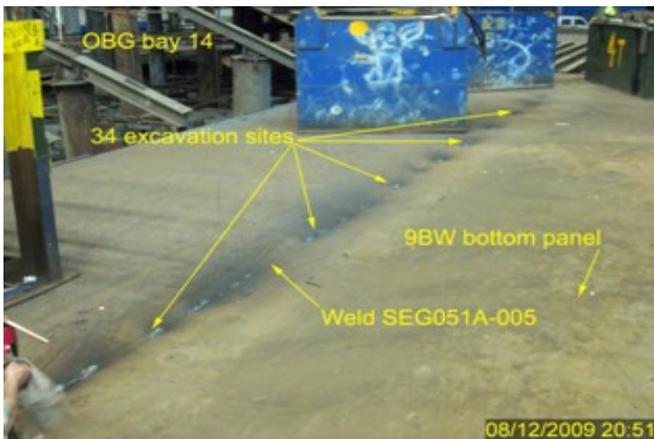
This QA observed ZPMC personnel excavating welds rejected by ZPMC QC Ultrasonic Testing (UT) technicians on bottom panel of OBG segment identified as 9BW. Welds are identified as SEG051A-004 (QA noted 26 excavated areas) and SEG051A-005 (QA noted 34 excavated areas).

This QA observed ZPMC qualified welding personnel identified as 045240 perform FCAW welding on OBG segment 6AW weld joint identified as SSD12-PP040-004. ZPMC QC identified as Mr. Yin Hai Peng was present to monitor the welding process. This QA observed that the contractor appears to have deviated from the weld joint design specified on the approved drawings for this weld. The contractor appears to have changed the weld joint from a fillet weld to a Complete Joint Penetration (CJP) weld without the Engineers approval. According to the contractors QC inspector identified as Mr. Yin Hai Peng the weld design was changed in order to compensate for a joint root opening in excess of 5mm. The QC inspector did not have an approved procedure in hand to change the required fillet weld to a CJP. This QA has submitted an incident report for this issue.
