**DEPARTMENT OF TRANSPORTATION**

Contract #: 04-0120F4Cty: SF/ALA Rte: 80 PM: 13.2/13.9File #: 69.28**WELDING INSPECTION REPORT****Resident Engineer:** Pursell, Gary**Address:** 333 Burma Road**City:** Oakland, CA 94607**Report No:** WIR-008636**Date Inspected:** 13-Aug-2009**Project Name:** SAS Superstructure**OSM Arrival Time:** 700**Prime Contractor:** American Bridge/Fluor Enterprises, a JV**OSM Departure Time:** 1900**Contractor:** Zhenhua Port Machinery Company, Ltd (ZPMC), Changxing Island **Location:** Shanghai, China**CWI Name:** Lv Li Qing / Shen Fu You**CWI Present:** Yes No**Inspected CWI report:** Yes No N/A**Rod Oven in Use:** Yes No N/A**Electrode to specification:** Yes No N/A**Weld Procedures Followed:** Yes No N/A**Qualified Welders:** Yes No N/A**Verified Joint Fit-up:** Yes No N/A**Approved Drawings:** Yes No N/A**Approved WPS:** Yes No N/A**Delayed / Cancelled:** Yes No N/A**Bridge No:** 34-0006**Component:** OBG Assembly**Summary of Items Observed:**

# WELDING INSPECTION REPORT

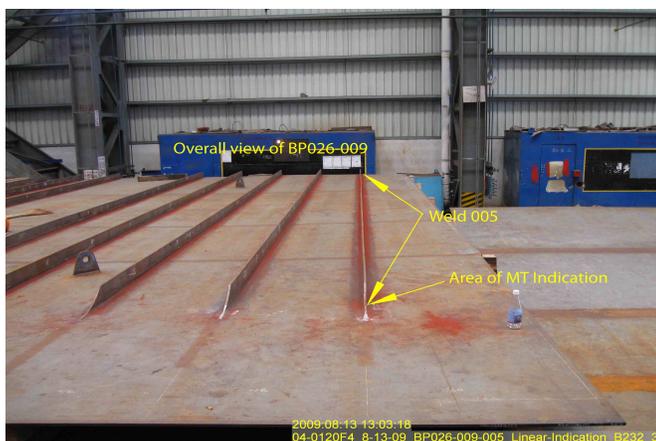
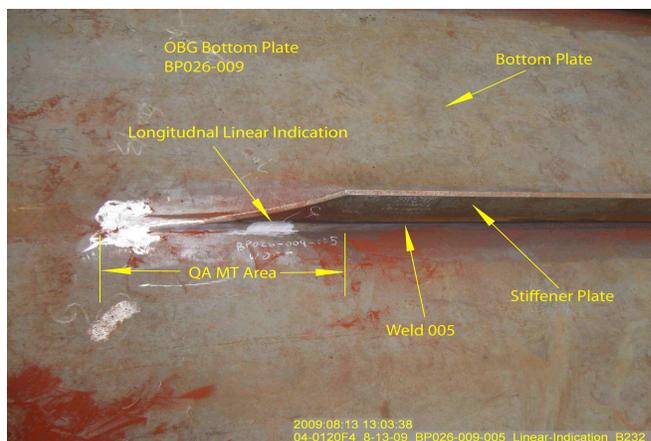
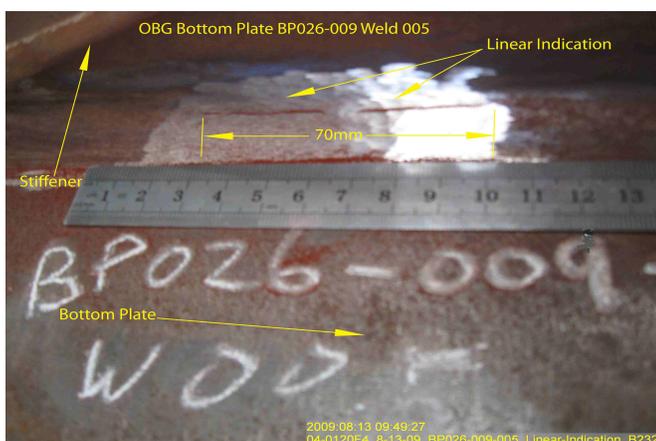
The QA inspector performed a random Magnetic Particle (MT) verification on Cross Beam Bottom Panel BP - 026 - 009 after ZPMC performed 100% MT and discovered a 70mm long longitudinal linear indication on weld number 005. A incident report was written on this issue. See attached photograph for additional information.
