DEPARTMENT OF TRANSPORTATION

Contract #: 04-0120F4Cty: SF/ALA Rte: 80 PM: 13.2/13.9File #: 69.28**WELDING INSPECTION REPORT****Resident Engineer:** Pursell, Gary**Address:** 333 Burma Road**City:** Oakland, CA 94607**Report No:** WIR-008694**Date Inspected:** 28-Aug-2009**Project Name:** SAS Superstructure**OSM Arrival Time:** 700**Prime Contractor:** American Bridge/Fluor Enterprises, a JV**OSM Departure Time:** 1900**Contractor:** Zhenhua Port Machinery Company, Ltd (ZPMC), Changxing Island **Location:** Shanghai, China**CWI Name:** Lv Li Qing / Shen Fu You**CWI Present:** Yes No**Inspected CWI report:** Yes No N/A**Rod Oven in Use:** Yes No N/A**Electrode to specification:** Yes No N/A**Weld Procedures Followed:** Yes No N/A**Qualified Welders:** Yes No N/A**Verified Joint Fit-up:** Yes No N/A**Approved Drawings:** Yes No N/A**Approved WPS:** Yes No N/A**Delayed / Cancelled:** Yes No N/A**Bridge No:** 34-0006**Component:** OBG Assembly**Summary of Items Observed:**

OBG Assembly Bay 14

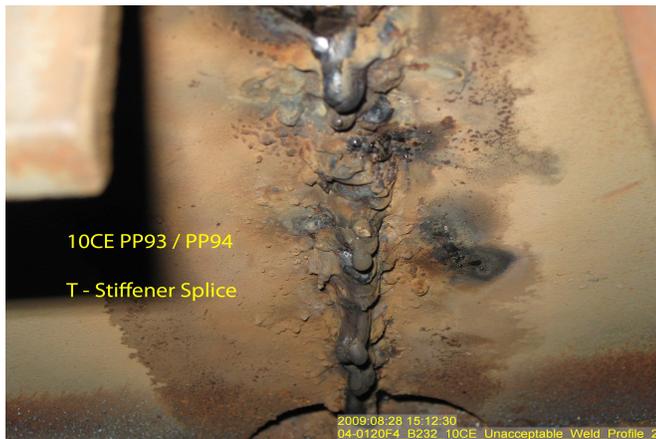
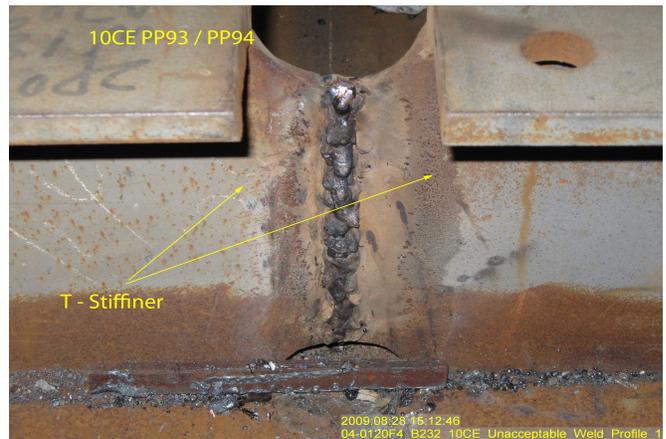
This Quality Assurance Inspector (QA) observed that the contractor has used steel backing on T-stiffener on assembly 10CE that does not conform to the code requirements. This backing bar appears to be from an unknown source and is not in intimate contact with the base metal. An incident will be written on this issue. See photographs for additional information.

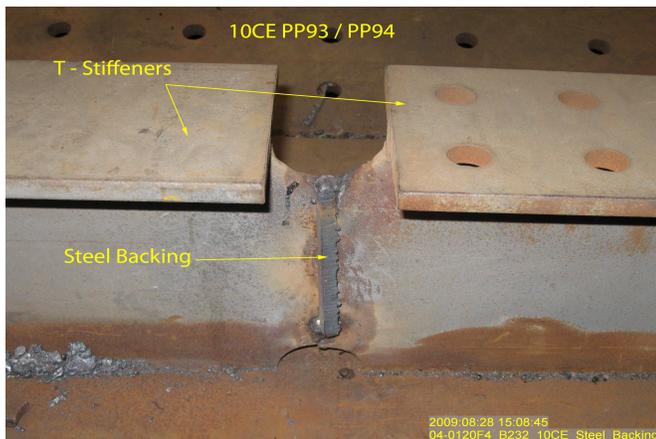
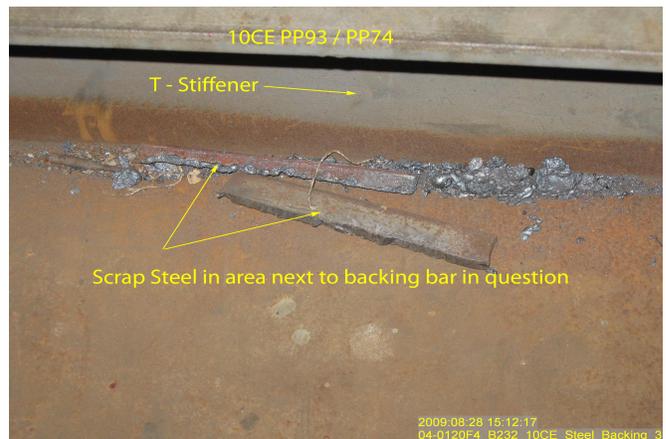
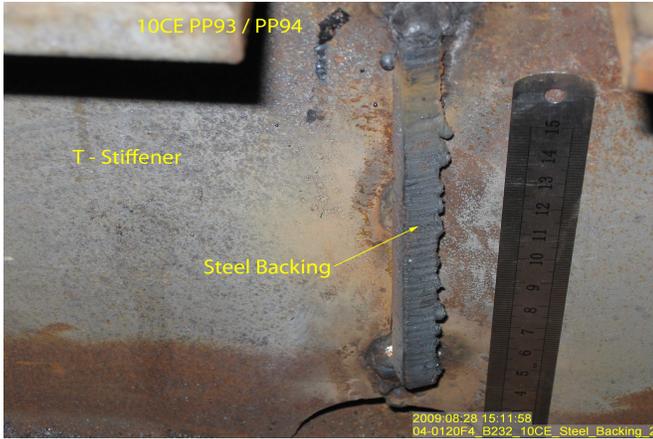
This Quality Assurance Inspector (QA) observed that the contractor has welded T – Stiffener on 10CE PP93 / PP74 improperly. This weld is in-process and not complete and no VT was performed by ZPMC QC. This is to capture in-process workmanship being performed on this weld joint. An incident report will be written on this issue. See photographs for additional information.
