DEPARTMENT OF TRANSPORTATION

Quality Assurance and Source Inspection

Contract #: 04-0120F4Cty: SF/ALA Rte: 80 PM: 13.2/13.9File #: 69.28**WELDING INSPECTION REPORT****Resident Engineer:** Pursell, Gary**Address:** 333 Burma Road**City:** Oakland, CA 94607**Report No:** WIR-008729**Date Inspected:** 31-Aug-2009**Project Name:** SAS Superstructure**OSM Arrival Time:** 700**Prime Contractor:** American Bridge/Fluor Enterprises, a JV**OSM Departure Time:** 1900**Contractor:** Zhenhua Port Machinery Company, Ltd (ZPMC), Changxing Island **Location:** Shanghai, China**CWI Name:** Li Zhi Jiang**CWI Present:** Yes No**Inspected CWI report:** Yes No N/A**Rod Oven in Use:** Yes No N/A**Electrode to specification:** Yes No N/A**Weld Procedures Followed:** Yes No N/A**Qualified Welders:** Yes No N/A**Verified Joint Fit-up:** Yes No N/A**Approved Drawings:** Yes No N/A**Approved WPS:** Yes No N/A**Delayed / Cancelled:** Yes No N/A**Bridge No:** 34-0006**Component:** OBG crossbeams**Summary of Items Observed:**

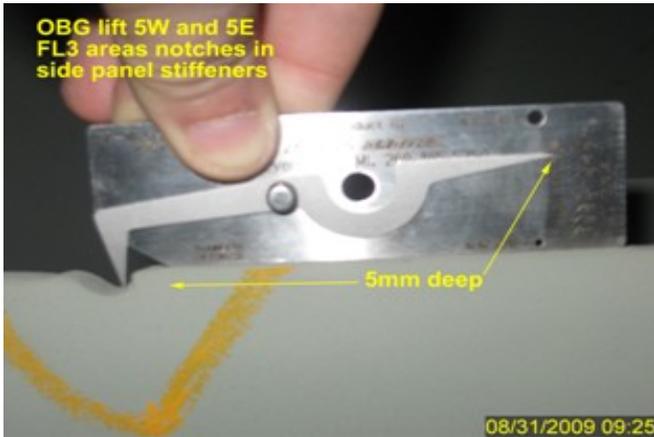
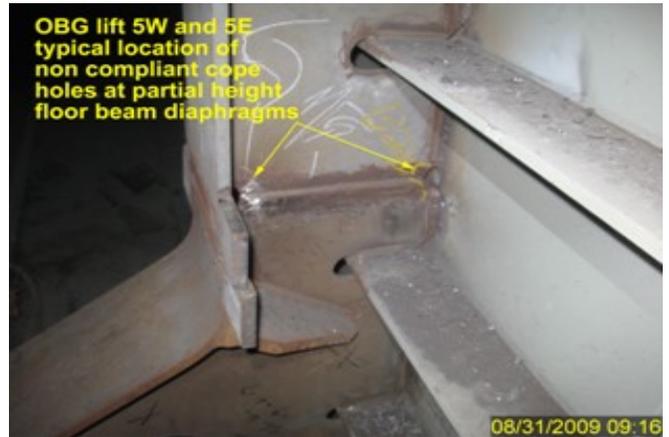
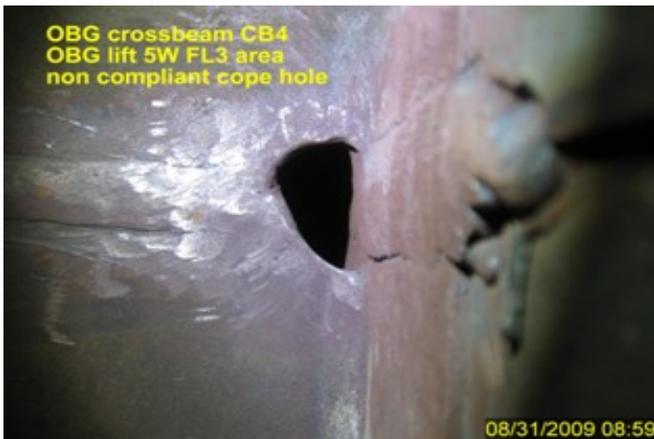
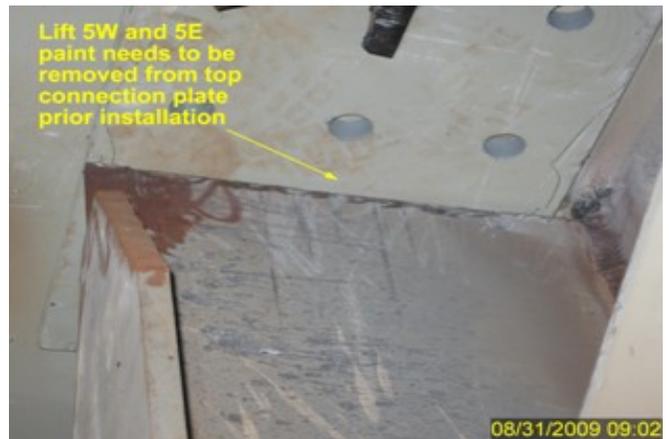
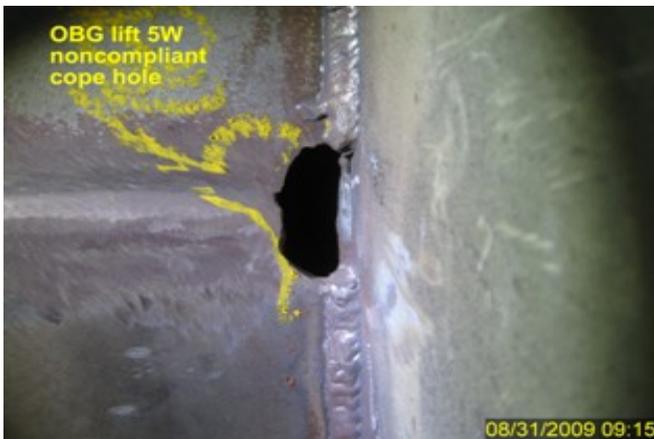
OBG cross beam CB4 outside trial assembly area

During random in process visual inspection of this crossbeam this QA found the following deficiencies:

1. Non compliant cope holes in the FL3 area on the partial height floor beam diaphragms where the vertical beam joins to the corner section. These cope holes are located at PP032 on the westline and eastline. See attached photos for details.
2. Weld joints between partial height floor beam diaphragms and top connection plate to OBG side panel needs to

have the paint removed from the joints prior to welding. This condition exists at PP031~PP033 at all locations. See attached photos for details.

3. Numerous nicks, notches and gouges in the edges of the side panels in the FL3 areas as well as inside of the crossbeam. Some of these notches measure up to 5mm in depth. See attached photos for details.
