DEPARTMENT OF TRANSPORTATION

Contract #: 04-0120F4Cty: SF/ALA Rte: 80 PM: 13.2/13.9File #: 69.28**WELDING INSPECTION REPORT****Resident Engineer:** Pursell, Gary**Address:** 333 Burma Road**City:** Oakland, CA 94607**Report No:** WIR-008744**Date Inspected:** 02-Sep-2009**Project Name:** SAS Superstructure**OSM Arrival Time:** 700**Prime Contractor:** American Bridge/Fluor Enterprises, a JV**OSM Departure Time:** 1900**Contractor:** Zhenhua Port Machinery Company, Ltd (ZPMC), Changxing Island **Location:** Shanghai, China**CWI Name:** Zhao Chen Sun**CWI Present:** Yes No**Inspected CWI report:** Yes No N/A**Rod Oven in Use:** Yes No N/A**Electrode to specification:** Yes No N/A**Weld Procedures Followed:** Yes No N/A**Qualified Welders:** Yes No N/A**Verified Joint Fit-up:** Yes No N/A**Approved Drawings:** Yes No N/A**Approved WPS:** Yes No N/A**Delayed / Cancelled:** Yes No N/A**Bridge No:** 34-0006**Component:** Crossbeams and OBG segment**Summary of Items Observed:**

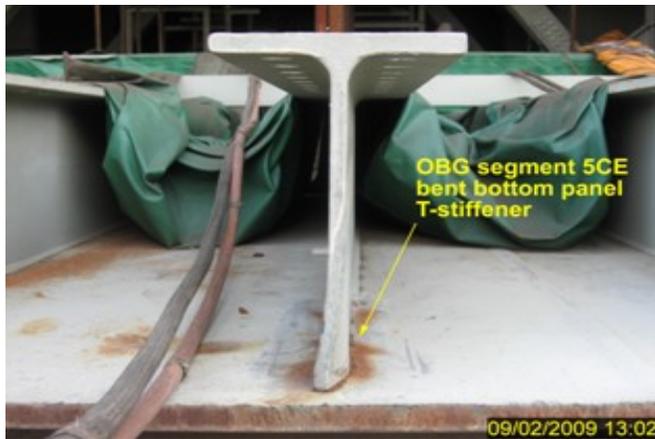
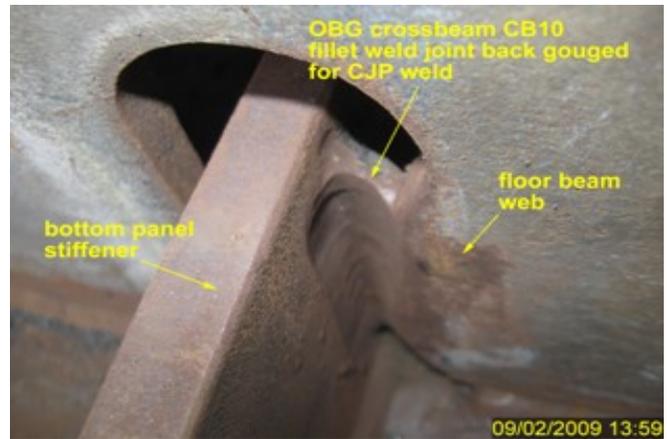
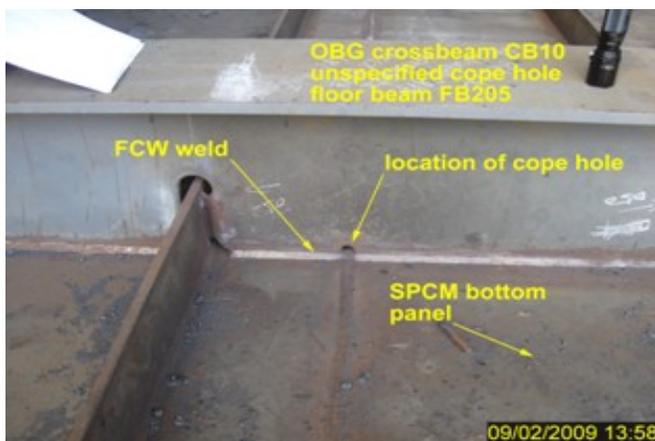
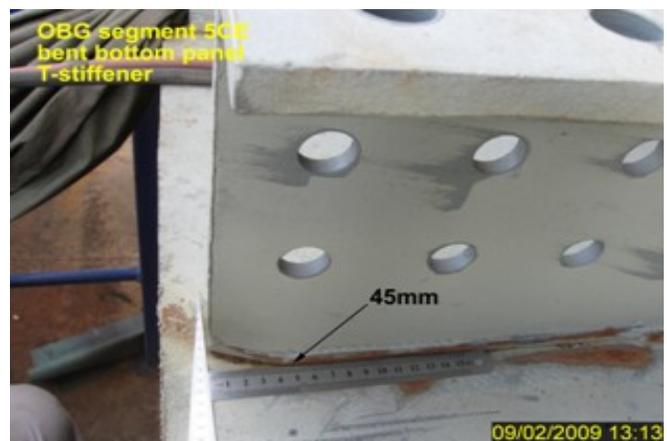
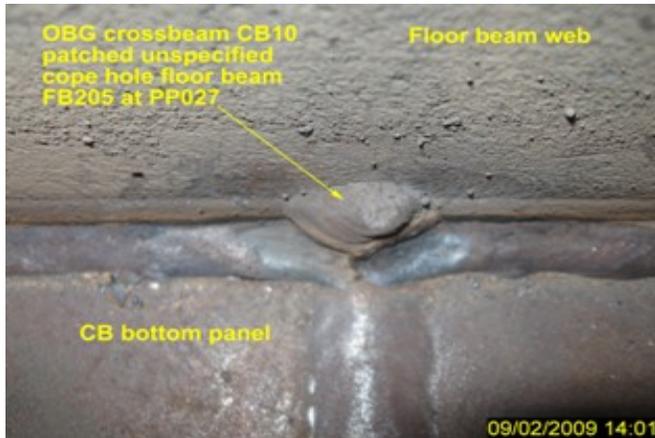
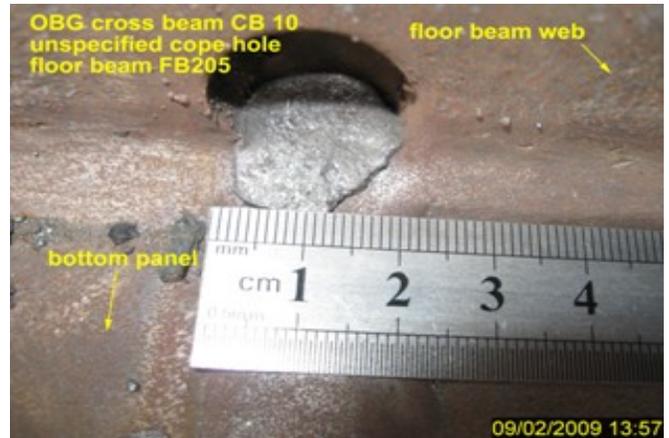
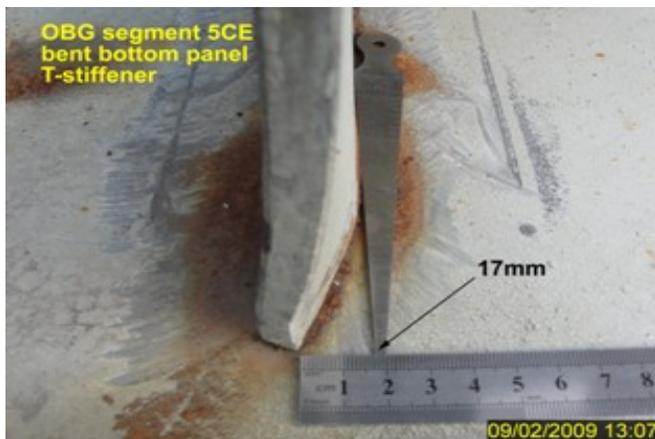
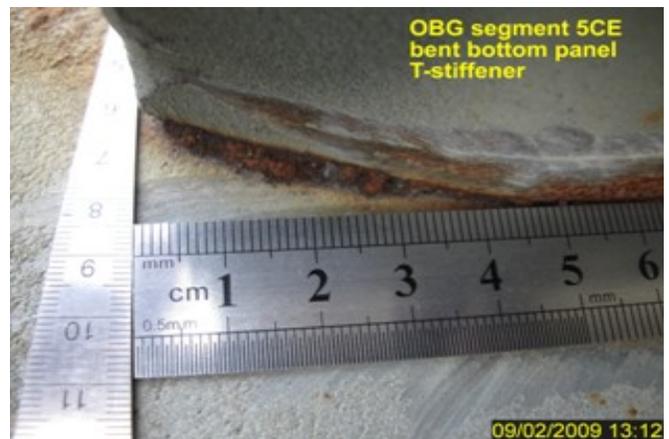
This QA observed that the contractor appears to have deviated from the weld joint design specified on the approved drawings. The contractor appears to have changed the weld joint from a fillet weld to a Complete Joint Penetration (CJP) weld without the Engineers approval. According to the contractors QC inspector, the weld design was changed in order to compensate for a joint root opening in excess of 5mm. This QA observed that the contractors welding personnel have welded all of these joints from one side and back gouged the joints in preparation to make them CJP. This condition exists in 23 locations where the bottom panel stiffeners pass through the floor beam diaphragms. See attached photo. AWS D1.5 2002 section 3.7.4 states "Prior approval of the Engineer shall be obtained for repairs to base metal (other than those required by 3.2), repair of major or delayed cracks, repairs to ESW and EGW welds with internal defects, or for a revised design to compensate for deficiencies".

During random in process visual inspection of OBG crossbeam CB10 this QA observed 20mm diameter cope holes that are not specified on the detail drawings. The unspecified cope holes are located in all four of the floor

beam diaphragms identified as FB205. There is one cope hole in each of the four floor beams. The fillet weld joining the floor beam to the SPCM bottom panel is a Fracture Critical Weld (FCW). The cope holes in two of the floor beams have been repaired by welding at PP027 and PP028. The cope holes in the floor beams at PP025 and PP026 have not yet been repaired. ZPMC QC CWI identified as Mr. Zhu Tian Shu could not produce an approved procedure to cut and/or repair these cope holes. According to Mr. Zhu these cope holes were cut in order to gain access to the bottom panel splice weld that passes under the floor beams. See attached photos for details. This QA informed ZPMC QC identified as Mr. Zhang Wei and ABF inspector identified as Mr. Kevin Chen of the above mentioned issues and that an incident report would be generated for both.

During random in process visual inspection of OBG segment 5CE this QA observed one bottom panel T-stiffener has been damaged during fabrication. The stiffener in question is located on the west end of this segment at the splice joint to segment 6AE, 7th stiffener from E4 line. See attached photos for details. 1999 Caltrans Standard Specifications section 55-1.04 states "In handling and shipping of the steel work, every care shall be taken to avoid bending, scraping or overstressing the pieces. All pieces bent or otherwise injured will be rejected". This QA informed ZPMC QC identified as Mr. Wang Lu and ABF inspector identified as Mr. Kevin Chen of the above mentioned issue and that an incident report would be generated.
