**DEPARTMENT OF TRANSPORTATION**

Contract #: 04-0120F4Cty: SF/ALA Rte: 80 PM: 13.2/13.9File #: 69.28**WELDING INSPECTION REPORT****Resident Engineer:** Pursell, Gary**Address:** 333 Burma Road**City:** Oakland, CA 94607**Report No:** WIR-008933**Date Inspected:** 01-Sep-2009**Project Name:** SAS Superstructure**OSM Arrival Time:** 700**Prime Contractor:** American Bridge/Fluor Enterprises, a JV**OSM Departure Time:** 1900**Contractor:** Zhenhua Port Machinery Company, Ltd (ZPMC), Changxing Island **Location:** Shanghai, China**CWI Name:** Li Jia**CWI Present:** Yes No**Inspected CWI report:** Yes No N/A**Rod Oven in Use:** Yes No N/A**Electrode to specification:** Yes No N/A**Weld Procedures Followed:** Yes No N/A**Qualified Welders:** Yes No N/A**Verified Joint Fit-up:** Yes No N/A**Approved Drawings:** Yes No N/A**Approved WPS:** Yes No N/A**Delayed / Cancelled:** Yes No N/A**Bridge No:** 34-0006**Component:** OBG Segments**Summary of Items Observed:**

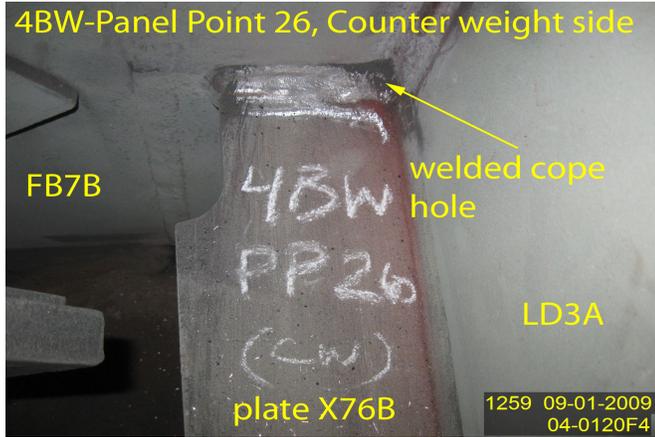
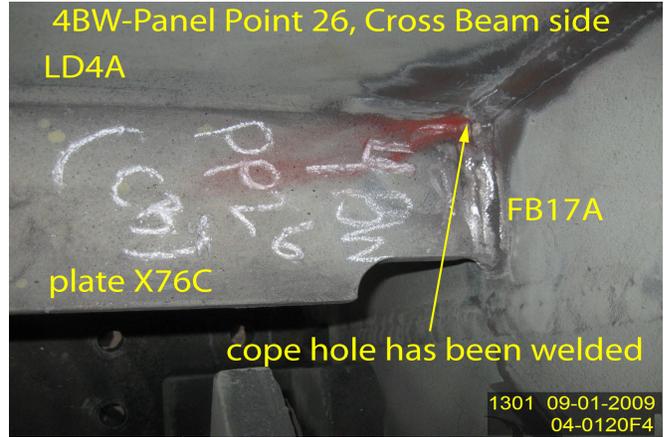
This QA Inspector observed the cope holes on stiffener plate X76B on Longitudinal Diaphragm LD3A and stiffener plate X76C on Longitudinal Diaphragm LD4A at panel point 26 have been welded. The cope hole was to allow access for the vertical Complete Joint Penetration weld joint connecting LD3A to the web of floor beam FB7B and LD4A to the web of floor beam FB17A. An incident report was written for this observation.
