DEPARTMENT OF TRANSPORTATION

Contract #: 04-0120F4Cty: SF/ALA Rte: 80 PM: 13.2/13.9File #: 69.28**WELDING INSPECTION REPORT****Resident Engineer:** Pursell, Gary**Address:** 333 Burma Road**City:** Oakland, CA 94607**Report No:** WIR-009198**Date Inspected:** 23-Sep-2009**Project Name:** SAS Superstructure**OSM Arrival Time:** 700**Prime Contractor:** American Bridge/Fluor Enterprises, a JV**OSM Departure Time:** 1900**Contractor:** Zhenhua Port Machinery Company, Ltd (ZPMC), Changxing Island **Location:** Shanghai, China**CWI Name:** Lv Li Qing / Shen Fu You**CWI Present:** Yes No**Inspected CWI report:** Yes No N/A**Rod Oven in Use:** Yes No N/A**Electrode to specification:** Yes No N/A**Weld Procedures Followed:** Yes No N/A**Qualified Welders:** Yes No N/A**Verified Joint Fit-up:** Yes No N/A**Approved Drawings:** Yes No N/A**Approved WPS:** Yes No N/A**Delayed / Cancelled:** Yes No N/A**Bridge No:** 34-0006**Component:** OBG Assembly**Summary of Items Observed:**

OBG Assembly Bay 14

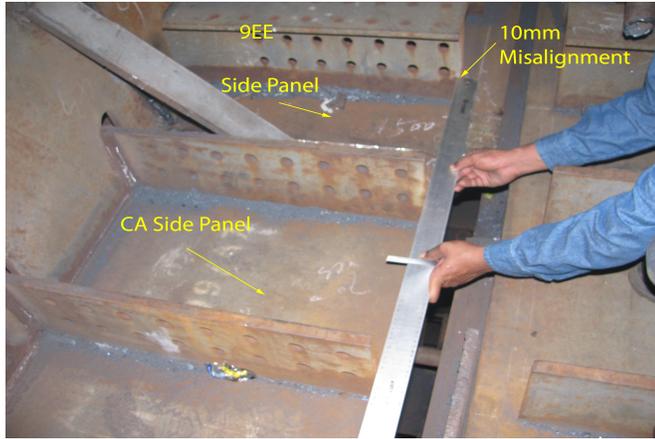
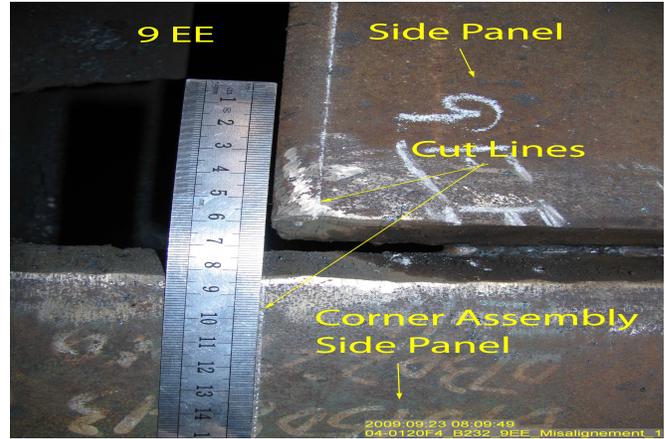
During random Visual Inspection of OBG Segment 9EE, the Caltrans Quality Assurance (QA) Inspector discovered cut lines on corner assembly Side Panel and main segment Side Panel are misaligned Approximately 10mm. This condition occurs where Corner Assembly 70A Side Panel section attaches to Side Panel 322A. See photographs for additional information. An incident report was written on this issue.
