**DEPARTMENT OF TRANSPORTATION**

Contract #: 04-0120F4Cty: SF/ALA Rte: 80 PM: 13.2/13.9File #: 69.28**WELDING INSPECTION REPORT****Resident Engineer:** Pursell, Gary**Address:** 333 Burma Road**City:** Oakland, CA 94607**Report No:** WIR-009207**Date Inspected:** 20-Sep-2009**Project Name:** SAS Superstructure**OSM Arrival Time:** 1845**Prime Contractor:** American Bridge/Fluor Enterprises, a JV**OSM Departure Time:** 645**Contractor:** Zhenhua Port Machinery Company, Ltd (ZPMC), Changxing Island **Location:** Shanghai, China**CWI Name:** Zhang Qin Jiang**CWI Present:** Yes No**Inspected CWI report:** Yes No N/A**Rod Oven in Use:** Yes No N/A**Electrode to specification:** Yes No N/A**Weld Procedures Followed:** Yes No N/A**Qualified Welders:** Yes No N/A**Verified Joint Fit-up:** Yes No N/A**Approved Drawings:** Yes No N/A**Approved WPS:** Yes No N/A**Delayed / Cancelled:** Yes No N/A**Bridge No:** 34-0006**Component:** Tower**Summary of Items Observed:**

# WELDING INSPECTION REPORT

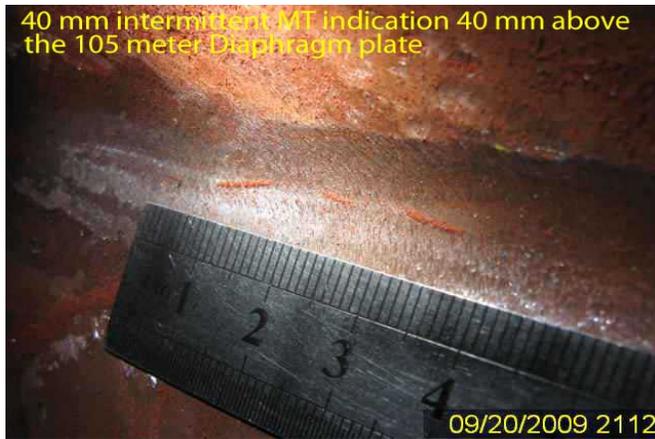
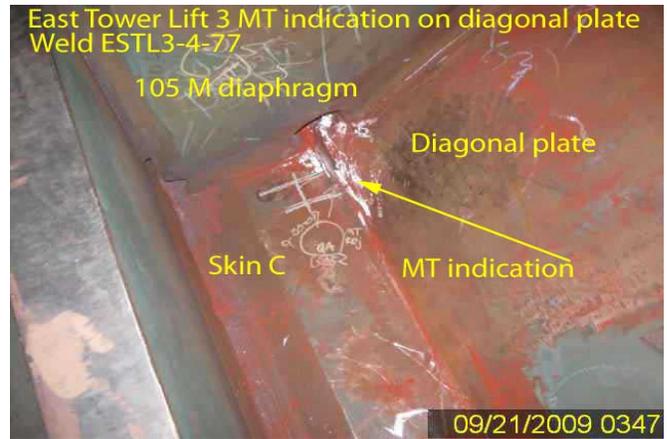
Caltrans QA performed Visual Testing (VT) and Magnetic Particle Testing (MT) verification of East Tower Lift 3 Skin C to D diagonal plate welds, this Quality Control Inspector discovered intermittent undercut up to 2.5 mm in depth from the 99 to 102.5 meter mark on weld ESTL3-4 B/K-78. Caltrans QA found two MT linear indications on weld ESTL3-4 B/K-77, 40 mm intermittent indication located 40 mm above the 105 meter diaphragm and a 10 mm linear indication at the 99 meter bottom diaphragm. The above mentioned welds have been previously tested and accepted by ZPMC Quality Control (QC). The following welds were tested and accepted by this QA inspector: ESTL3-4 H/K-151, 152, 75, 76, ESTL3-4 G/K-97, 98, ESTL3-4 F/K-151, 152, 75, 76, ESTL3-4 K/K-15, 26 and 39.
