Contract #: 04-0120F4Cty: SF/ALA Rte: 80 PM: 13.2/13.9File #: 69.28**WELDING INSPECTION REPORT****Resident Engineer:** Pursell, Gary**Address:** 333 Burma Road**City:** Oakland, CA 94607**Report No:** WIR-009535**Date Inspected:** 06-Oct-2009**Project Name:** SAS Superstructure**OSM Arrival Time:** 1845**Prime Contractor:** American Bridge/Fluor Enterprises, a JV**OSM Departure Time:** 645**Contractor:** Zhenhua Port Machinery Company, Ltd (ZPMC), Changxing Island **Location:** Shanghai, China**CWI Name:** Wang Chuan Qing**CWI Present:** Yes No**Inspected CWI report:** Yes No N/A**Rod Oven in Use:** Yes No N/A**Electrode to specification:** Yes No N/A**Weld Procedures Followed:** Yes No N/A**Qualified Welders:** Yes No N/A**Verified Joint Fit-up:** Yes No N/A**Approved Drawings:** Yes No N/A**Approved WPS:** Yes No N/A**Delayed / Cancelled:** Yes No N/A**Bridge No:** 34-0006**Component:** OBG and Tower**Summary of Items Observed:**

OBG Trial Assembly:

WELDING INSPECTION REPORT

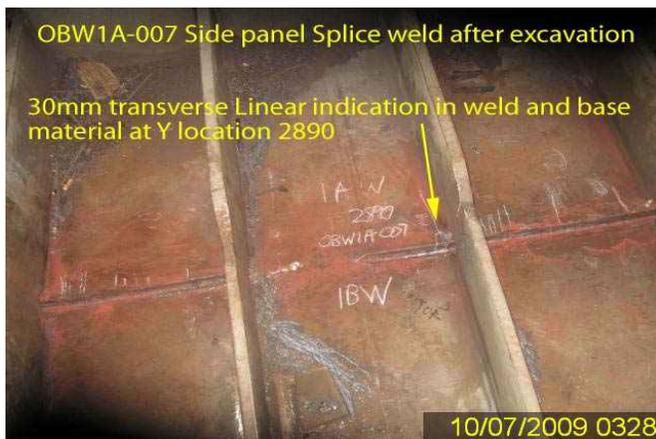
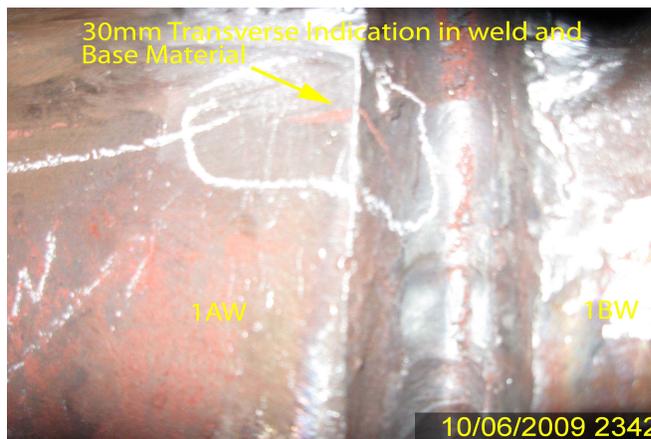
During random visual observations QA observed ZPMC personnel performing air carbon arc gouging of OBG segment 1AW to 1BW side panel transverse splice weld OBW1A-007. Caltrans QA reviewed ZPMC Weld Repair Report, # 8086 and observed that the repair was for "Transverse Linear Indications found Ultrasonically with Scanning Pattern D" by ZPMC Ultrasonic Testing Technicians. The weld repair report did not require Magnetic Particle Testing (MT) of excavation areas prior to welding. Caltrans QA Inspector performed MT after Air Carbon Arc Gouging and observed numerous transverse linear indications present ranging from 2 mm to 30 mm. Caltrans QA issued an incident report this date the transverse linear indications mentioned above. The Y locations and the number of number of transverse linear indications are as follows:

Weld OBW1A-007

50~2475 mm, (14) Transverse linear indications

2720~5030 mm, (29) Transverse linear indications

See attached photos for additional information
