**DEPARTMENT OF TRANSPORTATION**

Contract #: 04-0120F4Cty: SF/ALA Rte: 80 PM: 13.2/13.9File #: 69.28**WELDING INSPECTION REPORT****Resident Engineer:** Pursell, Gary**Address:** 333 Burma Road**City:** Oakland, CA 94607**Report No:** WIR-009588**Date Inspected:** 07-Oct-2009**Project Name:** SAS Superstructure**OSM Arrival Time:** 700**Prime Contractor:** American Bridge/Fluor Enterprises, a JV**OSM Departure Time:** 1900**Contractor:** Zhenhua Port Machinery Company, Ltd (ZPMC), Changxing Island **Location:** Shanghai, China**CWI Name:** Chen Xi**CWI Present:** Yes No**Inspected CWI report:** Yes No N/A**Rod Oven in Use:** Yes No N/A**Electrode to specification:** Yes No N/A**Weld Procedures Followed:** Yes No N/A**Qualified Welders:** Yes No N/A**Verified Joint Fit-up:** Yes No N/A**Approved Drawings:** Yes No N/A**Approved WPS:** Yes No N/A**Delayed / Cancelled:** Yes No N/A**Bridge No:** 34-0006**Component:** OBG Crossbeams**Summary of Items Observed:**

### OBG BAY 2

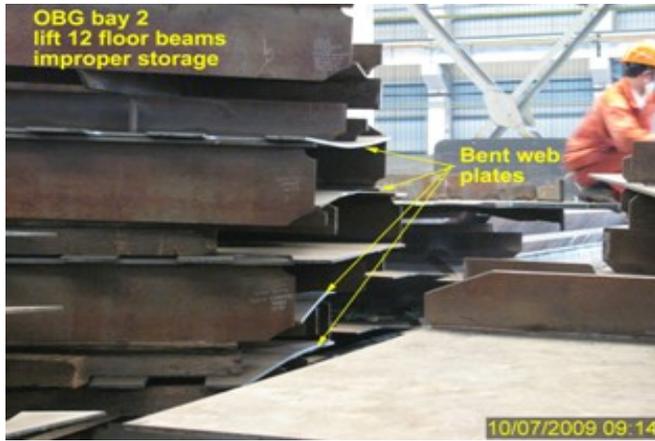
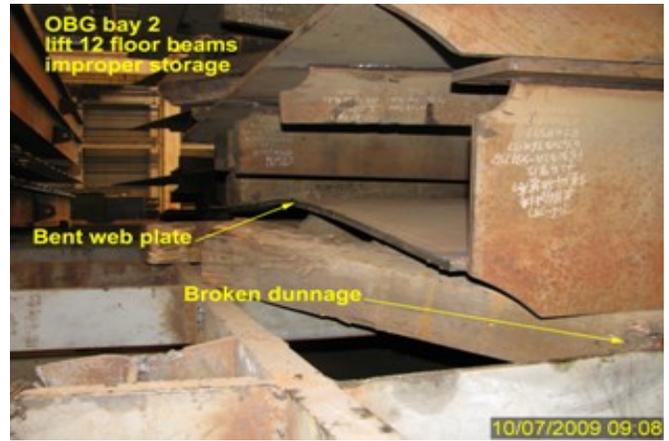
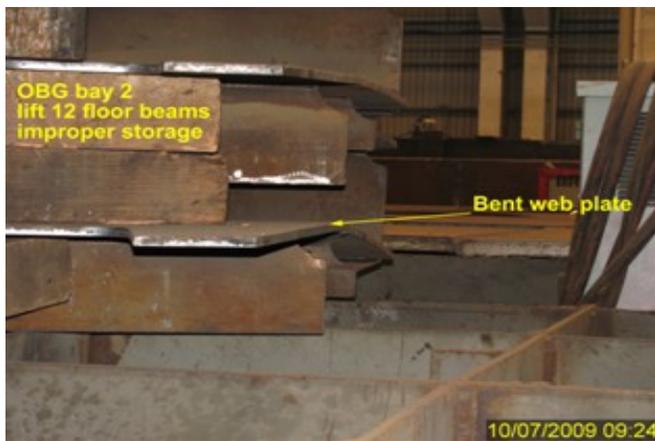
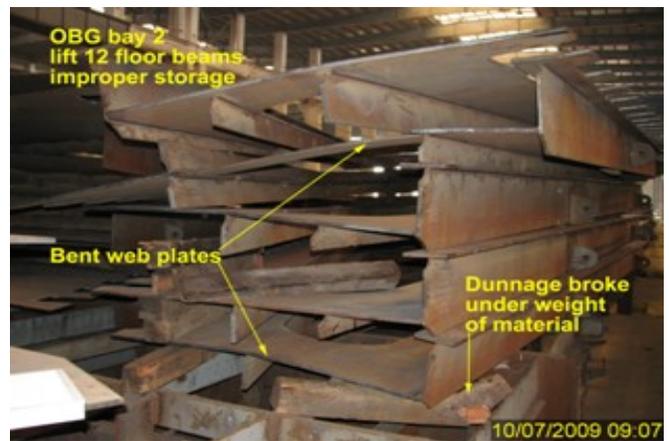
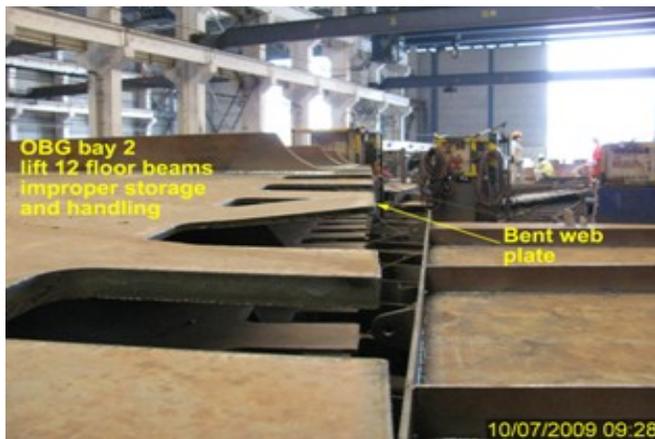
This QA observed lift 12 floor beam components that appear to have been bent/warped due to improper handling and/or storage. See attached photos. Caltrans standard specifications 1999 Section 6-1.3 states "Articles or materials to be incorporated in the work shall be stored in such a manner as to ensure the preservation of their quality and fitness for the work, and to facilitate inspection". Section 55-1.04. states " In handling and shipping of the steel work, every care shall be taken to avoid bending, scraping or overstressing the pieces. All pieces bent or otherwise injured will be rejected". This QA and other Caltrans QA inspectors have repeatedly requested that the contractor correct this issue over the last several days. The contractor has done little if anything to re-stack these floorbeam components in a manner compliant to the contract documents. This QA notified ZPMC QC CWI identified as Mr. Chen Xi and ABF QA inspector identified as Mr. Wang Wen Bin that an incident report would be generated for this issue.
