DEPARTMENT OF TRANSPORTATION

Contract #: 04-0120F4Cty: SF/ALA Rte: 80 PM: 13.2/13.9File #: 69.28**WELDING INSPECTION REPORT****Resident Engineer:** Pursell, Gary**Address:** 333 Burma Road**City:** Oakland, CA 94607**Report No:** WIR-009589**Date Inspected:** 08-Oct-2009**Project Name:** SAS Superstructure**OSM Arrival Time:** 700**Prime Contractor:** American Bridge/Fluor Enterprises, a JV**OSM Departure Time:** 1900**Contractor:** Zhenhua Port Machinery Company, Ltd (ZPMC), Changxing Island **Location:** Shanghai, China**CWI Name:** Chen Xi**CWI Present:** Yes No**Inspected CWI report:** Yes No N/A**Rod Oven in Use:** Yes No N/A**Electrode to specification:** Yes No N/A**Weld Procedures Followed:** Yes No N/A**Qualified Welders:** Yes No N/A**Verified Joint Fit-up:** Yes No N/A**Approved Drawings:** Yes No N/A**Approved WPS:** Yes No N/A**Delayed / Cancelled:** Yes No N/A**Bridge No:** 34-0006**Component:** OBG Crossbeams and cantilever brackets**Summary of Items Observed:**

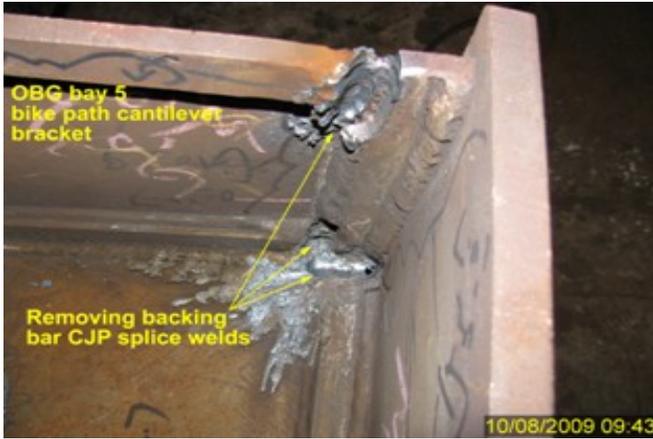
This QA observed ZPMC personnel removing the backing bar splice welds inside of the bike path cantilever brackets utilizing the carbon arc gouging method. The cantilever brackets are identified as BK001-031, 032, 033, 034, 035 and 036.
