**DEPARTMENT OF TRANSPORTATION**

Contract #: 04-0120F4Cty: SF/ALA Rte: 80 PM: 13.2/13.9File #: 69.28**WELDING INSPECTION REPORT****Resident Engineer:** Pursell, Gary**Address:** 333 Burma Road**City:** Oakland, CA 94607**Report No:** WIR-009632**Date Inspected:** 05-Oct-2009**Project Name:** SAS Superstructure**OSM Arrival Time:** 700**Prime Contractor:** American Bridge/Fluor Enterprises, a JV**OSM Departure Time:** 1900**Contractor:** Zhenhua Port Machinery Company, Ltd (ZPMC), Changxing Island **Location:** Shanghai, China

## WELDING INSPECTION REPORT

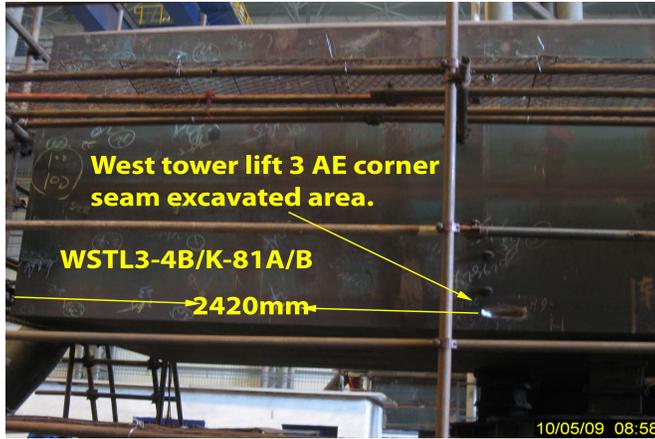
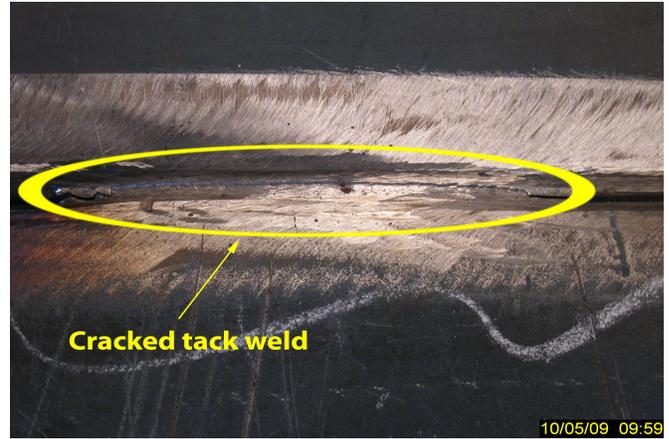
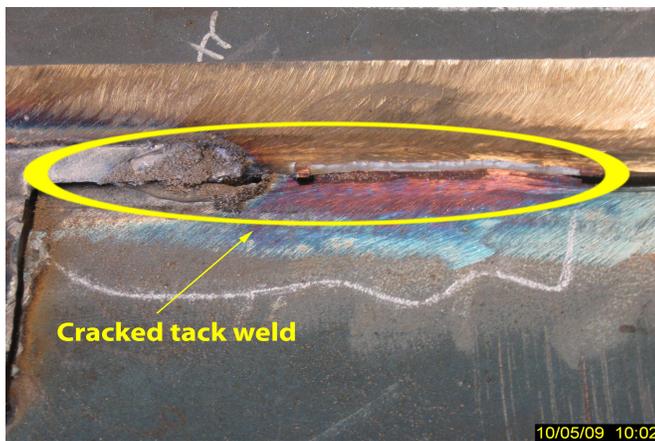
During random Visual Testing (VT), Caltrans Quality Assurance (QA) Inspector observed crack on the tack weld of weld ED1-STSA3-2-109M-1-8A of Strut plate. The attached picture provide additional details.
