DEPARTMENT OF TRANSPORTATION

Contract #: 04-0120F4Cty: SF/ALA Rte: 80 PM: 13.2/13.9File #: 69.28**WELDING INSPECTION REPORT****Resident Engineer:** Pursell, Gary**Address:** 333 Burma Road**City:** Oakland, CA 94607**Report No:** WIR-010100**Date Inspected:** 12-Nov-2009**Project Name:** SAS Superstructure**OSM Arrival Time:** 1900**Prime Contractor:** American Bridge/Fluor Enterprises, a JV**OSM Departure Time:** 700**Contractor:** Zhenhua Port Machinery Company, Ltd (ZPMC), Changxing Island **Location:** Shanghai, China**CWI Name:** Li Ming**CWI Present:** Yes No**Inspected CWI report:** Yes No N/A**Rod Oven in Use:** Yes No N/A**Electrode to specification:** Yes No N/A**Weld Procedures Followed:** Yes No N/A**Qualified Welders:** Yes No N/A**Verified Joint Fit-up:** Yes No N/A**Approved Drawings:** Yes No N/A**Approved WPS:** Yes No N/A**Delayed / Cancelled:** Yes No N/A**Bridge No:** 34-0006**Component:** OBG/Tower**Summary of Items Observed:**

OBG SEGMENT 2AW-2BW

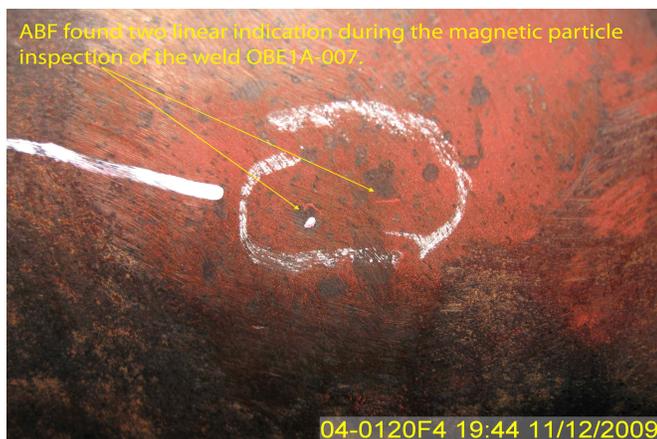
Magnetic Particle Testing (MT) performed on repair areas of side panel splice weld (cross beam side) between OBG segment 1AE and 1BE (OBE1A-006, 007). During the Magnetic Particle Inspection ABF found two linear indications in the weld OBE1A-007. The Y location of indication measured approximately 4200mm and the length of indications measured approximately 5mm and 3mm. For additional information see attached photo.
