**DEPARTMENT OF TRANSPORTATION**

Contract #: 04-0120F4Cty: SF/ALA Rte: 80 PM: 13.2/13.9File #: 69.28**WELDING INSPECTION REPORT****Resident Engineer:** Pursell, Gary**Address:** 333 Burma Road**City:** Oakland, CA 94607**Report No:** WIR-010218**Date Inspected:** 16-Nov-2009**Project Name:** SAS Superstructure**OSM Arrival Time:** 1900**Prime Contractor:** American Bridge/Fluor Enterprises, a JV**OSM Departure Time:** 700**Contractor:** Zhenhua Port Machinery Company, Ltd (ZPMC), Changxing Island **Location:** Shanghai, China**CWI Name:** Li Ming**CWI Present:** Yes No**Inspected CWI report:** Yes No N/A**Rod Oven in Use:** Yes No N/A**Electrode to specification:** Yes No N/A**Weld Procedures Followed:** Yes No N/A**Qualified Welders:** Yes No N/A**Verified Joint Fit-up:** Yes No N/A**Approved Drawings:** Yes No N/A**Approved WPS:** Yes No N/A**Delayed / Cancelled:** Yes No N/A**Bridge No:** 34-0006**Component:** OBG/Tower**Summary of Items Observed:**

OBG SEGMENT 1EAST

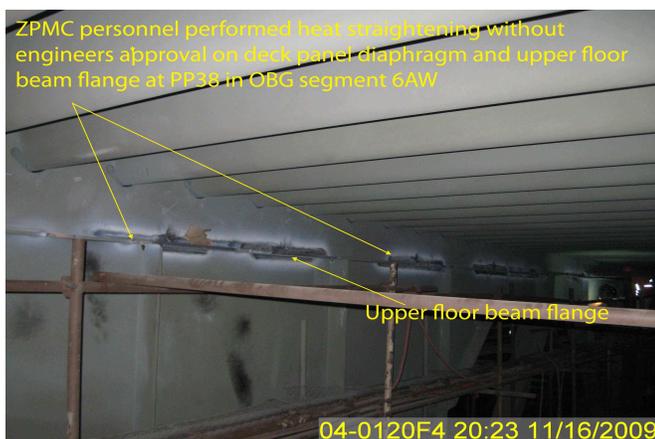
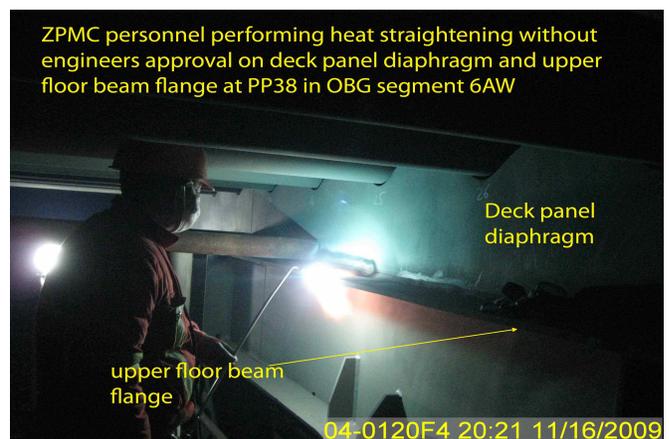
During random visual inspection this Caltrans Quality Assurance (QA) Inspector observed that contractor personnel was performing Heat Straightening on various location on deck panel diaphragm and the upper floor beam flange in OBG segment 6AW at panel point 38 without the approval of the Engineer. ZPMC QC or CWI was not present during the time of heat straightening. For additional information see attached photos. Incident report was send to the task leader and other supervisor.
