**DEPARTMENT OF TRANSPORTATION**

Quality Assurance and Source Inspection

Contract #: 04-0120F4Cty: SF/ALA Rte: 80 PM: 13.2/13.9File #: 69.28**WELDING INSPECTION REPORT****Resident Engineer:** Pursell, Gary**Address:** 333 Burma Road**City:** Oakland, CA 94607**Report No:** WIR-010651**Date Inspected:** 10-Dec-2009**Project Name:** SAS Superstructure**OSM Arrival Time:** 645**Prime Contractor:** American Bridge/Fluor Enterprises, a JV**OSM Departure Time:** 1845**Contractor:** Zhenhua Port Machinery Company, Ltd (ZPMC), Changxing Island **Location:** Shanghai, China**CWI Name:** Liu Fawen**CWI Present:** Yes No**Inspected CWI report:** Yes No N/A**Rod Oven in Use:** Yes No N/A**Electrode to specification:** Yes No N/A**Weld Procedures Followed:** Yes No N/A**Qualified Welders:** Yes No N/A**Verified Joint Fit-up:** Yes No N/A**Approved Drawings:** Yes No N/A**Approved WPS:** Yes No N/A**Delayed / Cancelled:** Yes No N/A**Bridge No:** 34-0006**Component:** Orthotropic Box Girder (OBG) & Tower Com**Summary of Items Observed:**

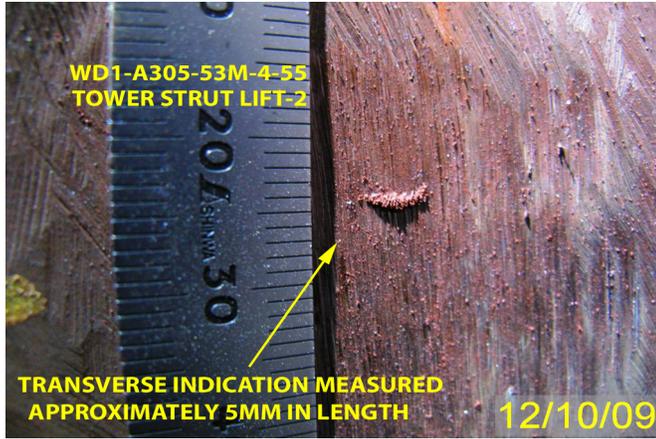
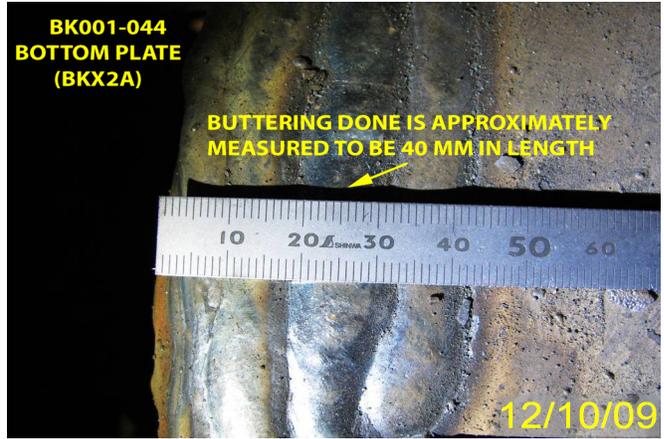
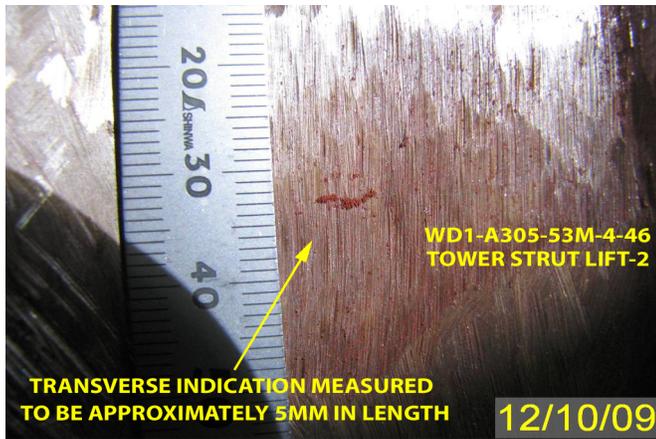
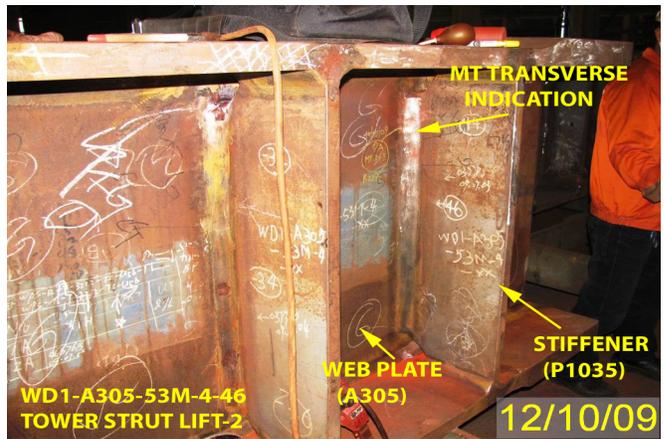
This Quality Assurance Inspector (QA) observed ZPMC personnel build up with weld (buttering) one (1) end of a bottom plate for a bike path cantilever bracket. This QA observed that ZPMC has deposited approximately 40mm of weld metal for the entire width of this plate. This exceeds the limits specified on the approved Critical Weld Repair (CWR) report presented to this QA by ZPMC Quality Control (QC). CWR #B-CWR0948 specifies 10mm to 15mm of buttering is required to correct the insufficient length of the plate. Additionally, the amount of buttering exceeds the limits specified in American Welding Society (AWS) D1.5 2002 section 3.3.4.1 (20mm). The bike path cantilever bracket is identified as BK001-044; bottom plate BKX2A.

The member is located in Orthotropic Box Girder (OBG) subassembly Bay 5.

AWS D1.5-2002, Section 3.3.4.1- “Root openings wider than those allowed in 3.3.4, but not greater than twice the thickness of the thinner part or 20 mm [3/4 in.], whichever is less, may be corrected by welding to acceptable dimensions prior to joining the parts by welding.”

AWS D1.5-2002, Section 3.3.4.2- “Root openings larger than those allowed in 3.3.4.1 may be corrected by welding only with the approval of the engineer.”

Approved CWR report #B-CWR948 specifies 10mm to 15mm of weld metal is required.

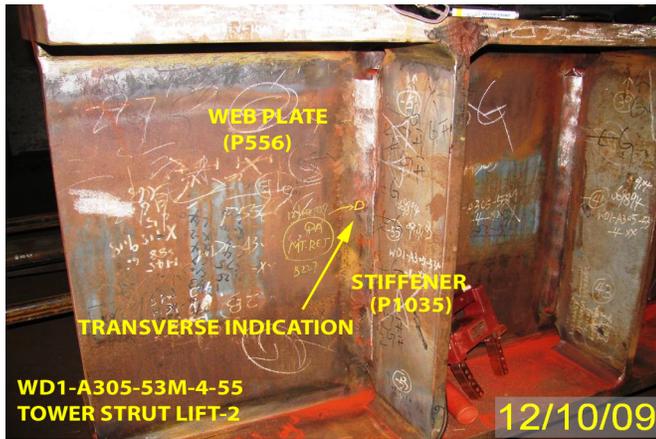
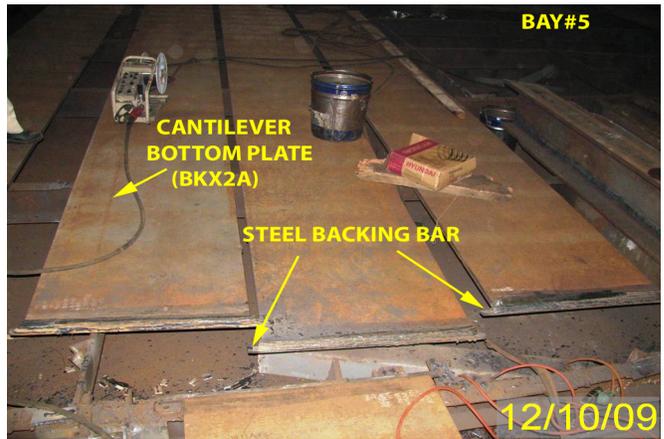
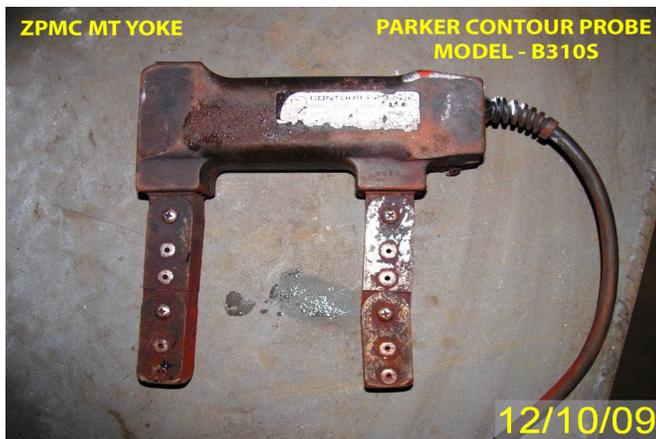
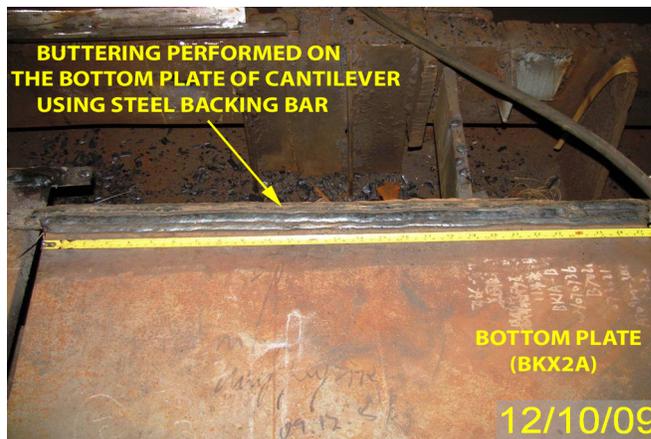
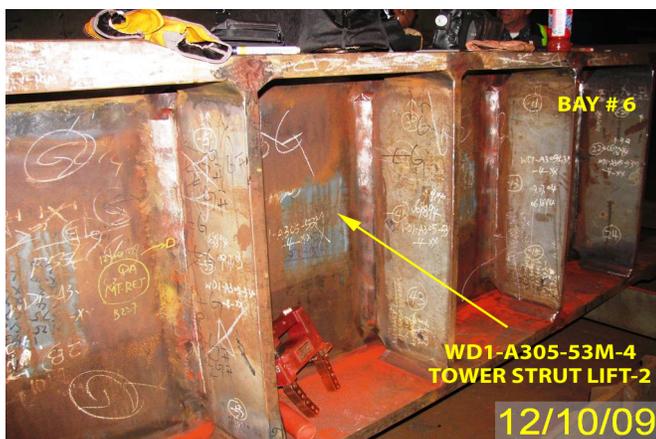
During the Quality Assurance Magnetic Particle Testing (MT) review of welds located on Tower Strut WD1-A305-53M-4, this Quality Assurance Inspector (QA) discovered the following issues:

-Total Two (2) transverse indications found.

1. WD1-A305-53M-4-46 – One (1) transverse indication measuring approximately 5mm in length  
The Weld is a T-joint fillet weld joining web plate (A305) to the stiffener plate (P1035).
2. WD1-A305-53M-4-55 – One (1) transverse indication measuring approximately 5mm in length  
The Weld is a T-joint fillet weld joining web plate (P556) to the stiffener plate (P1035).

-During the confirmation of the above indications by ZPMC MT technician, technician identified as Liu Zhang Min failed to find the indications with his MT equipment (yoke).

The Notice of Witness Inspection Number (NWIT) is 004835. The indication is located inside the area that has been previously tested and accepted by ZPMC Quality Control (QC) personnel. As per the contract documents, ZPMC's QC personnel are required to perform 100% MT inspection of these welds.
