Contract #: 04-0120F4Cty: SF/ALA Rte: 80 PM: 13.2/13.9File #: 69.28**WELDING INSPECTION REPORT****Resident Engineer:** Pursell, Gary**Address:** 333 Burma Road**City:** Oakland, CA 94607**Report No:** WIR-011961**Date Inspected:** 28-Jan-2010**Project Name:** SAS Superstructure**OSM Arrival Time:** 700**Prime Contractor:** American Bridge/Fluor Enterprises, a JV**OSM Departure Time:** 1900**Contractor:** Zhenhua Port Machinery Company, Ltd (ZPMC), Changxing Island **Location:** Shanghai, China**CWI Name:** You Qi Guo.**CWI Present:** Yes No**Inspected CWI report:** Yes No N/A**Rod Oven in Use:** Yes No N/A**Electrode to specification:** Yes No N/A**Weld Procedures Followed:** Yes No N/A**Qualified Welders:** Yes No N/A**Verified Joint Fit-up:** Yes No N/A**Approved Drawings:** Yes No N/A**Approved WPS:** Yes No N/A**Delayed / Cancelled:** Yes No N/A**Bridge No:** 34-0006**Component:** Tower**Summary of Items Observed:**

WELDING INSPECTION REPORT

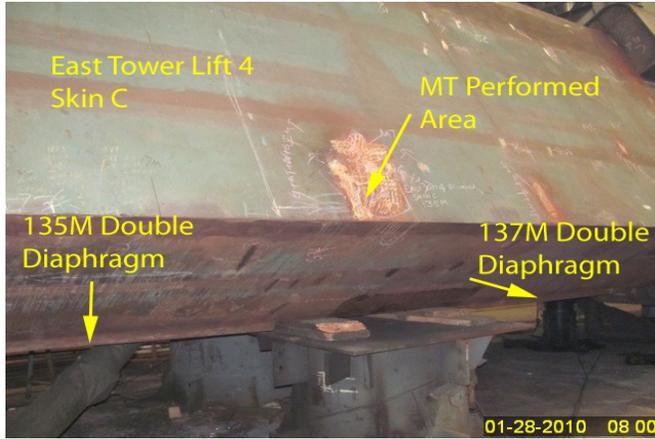
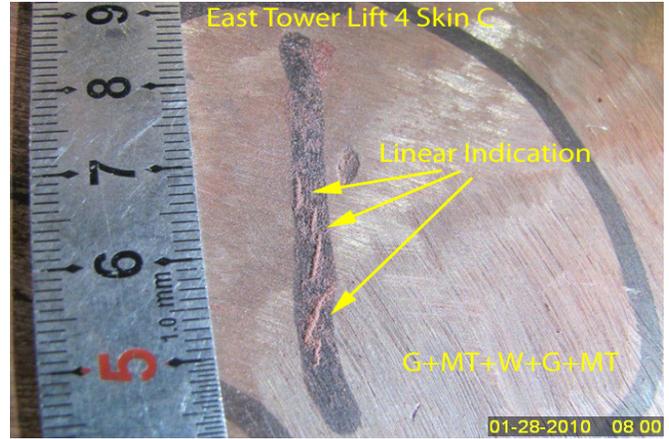
This QA Inspector observed during random Visual inspection, ZPMC MT Inspector all ready done Magnetic Particle Testing on base metal of East Tower lift 4 skin C. and they marked that area. For more information see attached photos.
