DEPARTMENT OF TRANSPORTATION

Contract #: 04-0120F4Cty: SF/Ala Rte: 80 PM: 13.2/13.9File #: 69.28**WELDING INSPECTION REPORT****Resident Engineer:** Pursell, Gary**Address:** 333 Burma Road**City:** Oakland, CA 94607**Report No:** WIR-012230**Date Inspected:** 26-Jan-2010**Project Name:** SAS Superstructure**OSM Arrival Time:** 1900**Prime Contractor:** American Bridge/Fluor Enterprises, a JV**OSM Departure Time:** 700**Contractor:** Zhenhua Port Machinery Company, Ltd (ZPMC), Changxing Island **Location:** Shanghai, China**CWI Name:** See below**CWI Present:** Yes No**Inspected CWI report:** Yes No N/A**Rod Oven in Use:** Yes No N/A**Electrode to specification:** Yes No N/A**Weld Procedures Followed:** Yes No N/A**Qualified Welders:** Yes No N/A**Verified Joint Fit-up:** Yes No N/A**Approved Drawings:** Yes No N/A**Approved WPS:** Yes No N/A**Delayed / Cancelled:** Yes No N/A**Bridge No:** 34-0006**Component:** Tower Components**Summary of Items Observed:**

WELDING INSPECTION REPORT

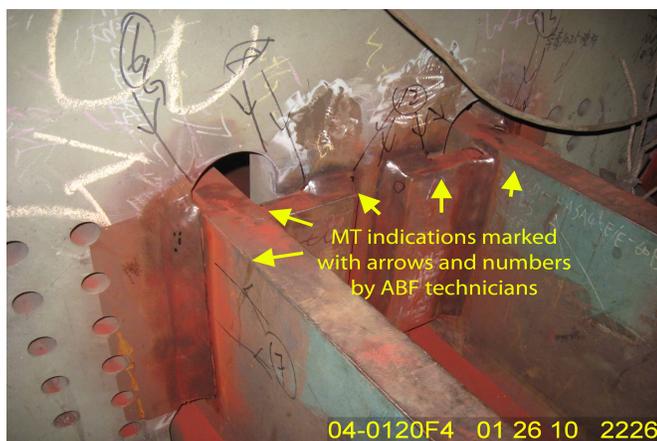
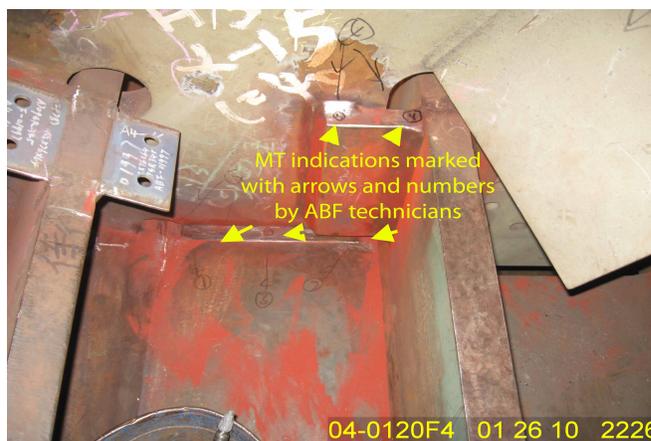
ABF technicians performing magnetic particle testing (MT) in PCMK south tower, lift 4, skin A at numerous locations of double diaphragms to skin, double diaphragms to fit lugs, and fit lugs to stiffeners. This QA Inspector observed many markings of MT indications left by the ABF technicians. See photos below.
