**DEPARTMENT OF TRANSPORTATION**

Contract #: 04-0120F4Cty: SF/ALA Rte: 80 PM: 13.2/13.9File #: 69.28**WELDING INSPECTION REPORT****Resident Engineer:** Pursell, Gary**Address:** 333 Burma Road**City:** Oakland, CA 94607**Report No:** WIR-011886**Date Inspected:** 03-Feb-2010**Project Name:** SAS Superstructure**OSM Arrival Time:** 645**Prime Contractor:** American Bridge/Fluor Enterprises, a JV**OSM Departure Time:** 1845**Contractor:** Zhenhua Port Machinery Company, Ltd (ZPMC), Changxing Island **Location:** Shanghai, China

# WELDING INSPECTION REPORT

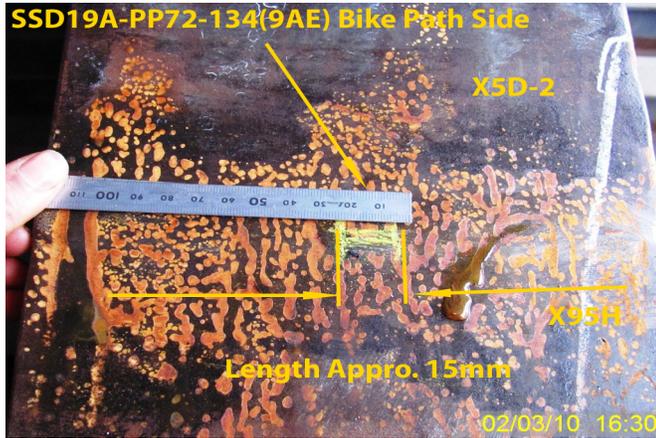
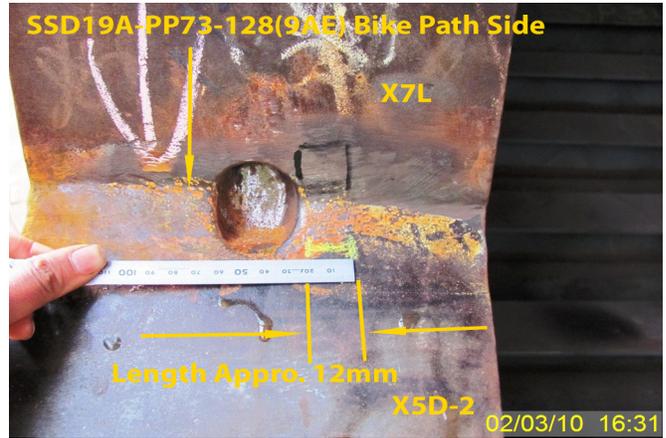
During the Quality Assurance Ultrasonic Testing (UT) review of welds located on Orthotropic Box Girder (OBG) segment 9AE, this Quality Assurance Inspector (QA) discovered the two (2) longitudinal Class "A" indication measuring approximately 15mm and 12 mm in length. The indication db ratings are +6 and +7.

Material thickness is 20mm for both joint. The depth of the indication is approximately 16.5mm and 17mm.

The welds are identified as SSD19A-PP72-134 and SSD19A-PP73-128. The welds are designated as Non Seismic Performance Critical Material. The indication is clearly marked on or near the weld. The Y distance for those

indications are 70mm and 55 mm from edge of the flange plate. The weld SSD19A-PP72-134 is Complete Joint Penetration (CJP) Butt joint joining Flange Plate X5D-2 (Non SPCM) to Floor Beam X5D(Non SPCM) and weld SSD19A-PP73-128 is Complete Joint Penetration (CJP) "T" joint joining Flange Plate X5D-2 (Non SPCM) to Floor Beam X7L(Non SPCM)
