**DEPARTMENT OF TRANSPORTATION**

Contract #: 04-0120F4Cty: SF/ALA Rte: 80 PM: 13.2/13.9File #: 69.28**WELDING INSPECTION REPORT****Resident Engineer:** Pursell, Gary**Address:** 333 Burma Road**City:** Oakland, CA 94607**Report No:** WIR-011892**Date Inspected:** 10-Feb-2010**Project Name:** SAS Superstructure**OSM Arrival Time:** 700**Prime Contractor:** American Bridge/Fluor Enterprises, a JV**OSM Departure Time:** 1900**Contractor:** Zhenhua Port Machinery Company, Ltd (ZPMC), Changxing Island **Location:** Shanghai, China**CWI Name:** Li Yang**CWI Present:** Yes No**Inspected CWI report:** Yes No N/A**Rod Oven in Use:** Yes No N/A**Electrode to specification:** Yes No N/A**Weld Procedures Followed:** Yes No N/A**Qualified Welders:** Yes No N/A**Verified Joint Fit-up:** Yes No N/A**Approved Drawings:** Yes No N/A**Approved WPS:** Yes No N/A**Delayed / Cancelled:** Yes No N/A**Bridge No:** 34-0006**Component:** OBG**Summary of Items Observed:**

**OBG SEGMENT 7BW**

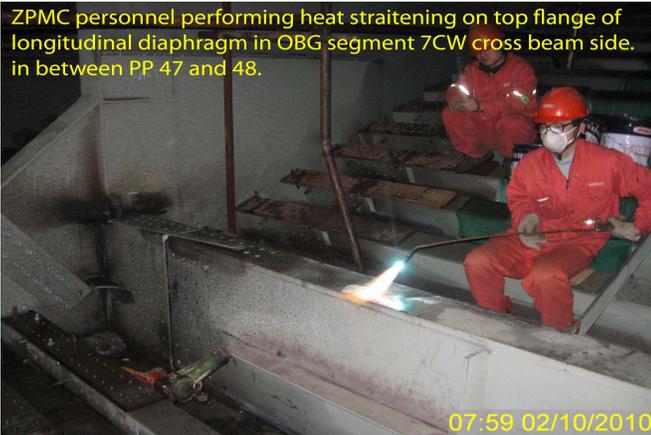
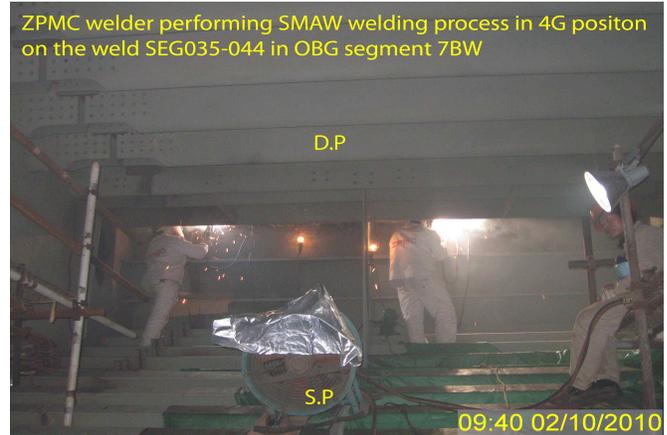
This Quality Assurance (QA) Inspector observed ZPMC personnel performing heat straitening on top flange of longitudinal diaphragm in between panel point 47 and 48(cross beam side). Heat straitening report identified as HSR1 (B)-8121. See attached photo.
