DEPARTMENT OF TRANSPORTATION

Contract #: 04-0120F4Cty: SF/ALA Rte: 80 PM: 13.2/13.9File #: 69.28**WELDING INSPECTION REPORT****Resident Engineer:** Pursell, Gary**Address:** 333 Burma Road**City:** Oakland, CA 94607**Report No:** WIR-012013**Date Inspected:** 16-Feb-2010**Project Name:** SAS Superstructure**OSM Arrival Time:** 700**Prime Contractor:** American Bridge/Fluor Enterprises, a JV**OSM Departure Time:** 1900**Contractor:** Zhenhua Port Machinery Company, Ltd (ZPMC), Changxing Island **Location:** Shanghai, China**CWI Name:** Li Yang**CWI Present:** Yes No**Inspected CWI report:** Yes No N/A**Rod Oven in Use:** Yes No N/A**Electrode to specification:** Yes No N/A**Weld Procedures Followed:** Yes No N/A**Qualified Welders:** Yes No N/A**Verified Joint Fit-up:** Yes No N/A**Approved Drawings:** Yes No N/A**Approved WPS:** Yes No N/A**Delayed / Cancelled:** Yes No N/A**Bridge No:** 34-0006**Component:** OBG Trial Assembly**Summary of Items Observed:**

Orthotropic Box Girder (OBG) Trial Assembly Areas

Segment 6AW (Corner Assembly)

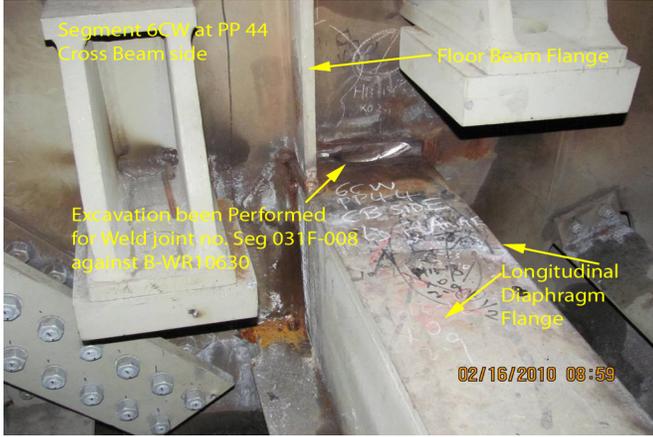
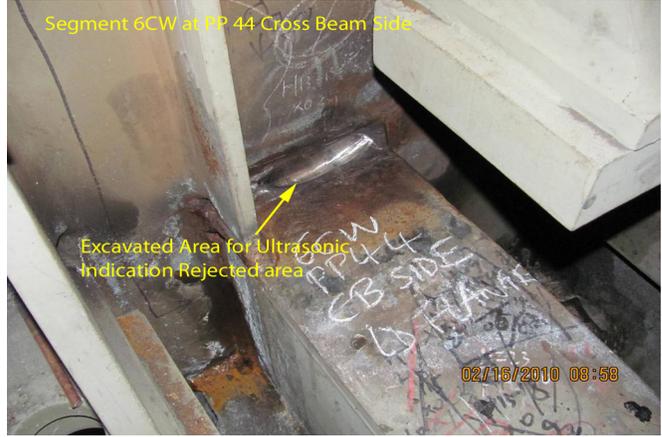
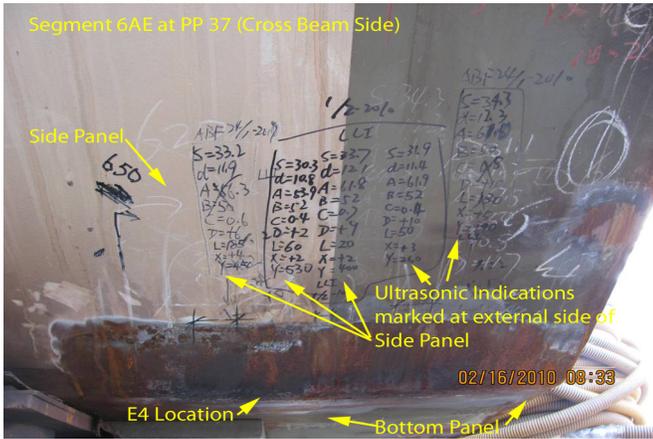
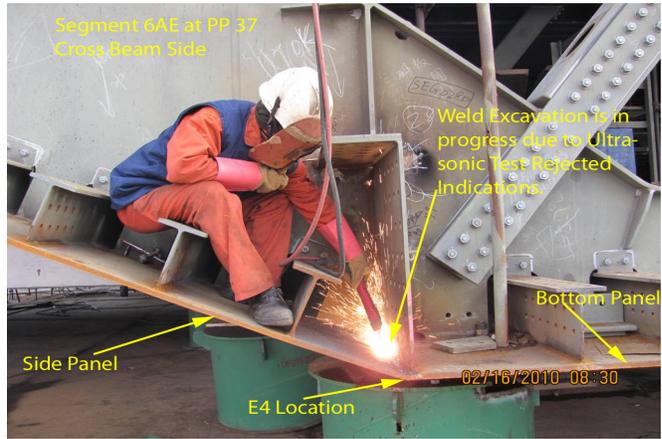
This QA Inspector observed ZPMC welding personnel performing repair welding by Shielded Metal Arc Welding (SMAW) for Longitudinal Diaphragm Flange for Segment 6CW at PP 44 Cross Beam side. The weld joint was identified as Seg 031F-008. The welder is identified as 066261. In process SMAW appears to be progressing in compliance with Caltrans Engineer Approved welding procedure i.e., WPS-345-SMAW-1G (1F)-Repair-1. It was observed that the parameters noted down by ZPMC QC are in compliance with WPS, for more comprehensive information refer the attached pictures.

This QA Inspector observed ZPMC personnel's performing carbon arc gouging for the weld connecting Side Panel to Bottom Panel at E4 location at Segment 6AE at PP 37 for UT rejected area, for more comprehensive information refer the attached pictures.
