**DEPARTMENT OF TRANSPORTATION**

Contract #: 04-0120F4Cty: SF/ALA Rte: 80 PM: 13.2/13.9File #: 69.28**WELDING INSPECTION REPORT****Resident Engineer:** Pursell, Gary**Address:** 333 Burma Road**City:** Oakland, CA 94607**Report No:** WIR-012134**Date Inspected:** 10-Feb-2010**Project Name:** SAS Superstructure**OSM Arrival Time:** 1900**Prime Contractor:** American Bridge/Fluor Enterprises, a JV**OSM Departure Time:** 700**Contractor:** Zhenhua Port Machinery Company, Ltd (ZPMC), Changxing Island **Location:** Shanghai, China

**OBG Trial Assembly**

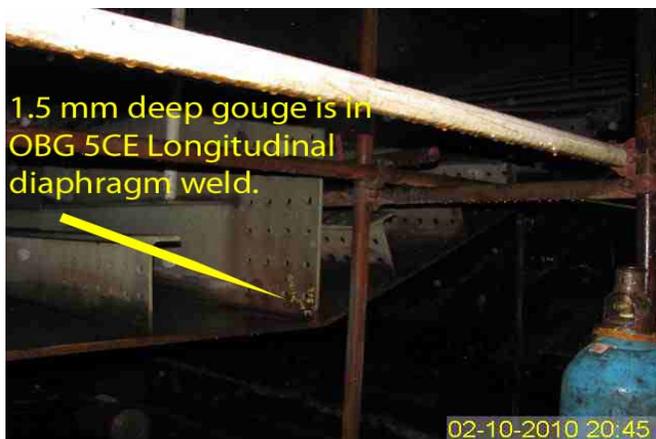
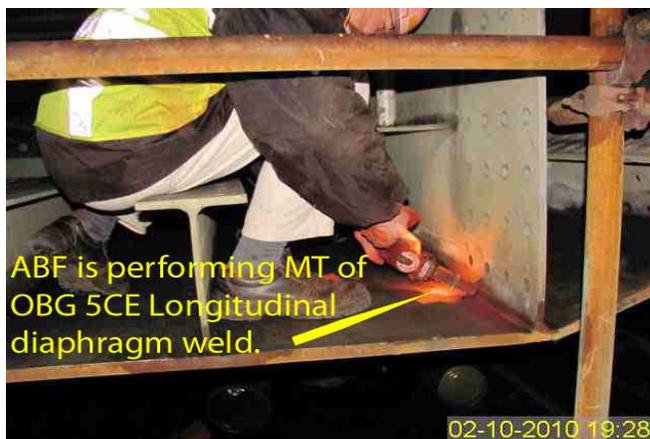
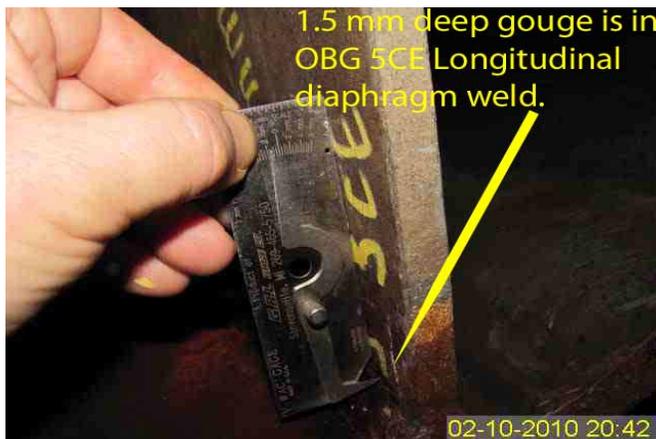
This QA Inspector observed no ZPMC personnel were welding or grinding on any of the OBG segments located in the OBG Trial Assembly yard. One welder was fabricating various pieces of steel that appear to be intended to be used as scaffolding or similar uses. Three ABF personnel appeared to be performing magnetic particle inspections of various welds in OBG segments 5BE and 5CE. This QA Inspector observed that one of the welds that were inspected with the magnetic particle process by ABF Inspectors was the longitudinal diaphragm to deck plate "hold back" weld on the cross beam side adjacent to where segment 6AE is to be joined to segment 5CE. This QA Inspector observed that the base material at top edge of the fillet weld located at approximately 20 mm from the end of the segment has been ground to a depth of approximately 1.5 mm and that the maximum allowable depth that can be ground is 1.0 mm. This QA Inspector informed ABF magnetic particle Inspectors that this weld appears to be visually unacceptable due to the depth of the grinding. The ABF Inspectors informed this QA Inspector that they were only performing magnetic particle inspections and they were not responsible for performing visual inspections of these welds. Since there were no ZPMC QC Inspectors in the area, this QA Inspector has left a turnover for dayshift Caltrans QA Personnel to contact ZPMC QC personnel to resolve this

visual rejection. See the photographs below for additional information.
