DEPARTMENT OF TRANSPORTATION

Contract #: 04-0120F4Cty: SF/ALA Rte: 80 PM: 13.2/13.9File #: 69.28**WELDING INSPECTION REPORT****Resident Engineer:** Pursell, Gary**Address:** 333 Burma Road**City:** Oakland, CA 94607**Report No:** WIR-012147**Date Inspected:** 16-Feb-2010**Project Name:** SAS Superstructure**OSM Arrival Time:** 700**Prime Contractor:** American Bridge/Fluor Enterprises, a JV**OSM Departure Time:** 1900**Contractor:** Zhenhua Port Machinery Company, Ltd (ZPMC), Changxing Island **Location:** Shanghai, China

WELDING INSPECTION REPORT

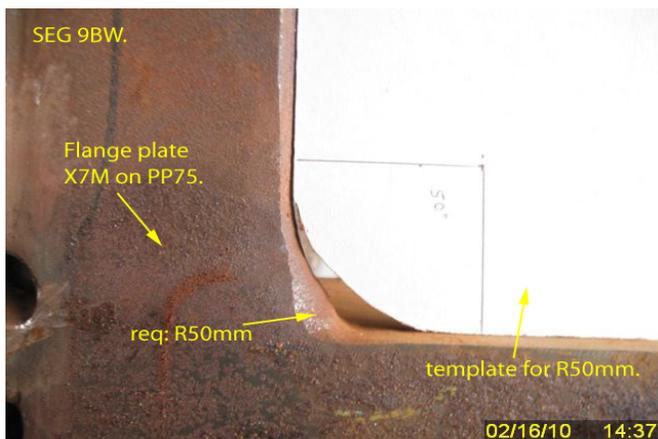
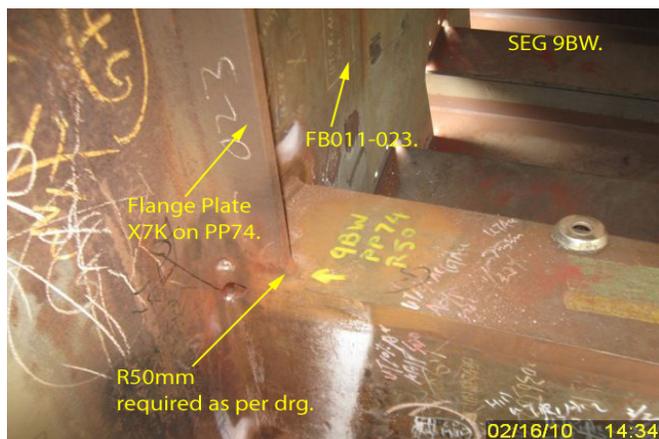
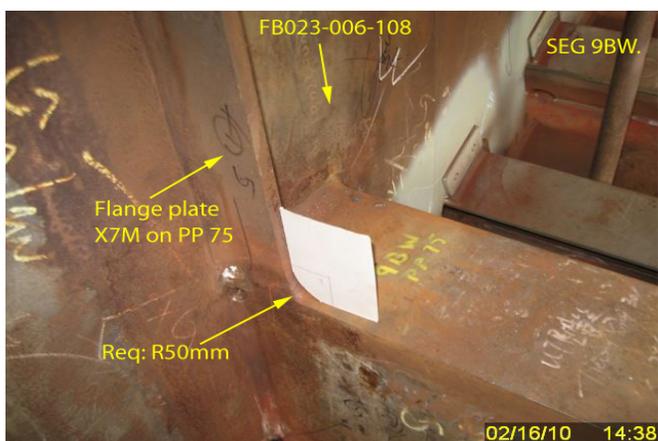
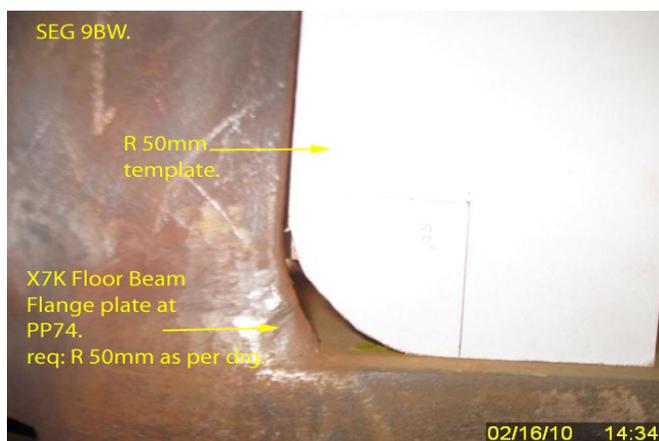
- This QA inspector performed in process Visual Inspection of the 50mm radii at the bottom end of Floor Beam Flange of X7 Flange Plate at PP74, PP75 & PP76.
- This QA observed that at least at two locations / Flange Plates, this 50mm radius, do not appear to comply with the Contract document & needs weld repair / rectification.
- These locations are identified as:

- 1) Flange Plate X7K on PP74, Floor Beam – FB011-023 &
 - 2) Flange Plate X7M on PP75, Floor Beam – FB023-006.
- For details, refer attached photos.
