DEPARTMENT OF TRANSPORTATION

Contract #: 04-0120F4Cty: SF/ALA Rte: 80 PM: 13.2/13.9File #: 69.28**WELDING INSPECTION REPORT****Resident Engineer:** Pursell, Gary**Address:** 333 Burma Road**City:** Oakland, CA 94607**Report No:** WIR-012185**Date Inspected:** 18-Feb-2010**Project Name:** SAS Superstructure**OSM Arrival Time:** 700**Prime Contractor:** American Bridge/Fluor Enterprises, a JV**OSM Departure Time:** 1900**Contractor:** Zhenhua Port Machinery Company, Ltd (ZPMC), Changxing Island **Location:** Shanghai, China**CWI Name:** Chen Xi.**CWI Present:** Yes No**Inspected CWI report:** Yes No N/A**Rod Oven in Use:** Yes No N/A**Electrode to specification:** Yes No N/A**Weld Procedures Followed:** Yes No N/A**Qualified Welders:** Yes No N/A**Verified Joint Fit-up:** Yes No N/A**Approved Drawings:** Yes No N/A**Approved WPS:** Yes No N/A**Delayed / Cancelled:** Yes No N/A**Bridge No:** 34-0006**Component:** OBG**Summary of Items Observed:**

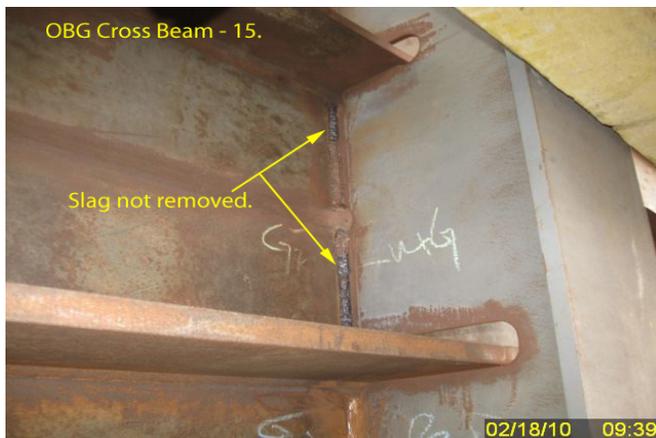
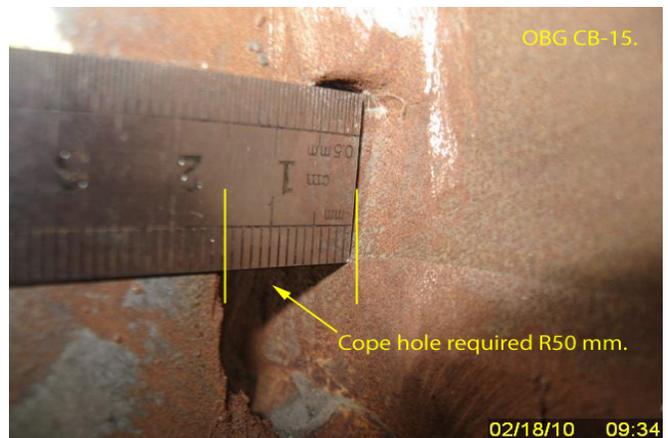
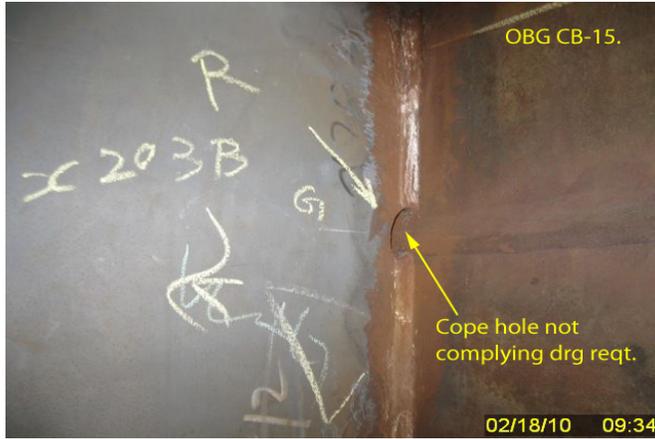
CB15:

- Some of the welds having poor weld profile and slag not removed.
- Some of the cope holes do not appear to comply with the contract documents.

This QA Inspector has marked above mentioned such locations in question for the Contractors QC to inspect and evaluate. Fabrication of this CB is in progress and is not yet released for Caltrans inspection.
