**DEPARTMENT OF TRANSPORTATION**

Contract #: 04-0120F4Cty: SF/ALA Rte: 80 PM: 13.2/13.9File #: 69.28**WELDING INSPECTION REPORT****Resident Engineer:** Pursell, Gary**Address:** 333 Burma Road**City:** Oakland, CA 94607**Report No:** WIR-012199**Date Inspected:** 22-Feb-2010**Project Name:** SAS Superstructure**OSM Arrival Time:** 645**Prime Contractor:** American Bridge/Fluor Enterprises, a JV**OSM Departure Time:** 1845**Contractor:** Zhenhua Port Machinery Company, Ltd (ZPMC), Changxing Island **Location:** Shanghai, China

**Segment 8CE**

**Segment 9DE**

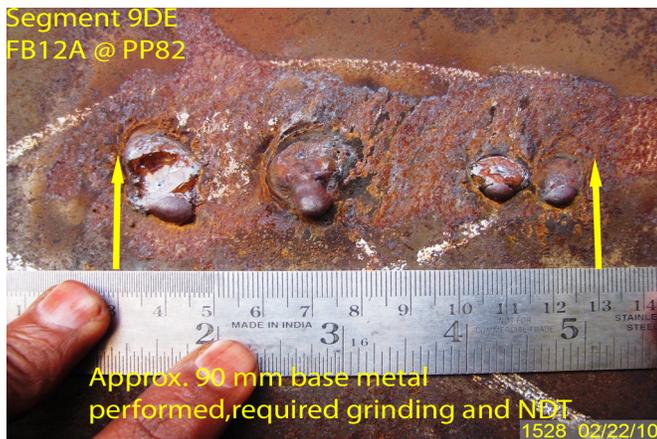
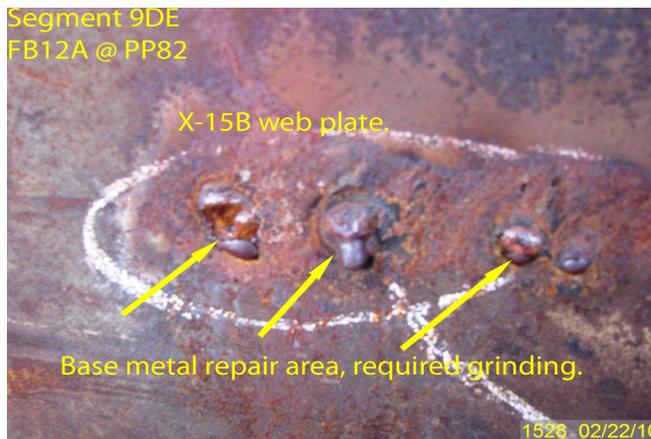
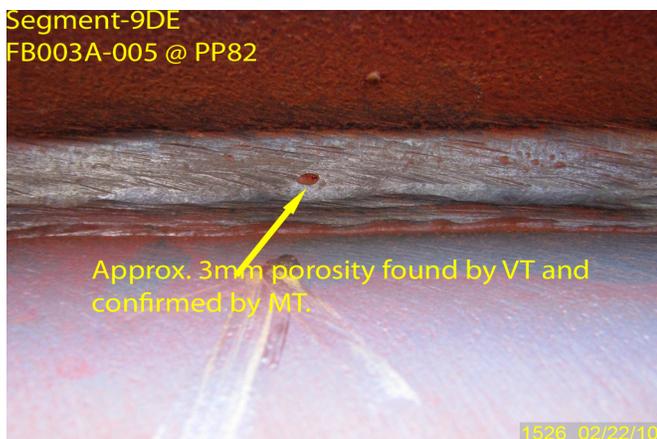
During random visual inspection of OBG Segment 9DE, this QA inspector observed that approximately 90mm base metal repair location in segment 9DE @ PP 82. Component is identified as floor beam, FB012A. Base metal repair located on web plate of FB012A, X15B. The location requires grinding and MT for further evaluation. For further information, please see attached pictures.

-(FB003A-005)@ PP82- 3mm Visual Porosity.
