**DEPARTMENT OF TRANSPORTATION**

Contract #: 04-0120F4Cty: SF/ALA Rte: 80 PM: 13.2/13.9File #: 69.28**WELDING INSPECTION REPORT****Resident Engineer:** Pursell, Gary**Address:** 333 Burma Road**City:** Oakland, CA 94607**Report No:** WIR-012209**Date Inspected:** 19-Feb-2010**Project Name:** SAS Superstructure**OSM Arrival Time:** 700**Prime Contractor:** American Bridge/Fluor Enterprises, a JV**OSM Departure Time:** 1900**Contractor:** Zhenhua Port Machinery Company, Ltd (ZPMC), Changxing Island **Location:** Shanghai, China**CWI Name:****CWI Present:**

**Bridge No:** 34-0006**Component:** OBG Trial Assembly**Summary of Items Observed:**

## WELDING INSPECTION REPORT

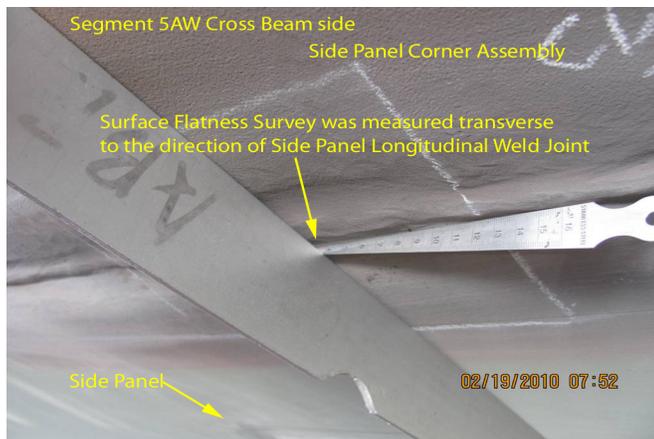
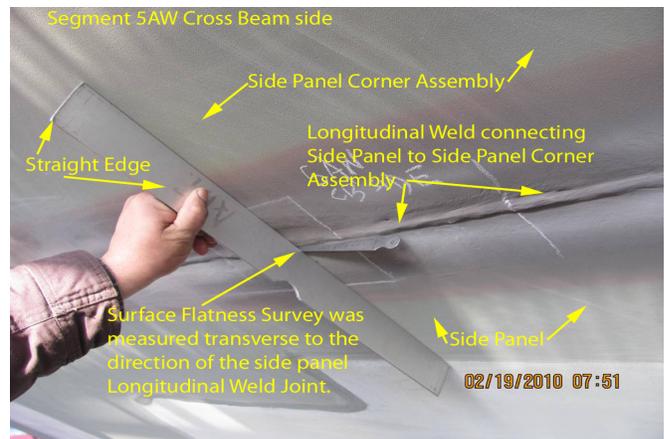
Transverse direction to the Longitudinal Weld connecting the Side Panel to Side Panel Corner Assembly between Segment 5AW, 5BW and 5CW (Shop Segment Splice) from Panel Point (PP) 29 and PP 36 Cross Beam and Counter Weight side.

Observed Heat Straightening was been performed against for Segment 5AW for Side Panel SP091A+SP409A against HSR (B)-348 Rev.0 Dated Feb 04, 2010.

Observed Heat Straightening was been performed against for Segment 5BW for Side Panel SP092A+SP410A against HSR (B)-349 Rev.0 Dated Feb 04, 2010.

Observed Heat Straightening was been performed against for Segment 5CW for Side Panel SP093A+SP411A against HSR (B)-350 Rev.0 Dated Feb 04, 2010.

For more comprehensive details please refer the attached pictures below.
