DEPARTMENT OF TRANSPORTATION

Contract #: 04-0120F4Cty: SF/ALA Rte: 80 PM: 13.2/13.9File #: 69.28**WELDING INSPECTION REPORT****Resident Engineer:** Pursell, Gary**Address:** 333 Burma Road**City:** Oakland, CA 94607**Report No:** WIR-012284**Date Inspected:** 23-Feb-2010**Project Name:** SAS Superstructure**OSM Arrival Time:** 700**Prime Contractor:** American Bridge/Fluor Enterprises, a JV**OSM Departure Time:** 1900**Contractor:** Zhenhua Port Machinery Company, Ltd (ZPMC), Changxing Island **Location:** Shanghai, China**CWI Name:****CWI Present:**

Bridge No: 34-0006**Component:** OBG Trial Assembly**Summary of Items Observed:**

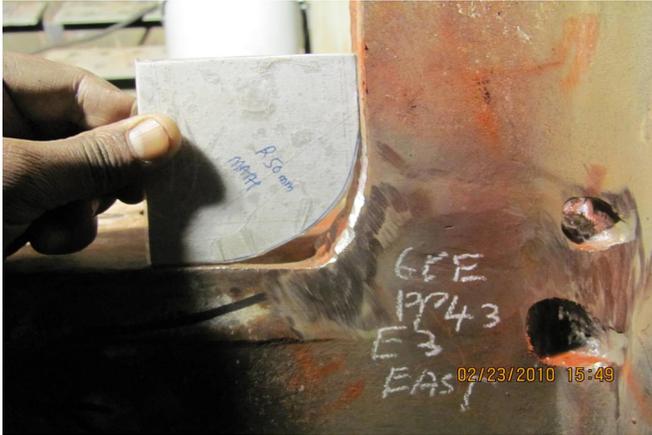
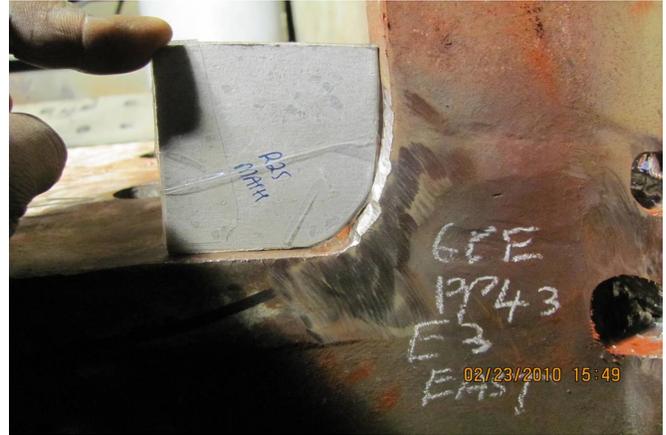
The QA inspector performed inspection for the Floor Beam Flange welded at Longitudinal Diaphragm for the Radius and Distance from the Flange to the Weld termination at E3 Location from Panel Point (PP) 37 to PP 47, East and West side of Floor Beam.

Report forwarded to team leader for further action, kindly refer to the pictures attached below when measured with 25mm Radius template and 50mm Radius template.
