**DEPARTMENT OF TRANSPORTATION**

Contract #: 04-0120F4Cty: SF/ALA Rte: 80 PM: 13.2/13.9File #: 69.28**WELDING INSPECTION REPORT****Resident Engineer:** Pursell, Gary**Address:** 333 Burma Road**City:** Oakland, CA 94607**Report No:** WIR-012308**Date Inspected:** 09-Feb-2010**Project Name:** SAS Superstructure**OSM Arrival Time:** 645**Prime Contractor:** American Bridge/Fluor Enterprises, a JV**OSM Departure Time:** 1900**Contractor:** Zhenhua Port Machinery Company, Ltd (ZPMC), Changxing Island **Location:** Shanghai, China

# WELDING INSPECTION REPORT

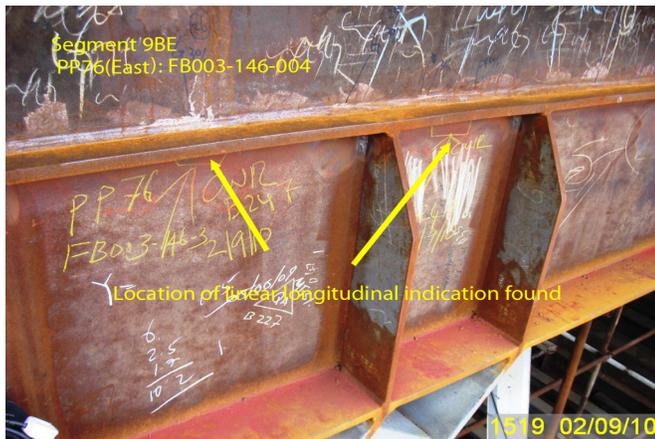
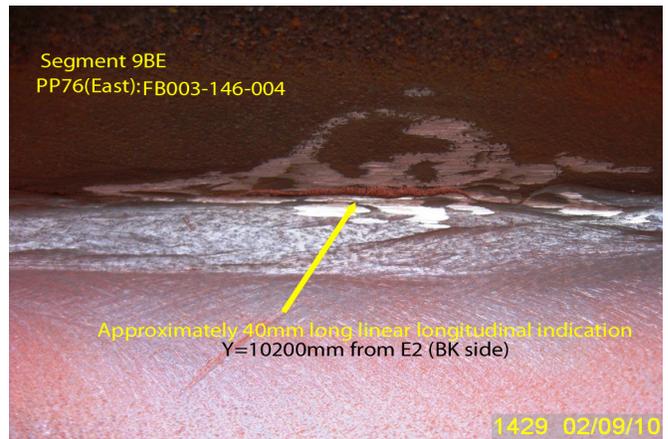
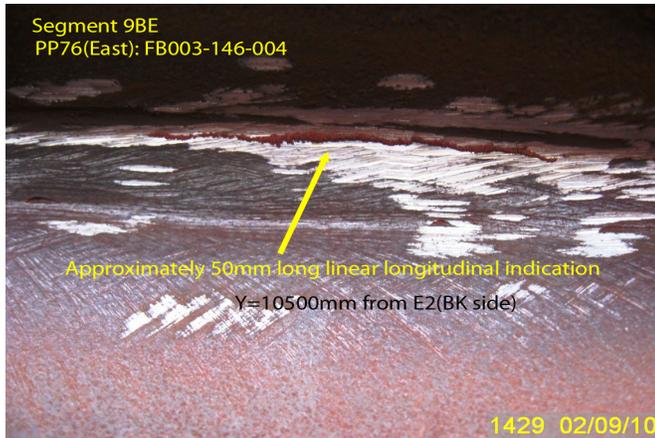
The following weld did not appear to comply with the applicable contract documents:

SEG 9BE:

1) PP75-FB003-146 – 004.

- During in process visual inspection of the above mentioned weld, this QA observed Two (2) linear indications.
- This was confirmed with MT wherein, One (1) longitudinal crack measuring approximately 50 mm length. Second (1) linear crack measuring approximately 40mm length respectively were observed.
- The above mentioned welds were previously Magnetic Particle Testing (MT) tested and accepted by ZPMC Quality Control (QC) personnel.
- The member(s) are identified as OBG components – Floor Beam & Floor Beam Flange on PP75 east side.
- This QA Inspector has generated MT report for this date.
- For further information, please see the attached photos.

During the Quality Assurance Magnetic particle Testing (MT) review of welds located on OBG Segment 9BE, this Quality Assurance Inspector (QA) discovered the following issue:

- Two (2) linear Longitudinal indication that measured approximately 50mm and 40mm in length.
