DEPARTMENT OF TRANSPORTATION

Contract #: 04-0120F4Cty: SF/ALA Rte: 80 PM: 13.2/13.9File #: 99.28**WELDING INSPECTION REPORT****Resident Engineer:** Pursell, Gary**Address:** 333 Burma Road**City:** Oakland, CA 94607**Report No:** WIR-012333**Date Inspected:** 24-Feb-2010**Project Name:** SAS Superstructure**OSM Arrival Time:** 645**Prime Contractor:** American Bridge/Fluor Enterprises, a JV**OSM Departure Time:** 1845**Contractor:** Zhenhua Port Machinery Company, Ltd (ZPMC) Chanxing Island**Location:** Shanghai, China

CWI Name:	N/A	CWI Present:	Yes	No
Inspected CWI report:	Yes No N/A	Rod Oven in Use:	Yes No N/A	
Electrode to specification:	Yes No N/A	Weld Procedures Followed:	Yes No N/A	
Qualified Welders:	Yes No N/A	Verified Joint Fit-up:	Yes No N/A	
Approved Drawings:	Yes No N/A	Approved WPS:	Yes No N/A	
		Delayed / Cancelled:	Yes No N/A	
Bridge No:	34-0006	Component:	OBG Segment 10BE

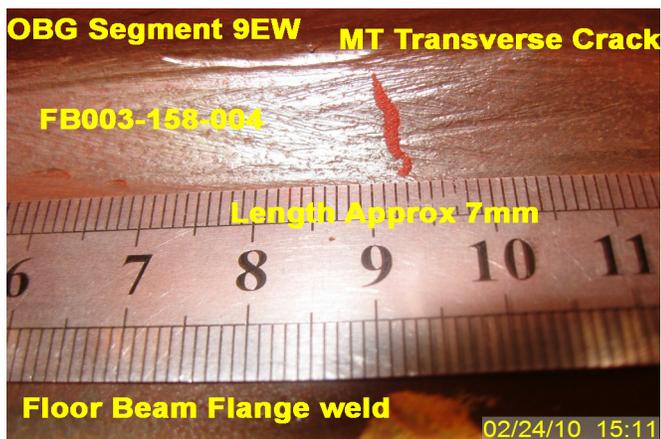
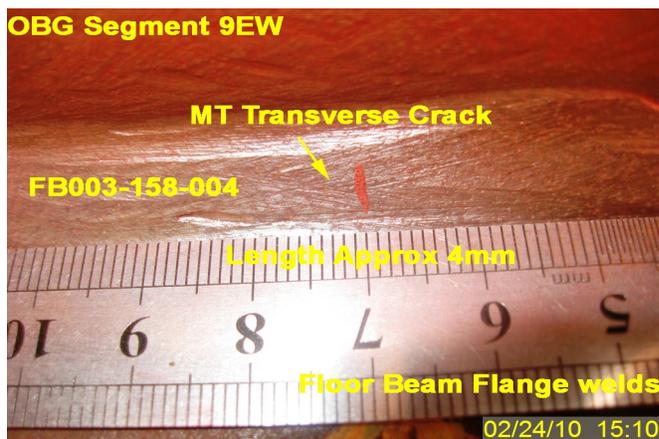
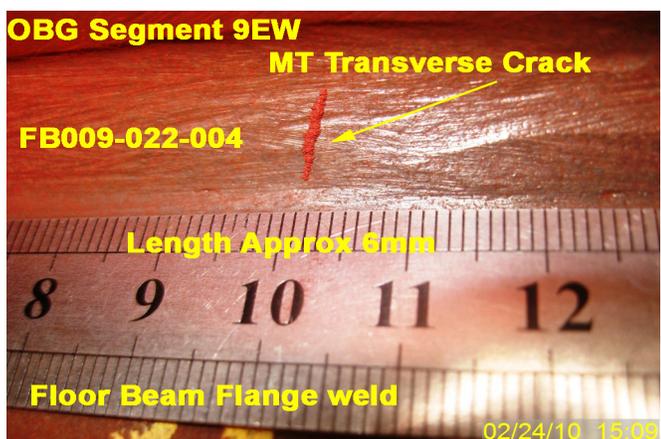
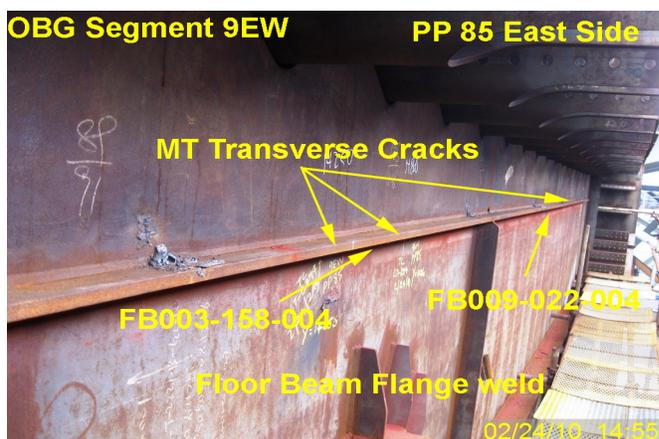
Description of Incident: During random Quality Assurance Visual review of welds located on segment 9EW, this Quality Assurance Inspector (QA) discovered three (3) Transverse linear indications measuring approximately 4mm, 6mm & 7mm in lengths. The indications were discovered visually and confirmed by Magnetic particle Testing (MT) by Caltrans QA. ZPMC Quality Control MT Technicians claimed that magnetic particle testing have been performed on these welds that require 25% MT. The indication is clearly marked on the material near the weld. The welds are identified as FB003-158-004 and FB009-022-004. The panel point is identified as a PP85. This weld is a Fillet weld joining the Floor beam Web to Flange. The Floor Beam Flange weld is identified as Non SPCM. For further information, please see the attached pictures
