DEPARTMENT OF TRANSPORTATION

Contract #: 04-0120F4Cty: SF/ALA Rte: 80 PM: 13.2/13.9File #: 69.28**WELDING INSPECTION REPORT****Resident Engineer:** Pursell, Gary**Address:** 333 Burma Road**City:** Oakland, CA 94607**Report No:** WIR-012350**Date Inspected:** 28-Feb-2010**Project Name:** SAS Superstructure**OSM Arrival Time:** 645**Prime Contractor:** American Bridge/Fluor Enterprises, a JV**OSM Departure Time:** 1845**Contractor:** Zhenhua Port Machinery Company, Ltd (ZPMC), Changxing Island **Location:** Shanghai, China

Segment-10AE

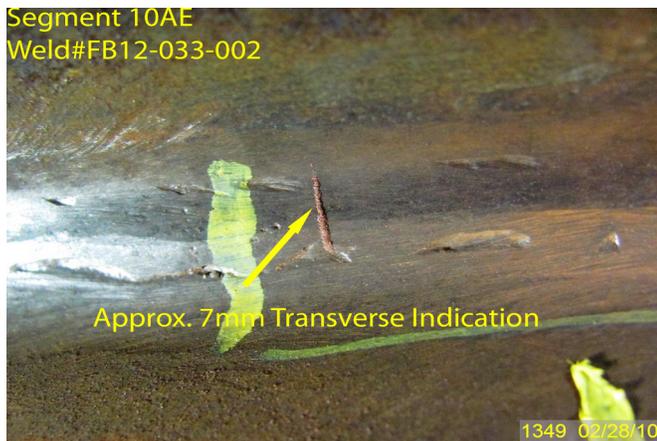
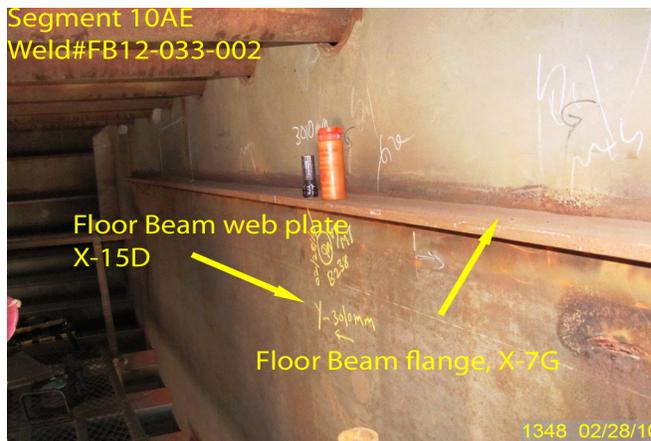
- One (1) linear indication in sub-assembly floor beam flange to web weld at panel point 87.
- The welds were identified as:
 - FB012-033-002 (7mm transverse linear indication) at "Y" location 3010mm (panel point 87 east side).
 - The "Y" Location measurement for weld FB012-033-002 was pulled from weld SSD17A-PP87-002.
- This indication is clearly marked on the material or near the weld.
- Visual indication was confirmed by Magnetic Particle Testing by Caltrans QA.
- Indication appears to be outside of the area tested and accepted by ZPMC QC.
- The welds are 6mm fillet welds joining the FL1 floor beam web to flange.
- This OBG Segment is located at outside yard.
