**DEPARTMENT OF TRANSPORTATION**

Contract #: 04-0120F4Cty: SF/ALA Rte: 80 PM: 13.2/13.9File #: 69.28**WELDING INSPECTION REPORT****Resident Engineer:** Pursell, Gary**Address:** 333 Burma Road**City:** Oakland, CA 94607**Report No:** WIR-012351**Date Inspected:** 27-Feb-2010**Project Name:** SAS Superstructure**OSM Arrival Time:** 645**Prime Contractor:** American Bridge/Fluor Enterprises, a JV**OSM Departure Time:** 1845**Contractor:** Zhenhua Port Machinery Company, Ltd (ZPMC), Changxing Island **Location:** Shanghai, China

**Segment-9DW**

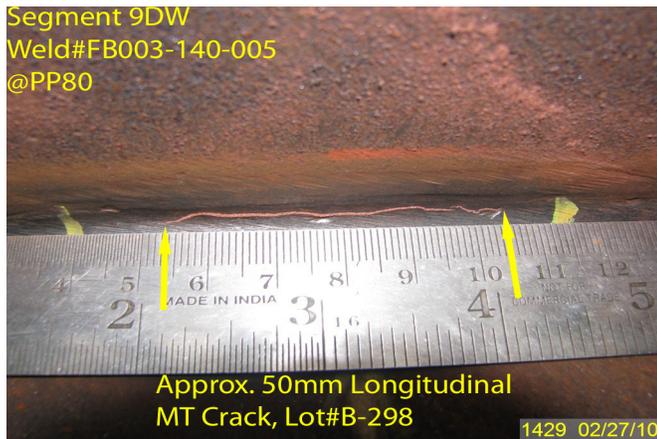
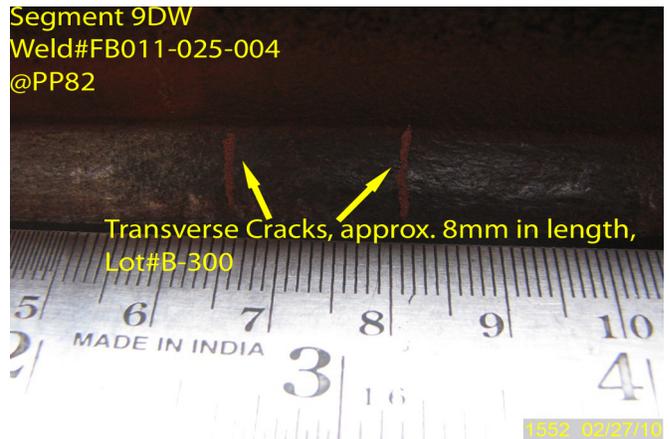
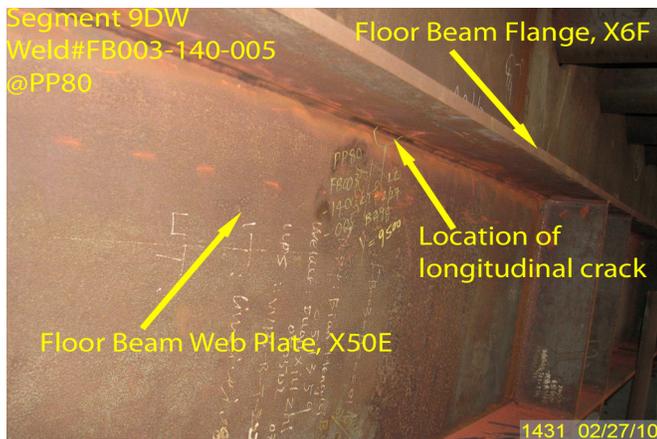
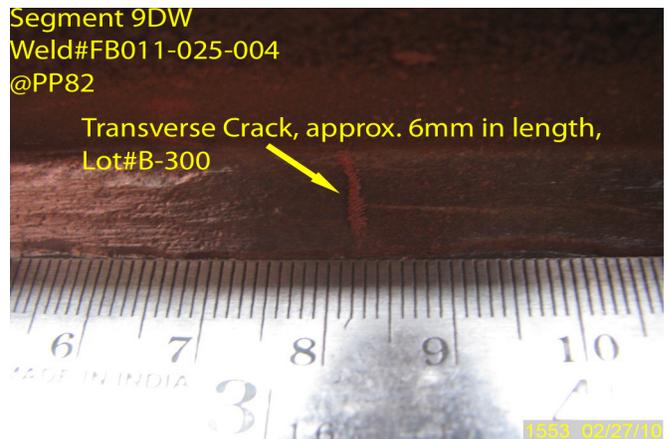
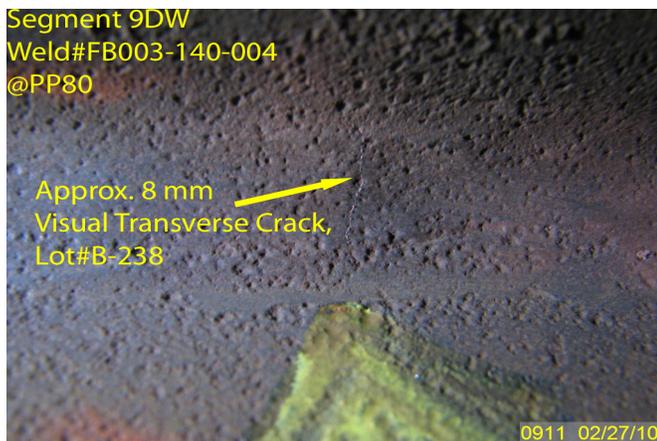
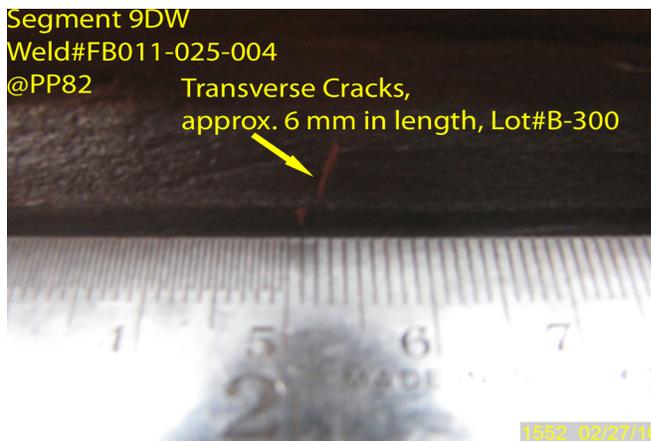
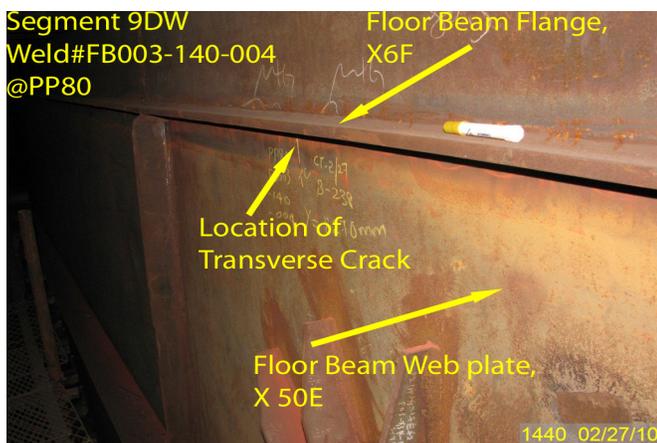
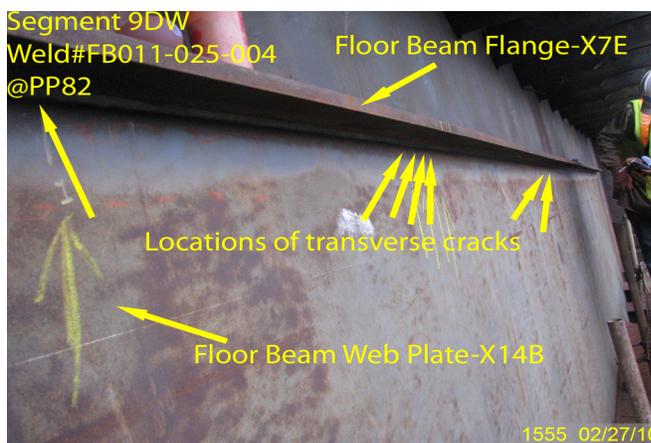
During random Quality Assurance Visual review of welds located on segment 9DW, this Quality Assurance Inspector (QA) discovered the following issues:

-Nine (9) linear indications measuring approximately 4 mm and 50 mm in length.

-The indications are clearly marked on the material near the weld.

1. FB003-140-005, Longitudinal crack, approximately 50mm in length@ PP80, Y location-9500mm from Counter Weight side.

2. FB003-140-004, Transverse crack, approximately 6mm in length@ PP80, Y location-8270mm from Cross Beam side.

3. FB011-025-004, total seven (7) Transverse cracks, measuring approximately 4mm to 8mm in Length and Y locations is as given below.

- Indication 1- 9220 mm from Counter Weight side.
- Indication 2&3- 6440 mm from Counter Weight side.
- Indication 4&5- 6320 mm from Counter Weight side.
- Indication 6&7- 1040 mm from Counter Weight side.

-These welds are Fillet weld joining the Floor beam Web to Flange.

- These welds are designated as non Seismic Performance Critical Member (non SPCM).
  - OBG segment 9DW is located in outside yard, behind OBG Bay#14.
  - The indications were discovered visually and confirmed by Magnetic particle Testing (MT) by Caltrans QA.
  - ZPMC Quality Control Personnel have performed 25% Magnetic Particle Testing of these welds.
- For further information, see the attached pictures below. Please see incident report on this date.
