DEPARTMENT OF TRANSPORTATION

Contract #: 04-0120F4Cty: SF/ALA Rte: 80 PM: 13.2/13.9File #: 69.28**WELDING INSPECTION REPORT****Resident Engineer:** Pursell, Gary**Address:** 333 Burma Road**City:** Oakland, CA 94607**Report No:** WIR-012389**Date Inspected:** 07-Feb-2010**Project Name:** SAS Superstructure**OSM Arrival Time:** 645**Prime Contractor:** American Bridge/Fluor Enterprises, a JV**OSM Departure Time:** 1845**Contractor:** Zhenhua Port Machinery Company, Ltd (ZPMC), Changxing Island **Location:** Shanghai, China

OBG Trial Assembly-

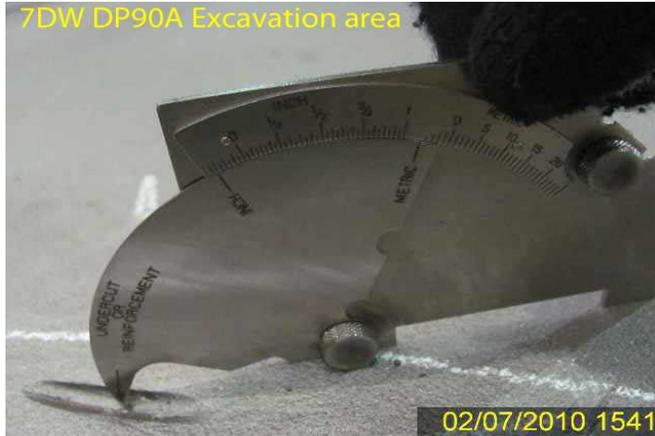
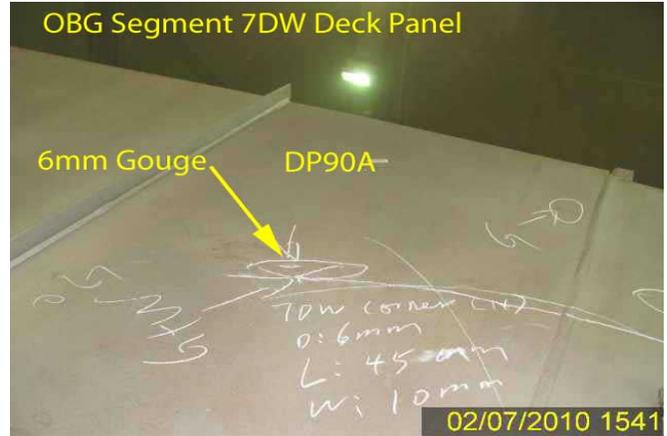
Caltrans Quality Assurance (QA) Inspectors performed random visual inspection of OBG segment 7DW external surfaces after grit blasting. Areas that marked for repair were recorded for future repair. Areas requiring additional grinding were marked by QA and repaired by ZPMC personnel. Please see attached photos of repair area located on OBG Segment 7DW exterior Deck Panel DP90A.
