DEPARTMENT OF TRANSPORTATION

Contract #: 04-0120F4Cty: SF/ALA Rte: 80 PM: 13.2/13.9File #: 69.28**WELDING INSPECTION REPORT****Resident Engineer:** Pursell, Gary**Address:** 333 Burma Road**City:** Oakland, CA 94607**Report No:** WIR-012543**Date Inspected:** 28-Feb-2010**Project Name:** SAS Superstructure**OSM Arrival Time:** 700**Prime Contractor:** American Bridge/Fluor Enterprises, a JV**OSM Departure Time:** 1900**Contractor:** Zhenhua Port Machinery Company, Ltd (ZPMC), Changxing Island **Location:** Shanghai, China

WELDING INSPECTION REPORT

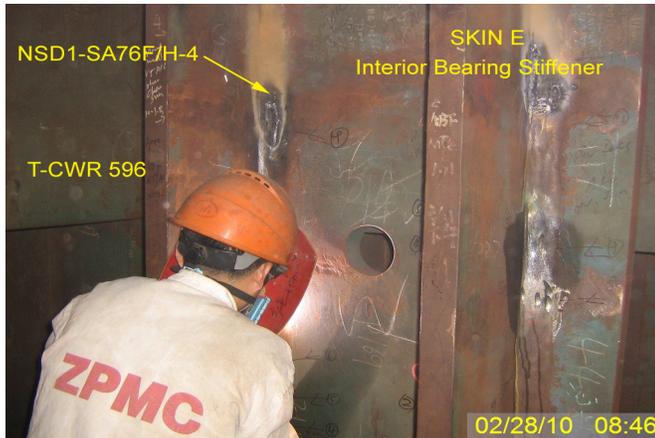
ZPMC performed Base metal repair of Interior Bearing Stiffener located on Skin E (NSD1-SA76F/H-4). The weld metal repair areas were approximately 3mm depth and app.100mm length at 3 random locations. The material is A 709M Grade 345 Non-SPCM. Welder is identified as 500331.ZPMC CWI is identified as Mr. You Qi Guo. SMAW welding was been performed against Critical Weld repair report T-CWR596. The welding variables recorded by QC appeared to comply with the WPS-345-SMAW-3G (3F)-Repair. Please see the attached picture below.

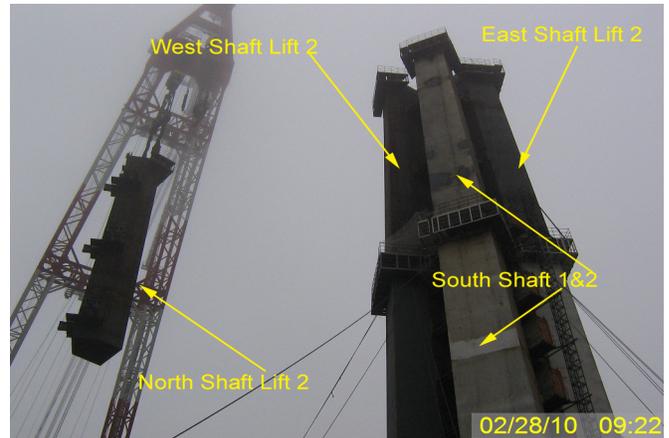
During In-process inspection in Heavy Dock Tower Trail Assembly area this Caltrans Quality Assurance (QA) Inspector covered North Tower Lift 2 Tipping. Please see the attached pictures below.
