DEPARTMENT OF TRANSPORTATION

Quality Assurance and Source Inspection

Contract #: 04-0120F4Cty: SF/ALA Rte: 80 PM: 13.2/13.9File #: 69.28**WELDING INSPECTION REPORT****Resident Engineer:** Pursell, Gary**Address:** 333 Burma Road**City:** Oakland, CA 94607**Report No:** WIR-013205**Date Inspected:** 18-Feb-2010**Project Name:** SAS Superstructure**OSM Arrival Time:** 7000**Prime Contractor:** American Bridge/Fluor Enterprises, a JV**OSM Departure Time:** 1900**Contractor:** Zhenhua Port Machinery Company, Ltd (ZPMC), Changxing Island **Location:** Shanghai, China

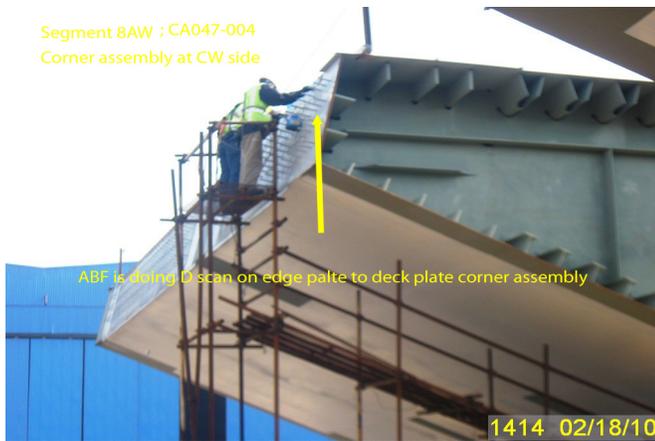
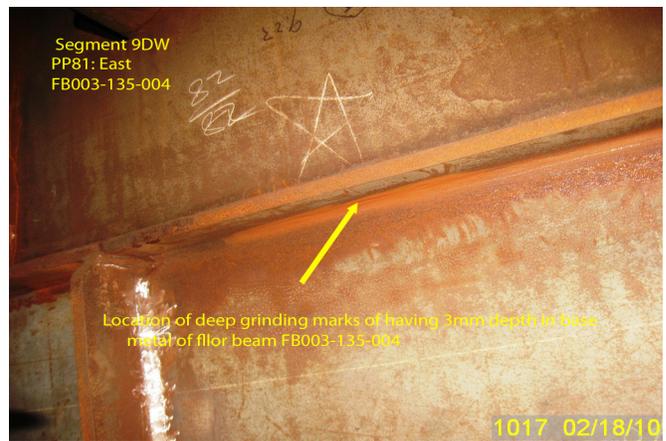
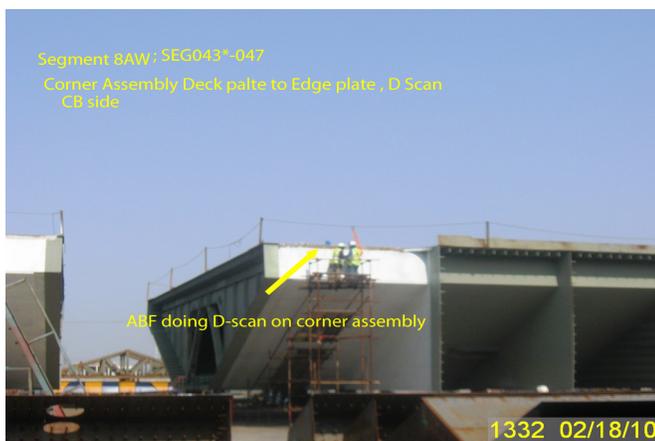
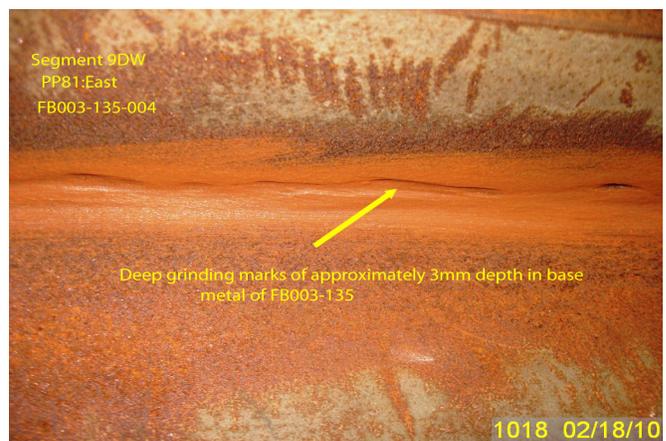
Caltrans Quality Assurance (QA) Inspectors performed random visual inspection of OBG segment 8CE internal deck panel, floor beam and corner assembly surfaces from the panel point 67.5 to 69 after grit blasting. Areas requiring additional grinding were marked by QA and repaired by ZPMC personnel.

Caltrans Quality Assurance (QA) Inspectors performed random visual inspection of OBG segment 8CE. The whole segment exterior Bottom panel, side panel, deck panel carried out. Areas requiring additional grinding were marked by QA and repaired by ZPMC personnel

-This QA inspector performed in process Visual Inspection of the below mentioned fillet welds between Floor Beam and Floor Beam Flange at East side

1)PP81-FB003-135 – 004.

-One location found some deep grinding marks of approximately 3mm deep, those location marked for future

ZPMC repair and NDT.

-Visually, these welds appeared to comply with the contract documents.

ABF Quality control (QC) personnel doing UT scanning pattern D as per contract documents on OBG corner assembly CA047 weld is identified as CA047-004 and SEG043*-047 which is connecting Deck plate to Edge plate.
