DEPARTMENT OF TRANSPORTATION

Contract #: 04-0120F4Cty: SF/ALA Rte: 80 PM: 13.2/13.9File #: 69.28**WELDING INSPECTION REPORT****Resident Engineer:** Pursell, Gary**Address:** 333 Burma Road**City:** Oakland, CA 94607**Report No:** WIR-013507**Date Inspected:** 23-Feb-2010**Project Name:** SAS Superstructure**OSM Arrival Time:** 7000**Prime Contractor:** American Bridge/Fluor Enterprises, a JV**OSM Departure Time:** 1900**Contractor:** Zhenhua Port Machinery Company, Ltd (ZPMC), Changxing Island **Location:** Shanghai, China**CWI Name:** Li Huaji**CWI Present:** Yes No**Inspected CWI report:** Yes No N/A**Rod Oven in Use:** Yes No N/A**Electrode to specification:** Yes No N/A**Weld Procedures Followed:** Yes No N/A**Qualified Welders:** Yes No N/A**Verified Joint Fit-up:** Yes No N/A**Approved Drawings:** Yes No N/A**Approved WPS:** Yes No N/A**Delayed / Cancelled:** Yes No N/A**Bridge No:** 34-0006**Component:** OBG Components**Summary of Items Observed:**

Segment 9DE

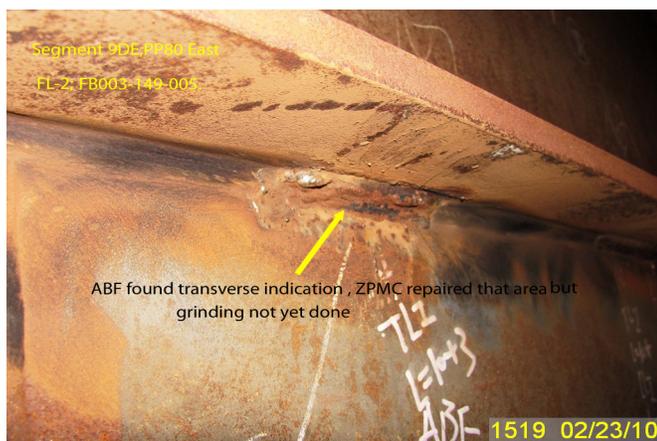
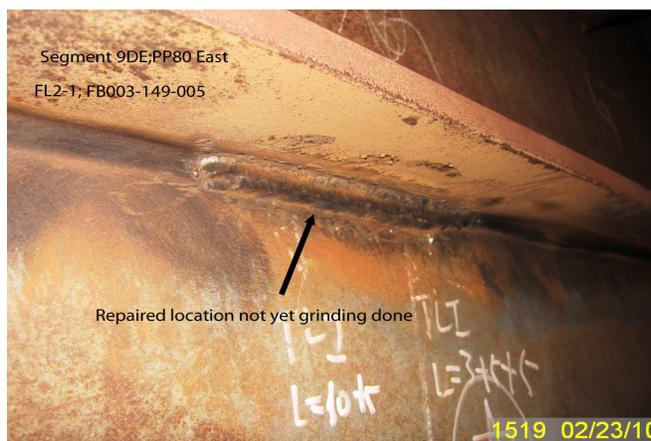
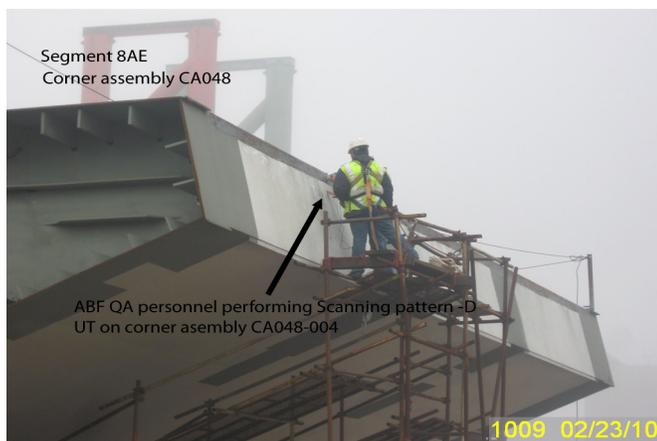
During visual inspection this QA inspector found that some locations in Floor beam FL2 FB003-149-005

ABF QA personnel found some linear and longitudinal indication marked on the welds 6 different location, those areas already repaired by ZPMC but grinding not yet done. These welds were previously MT tested and accepted by ZPMC Quality Control (QC) personnel. For more information please see the photos.
