DEPARTMENT OF TRANSPORTATION

Contract #: 04-0120F4Cty: SF/ALA Rte: 80 PM: 13.2/13.9File #: 69.28**WELDING INSPECTION REPORT****Resident Engineer:** Pursell, Gary**Address:** 333 Burma Road**City:** Oakland, CA 94607**Report No:** WIR-012439**Date Inspected:** 05-Mar-2010**Project Name:** SAS Superstructure**OSM Arrival Time:** 700**Prime Contractor:** American Bridge/Fluor Enterprises, a JV**OSM Departure Time:** 1900**Contractor:** Zhenhua Port Machinery Company, Ltd (ZPMC), Changxing Island **Location:** Shanghai, China**CWI Name:****CWI Present:**

Bridge No: 34-0006**Component:** OBG Trial Assembly**Summary of Items Observed:**

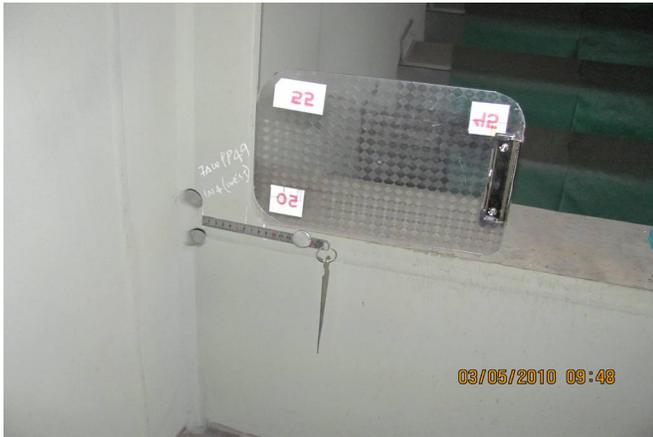
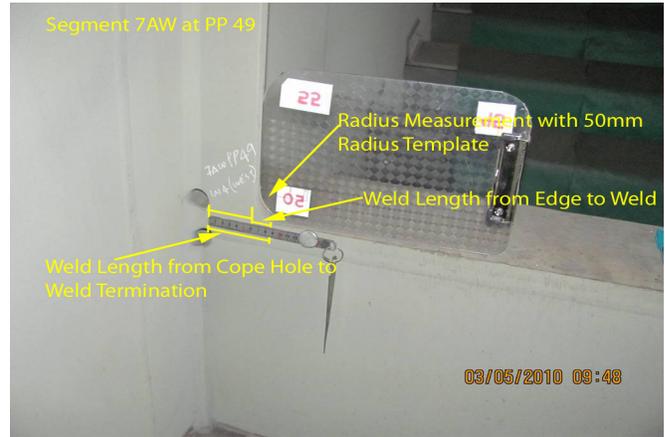
This Quality Assurance (QA) Inspector measured and recorded the Dimension for Floor Beam Stiffener to Longitudinal Diaphragm Flange for the Radius and Distance from the Edge to Weld and Weld Length from Cope Hole at W3 and W4 locations Panel Point (PP) 48 and PP 49. Report forwarded to team leader for further action. Please refer the picture attached below for more comprehensive details of measurements locations.
