DEPARTMENT OF TRANSPORTATION

Quality Assurance and Source Inspection

Contract #: 04-0120F4Cty: SF/ALA Rte: 80 PM: 13.2/13.9File #: 69.28**WELDING INSPECTION REPORT****Resident Engineer:** Pursell, Gary**Address:** 333 Burma Road**City:** Oakland, CA 94607**Report No:** WIR-012440**Date Inspected:** 06-Mar-2010**Project Name:** SAS Superstructure**OSM Arrival Time:** 700**Prime Contractor:** American Bridge/Fluor Enterprises, a JV**OSM Departure Time:** 1900**Contractor:** Zhenhua Port Machinery Company, Ltd (ZPMC), Changxing Island **Location:** Shanghai, China**CWI Name:** Li Yang**CWI Present:** Yes No**Inspected CWI report:** Yes No N/A**Rod Oven in Use:** Yes No N/A**Electrode to specification:** Yes No N/A**Weld Procedures Followed:** Yes No N/A**Qualified Welders:** Yes No N/A**Verified Joint Fit-up:** Yes No N/A**Approved Drawings:** Yes No N/A**Approved WPS:** Yes No N/A**Delayed / Cancelled:** Yes No N/A**Bridge No:** 34-0006**Component:** OBG Trial Assembly**Summary of Items Observed:**

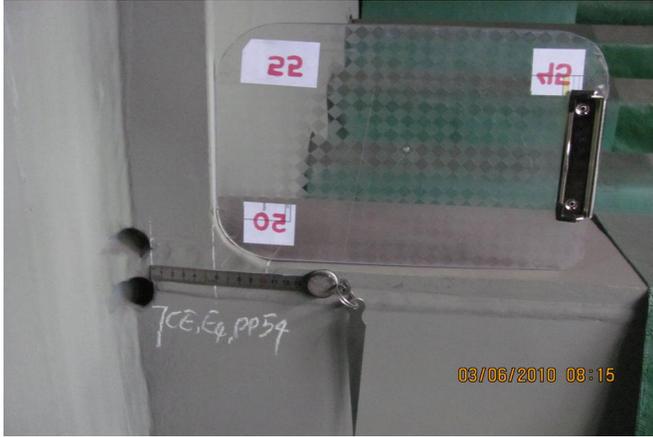
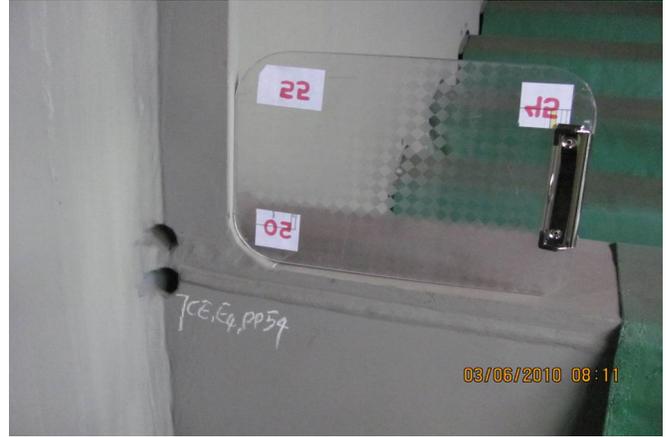
This Quality Assurance (QA) Inspector measured and recorded the Dimension for Floor Beam Stiffener to Longitudinal Diaphragm Flange for the Radius and Distance from the Edge to Weld and Weld Length from Cope Hole at Panel Point (PP) 53, PP 54 and PP 55(East and West Side of the Floor Beam). At PP 55 East side the measurements were not recorded as Floor Beam stiffener not welded to Longitudinal Diaphragm Flange. Report forwarded to team leader for further action. Please refer the pictures attached below for more comprehensive details.
